ARABIAN MINE SURVEY AND RECONNAISSANCE

ENGINEERS INTERNATIONAL, INC. PROJECT NO. AZ1075

SEPTEMBER, 1991

ARIZONA DEPARTMENT OF TRANSPORTATION
HIGHWAYS DIVISION
PHOENIX, ARIZONA

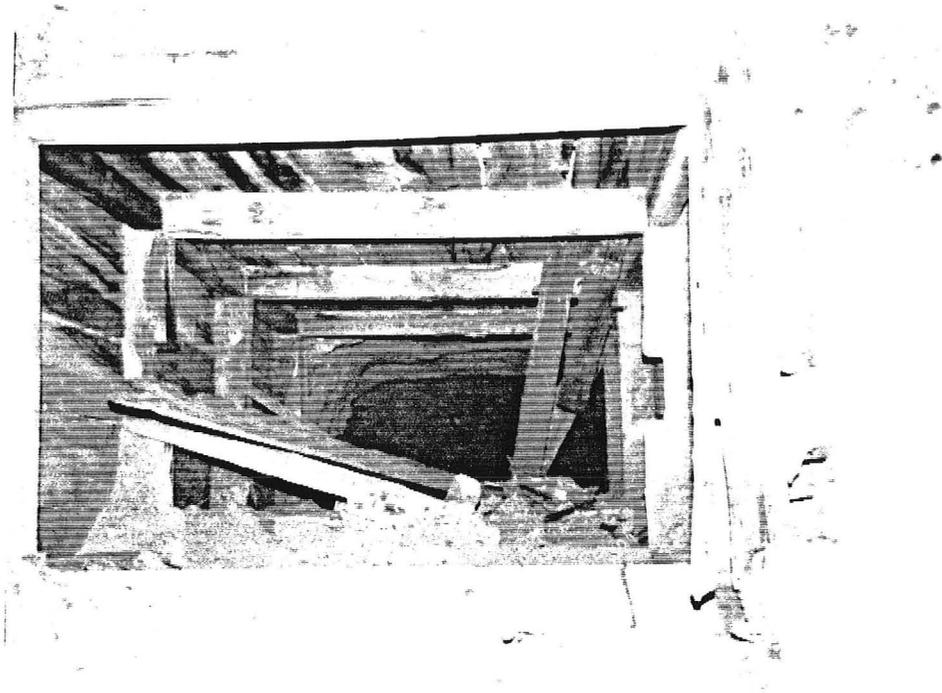
At the Philadelphia No. 1, the shaft collar timber was found to be in good condition, although there was a considerable hazard from collapsed ladders and

Photo 1 Philadelphia No. 1 Shaft. View down the shaft, taken at night prior to the mine entry. Note the generally intact condition of the collar timber. The loose timbers and ladders were removed prior to mine entry.

old wooden shaft guides hanging in the shaft. These held back significant rocks that had fallen into the shaft. To alleviate any chance of personnel working in the shaft with loose debris or rocks overhead, the old ladders and other debris was hoisted out of the shaft and discarded. The ladders were later destroyed to prevent unauthorized replacement of these hazards into the shaft.

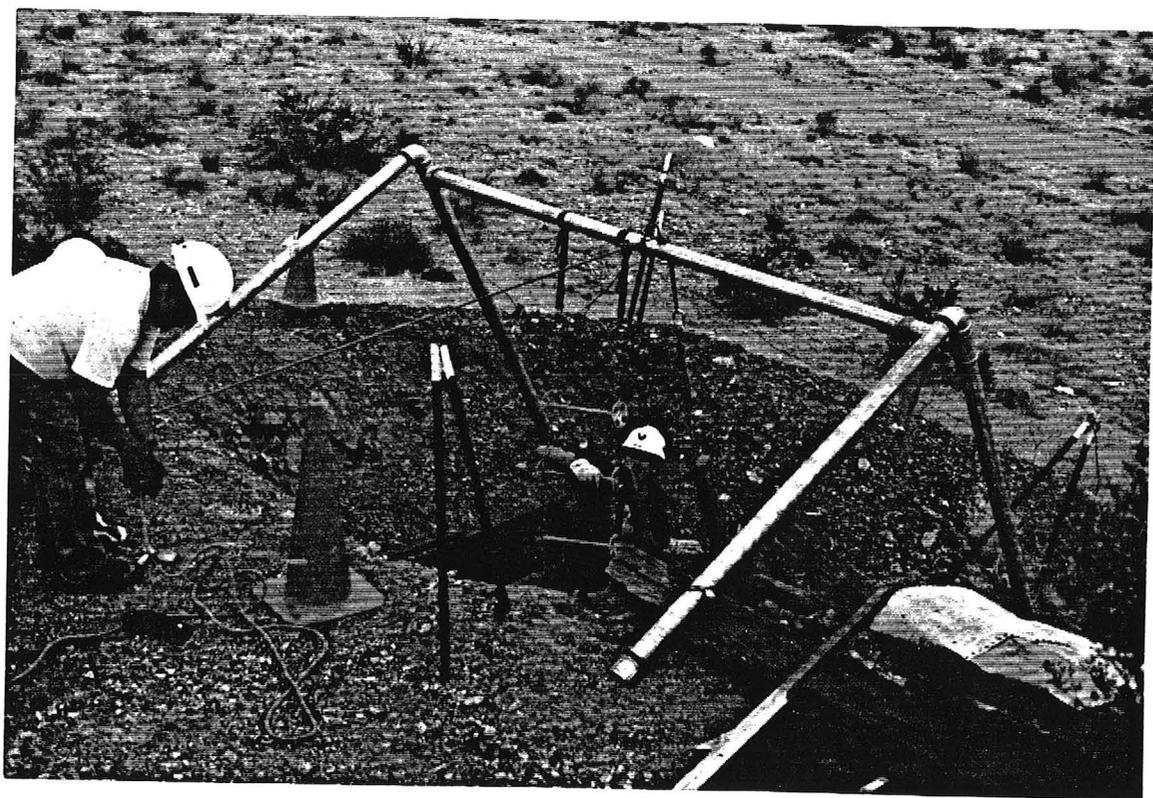
Photo 2 Philadelphia No. 1 Shaft. Hazardous timber and ladders were removed prior to mine entry. Here, a 20-ft section of damaged shaft ladder is being removed. Ship's ladders hanging off a temporary pipe framework were used to support the mine entry and mapping activity.

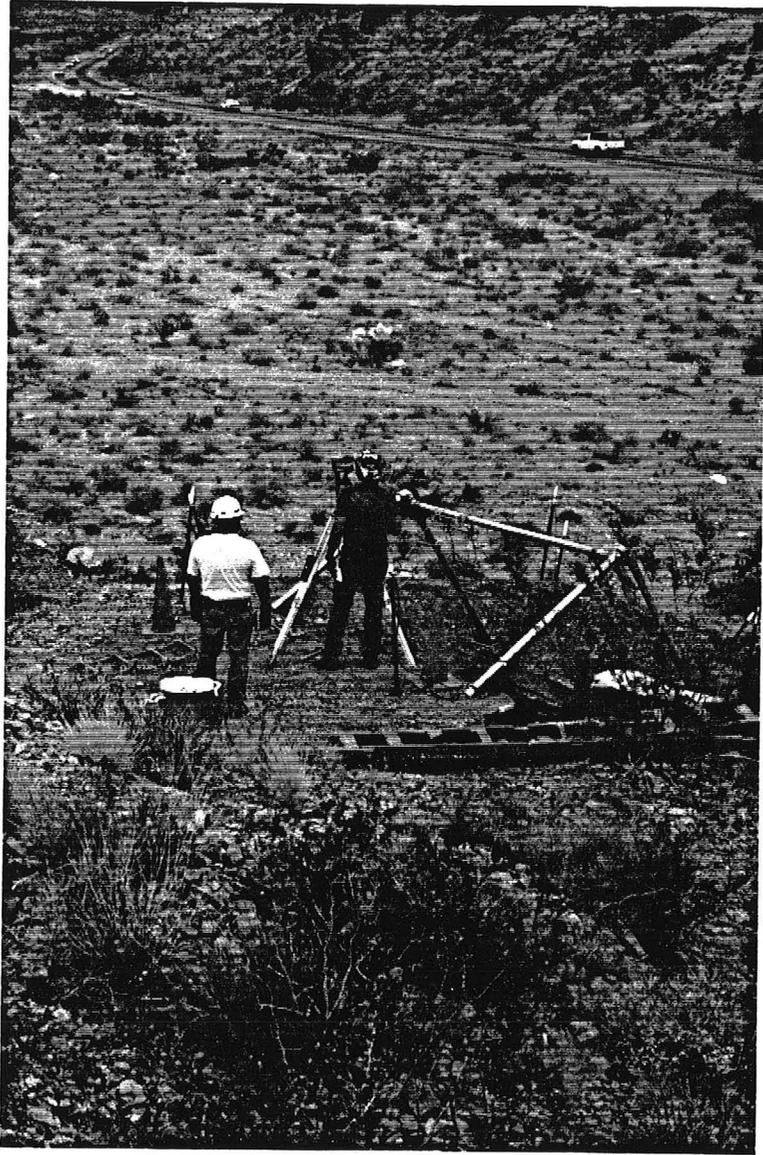
Photo 3 Philadelphia No. 1 Shaft. Shaft collar was tied in with a theodolite and an EDM. Note the proximity of S.R. 68 in the background.

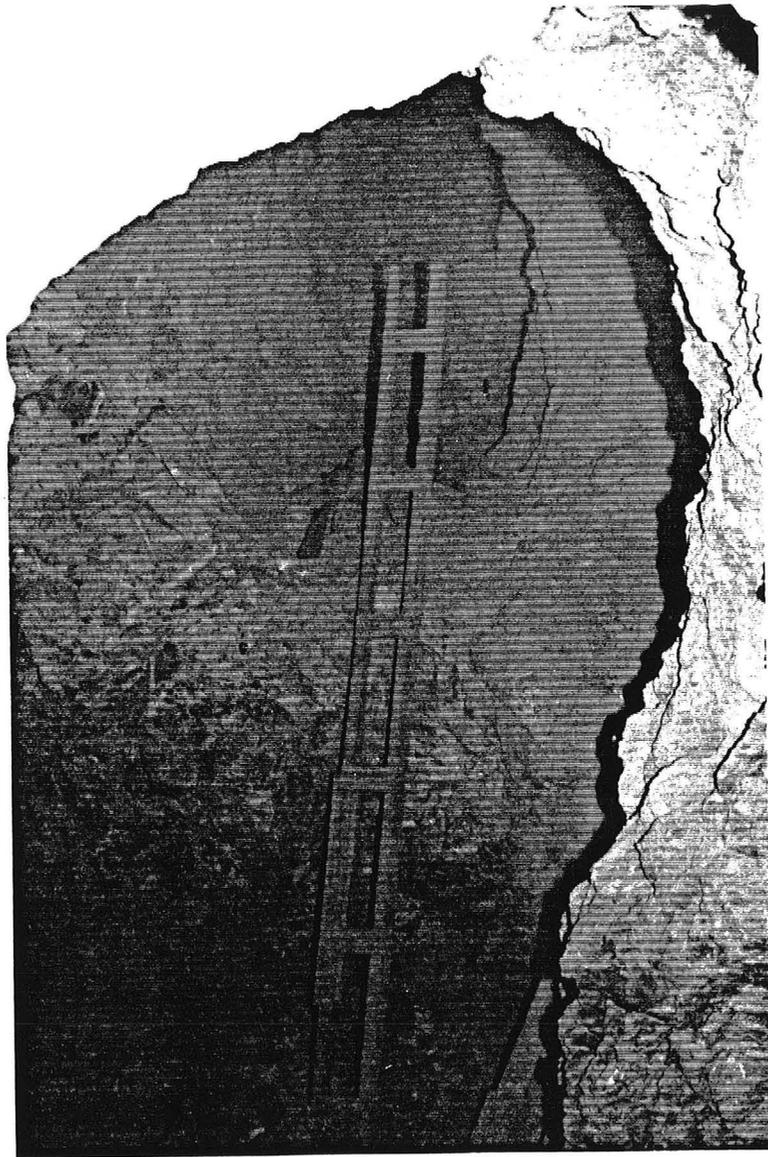
Photo 4 Philadelphia No. 1 Shaft. View ahead from existing spad (designated EI-1) at the bottom of the shaft ("60 level"), looking at the old shaft station. The drift ahead is in the direction toward the highway (same general bearing as the shaft) but dead-ends in granite and gravels. To the left is a stope and to the right is the drift over to the winze between the "60-ft" and "100-ft" levels. All workings on the "60" level were dry at the time of the survey and probably are dry most or all the time.

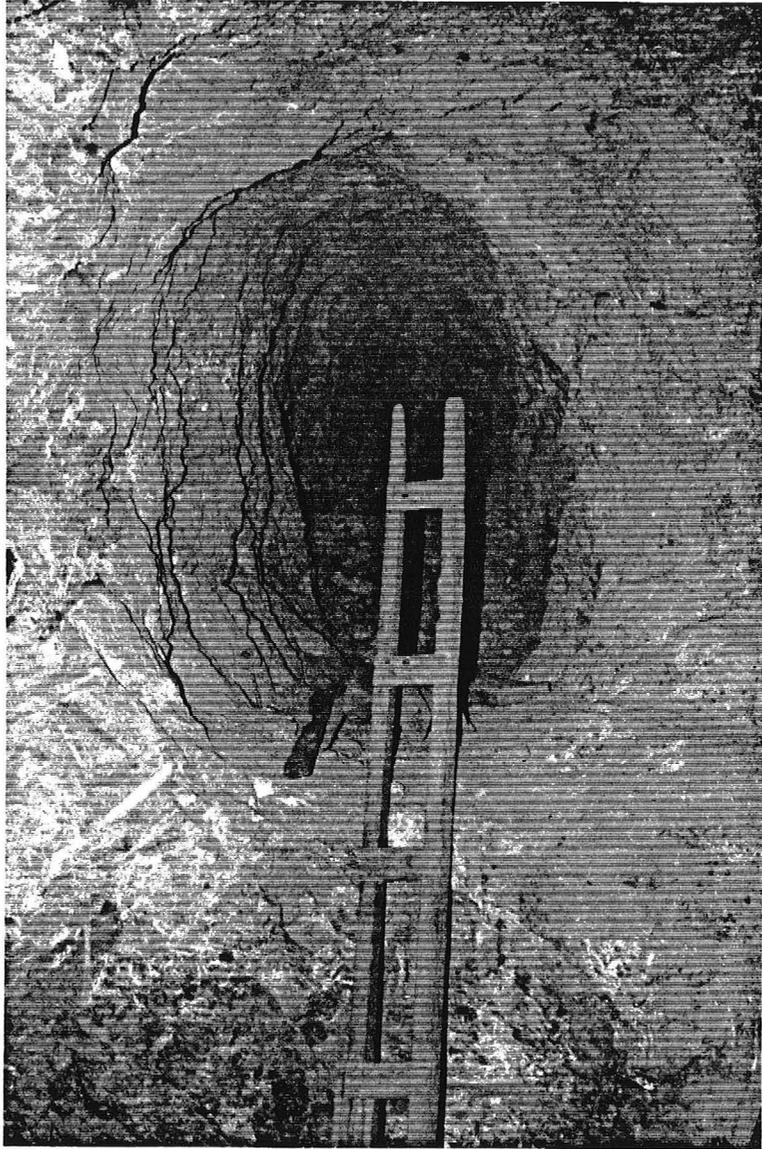
Photo 5 Philadelphia No. 1 Shaft. View ahead from existing spad (designated EI-2) at the shaft station ("60 level"). Shaft station invert is about 6 ft below the invert of the level. The strike of the vein is roughly transverse to the line of the photo. The yellow numbering corresponds to channel sample locations shown on assay maps provided by the Owner. Drift ahead dead-ends in granite and gravels.

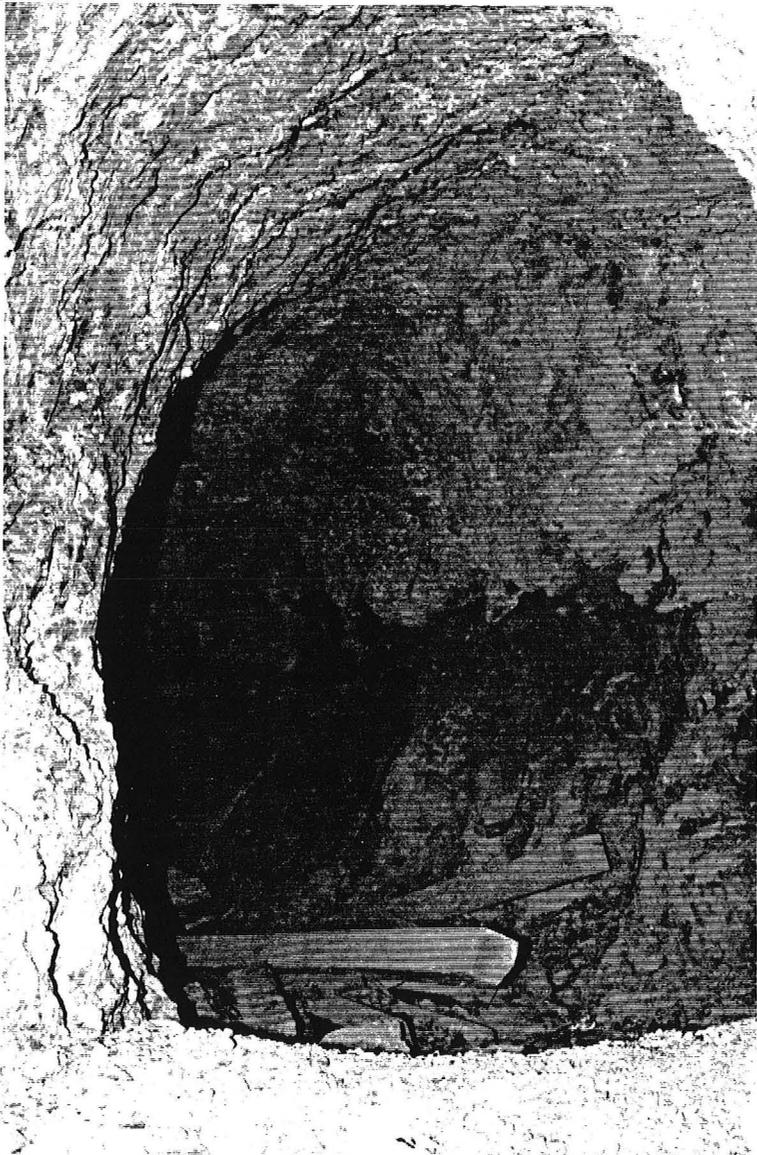
Photo 11 Philadelphia No. 1 Shaft. View from the spad marked EI-2 down the drift leading to the winze ("60 level"); photo taken in the direction of the Philadelphia No. 2 Shaft. Lip of the shaft station is visible at extreme bottom. Note the spalling along a slickensided shear zone along the right rib. The existing spad designated EI-2R1 may be found at upper right center, and is located by the vertical orange marks painted on the ribs by the EI survey team.

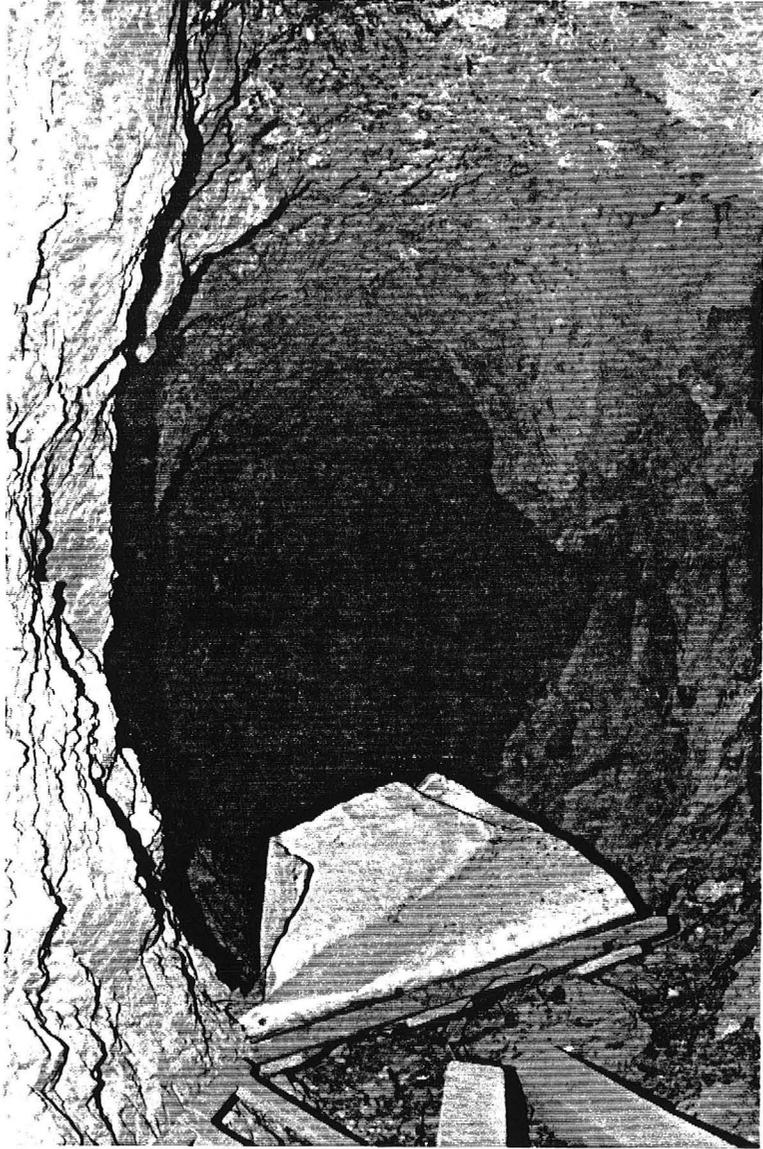
Photo 12 Philadelphia No. 1 Shaft. View towards Philadelphia No. 2 Shaft from the spad EI-2R1. Note the overhang along the shear zone mentioned above. The far-distant rib in the center of the photo is one rib of a crosscut to the left. The drift continues to the right. The existing spad designated EI-2R2 is in this intersection.

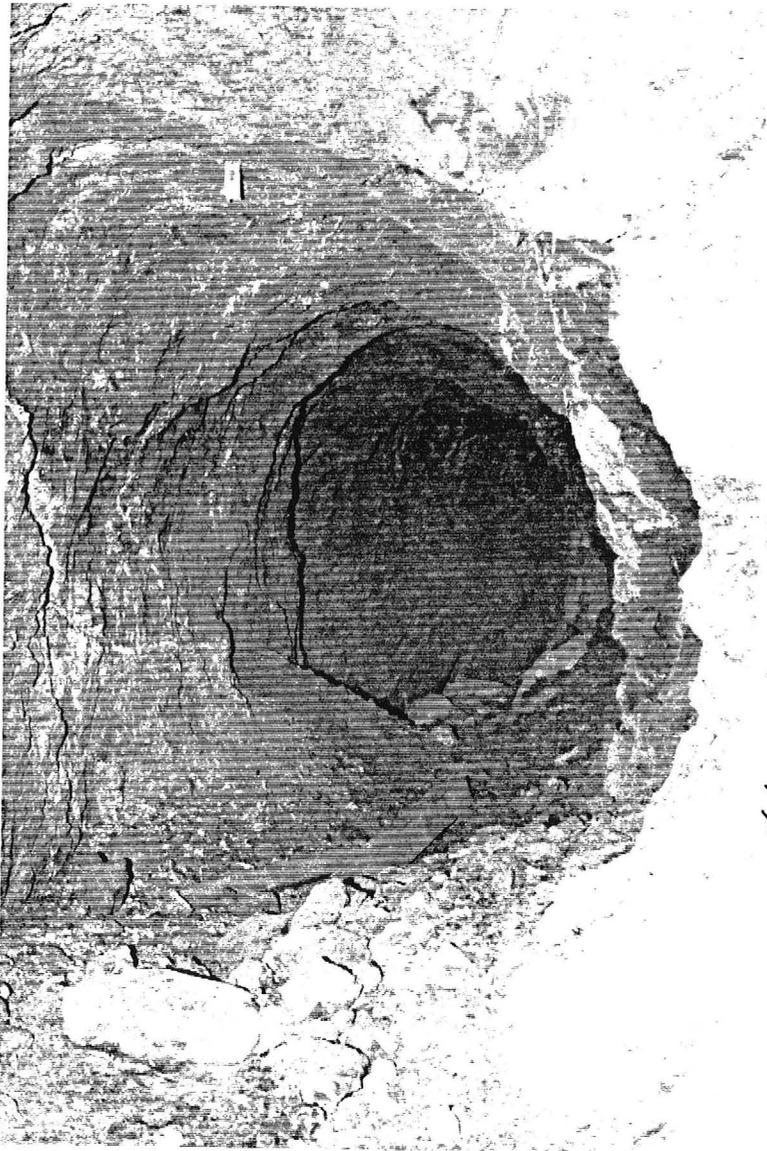
Photo 14 Philadelphia No. 1 Shaft. Photo taken from EI-2R2 toward the Philadelphia No. 2 shaft. The drift ends at the winze, which is where the water pipe projects up in the photo. An existing spad was noted atop the winze and was designated EI-2R3. The spad block at upper left was placed by EI but was not used in the survey. Note the ravelling of the left rib, attesting to the sugary fracturing of the vein material. The vein material is not blocky and not brittle. Contrast this ravelling with that of the right rib, which is block fall from the fault comprising the footwall.

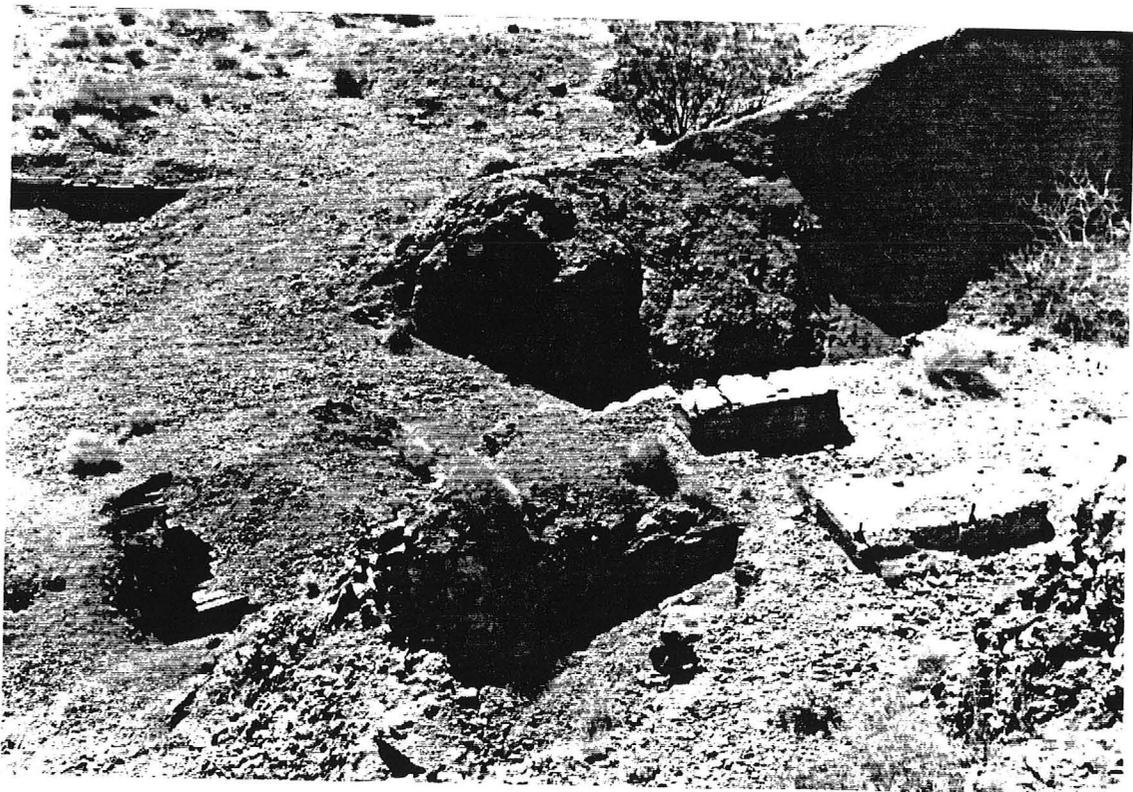
Photo 17 Philadelphia No. 2 Shaft. View from old headframe site above shaft. Note that the shaft is partially covered by a loading platform built to accommodate removal of muck from the depression to the right, which was probably the location of the R-2 Shaft. Note also that the shaft collar timbers are now below the existing ground surface. At one time the shaft collar was near the elevations of the concrete footings in the photo.

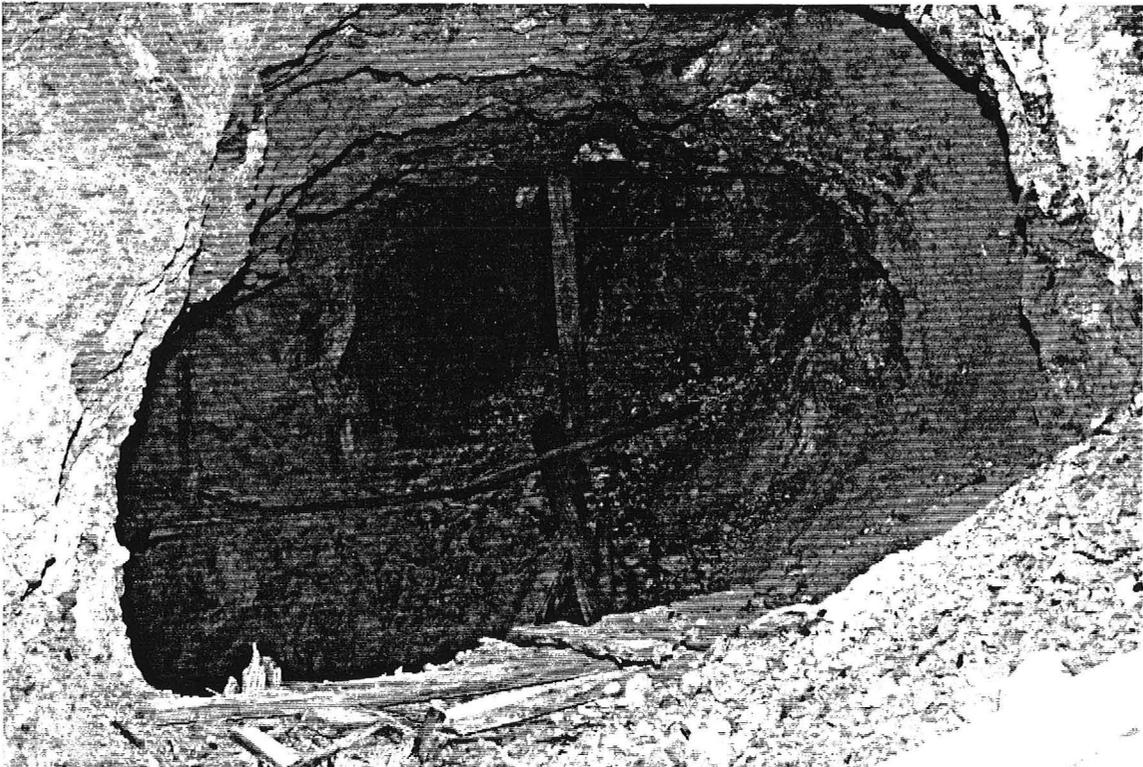
Photo 20 Philadelphia No. 2 Shaft. View of "100" ft level off the shaft, bearing southwest, looking down the strike toward Bullhead City. Photo is taken from the lip of the shaft station, at an intersection with a nearly east-west crosscut running toward the highway that dead-ends in gravels. Shown are the opening of a very steep stope at lower left, and two chutes at right, that empty at the near and far limits of the stope. At lower left is the muck from a third loading chute, caved, that centers about 17 ft from the shaft centerline. The "100" level continues beyond, but is not safely accessible without means to bridge the stope. The accessible portion of the drift runs about 20 degrees west of the strike of a quartz vein that dips moderately eastward. The shaft was enlarged at the level station, which is provided with timber staging. Water is at the same level in the stope as it is in the shaft, which is filled with trash. Beneath the trash, considerable timber clogs the shaft below water level.

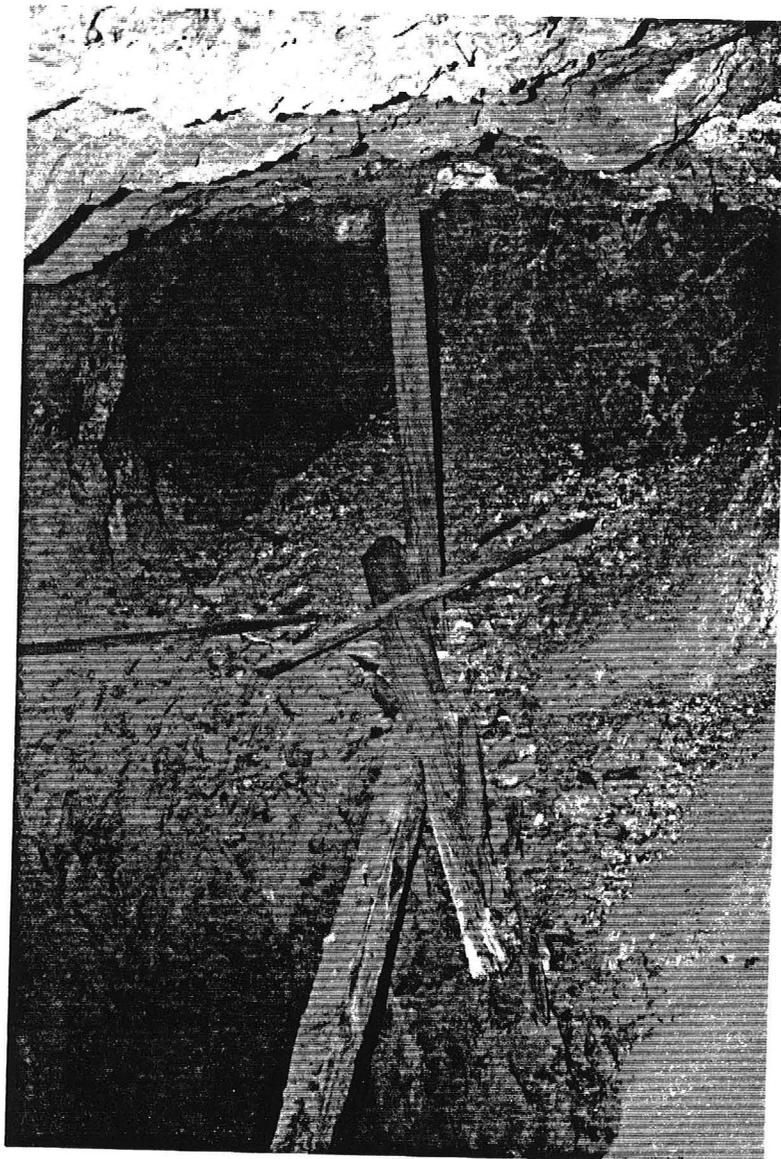
Photo 21 Philadelphia No. 2 Shaft. View of the same drift as in Photo 19, but taken from the lip of the stope. Water level in the stope was measured at 13 ft below the drift invert. The angle to the left made by the "100" level as it continues beyond the stope appears to be about 30 degrees.

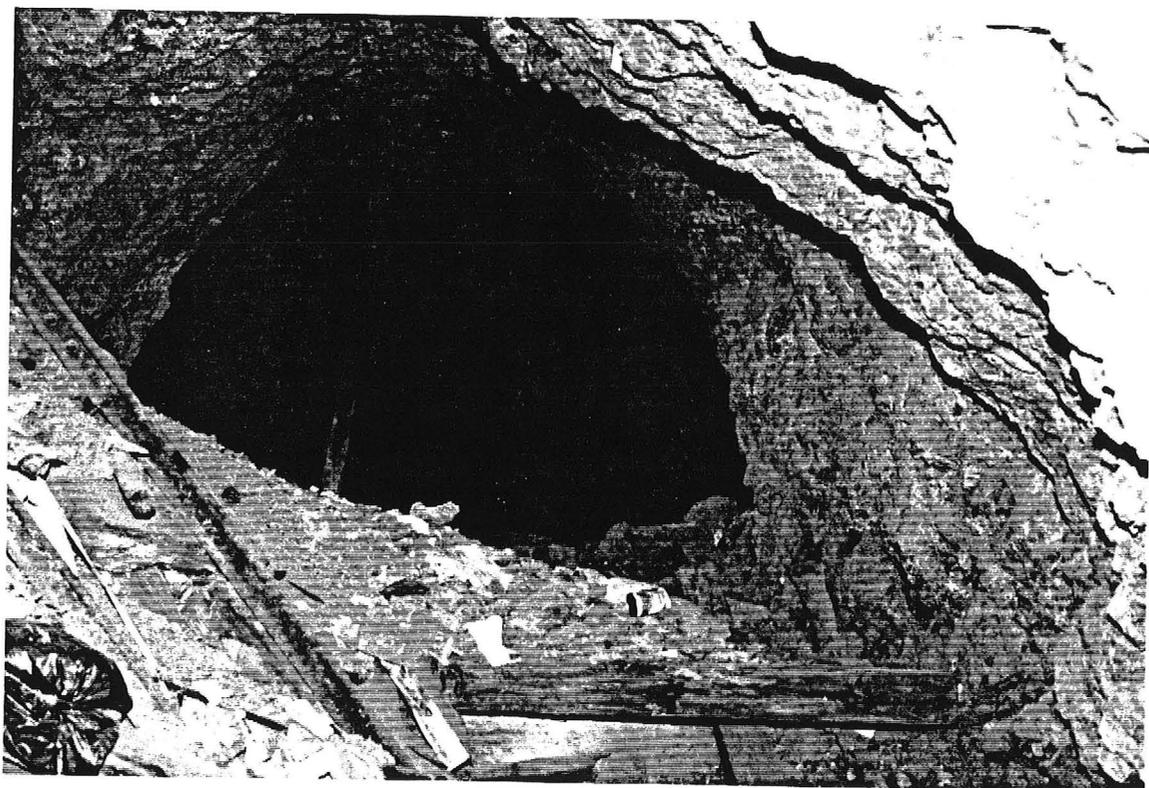
Photo 22 Philadelphia No. 2 Shaft. View of stope entrance in the opposite direction from Photo 17 (northeast). This was also the "100" level. It drops immediately into an inaccessible stope just beyond the shaft wall. The track still remaining in the inclined shaft is visible at left. At top center is a reflector set by EI that was moved downward in order to be visible from the shaft collar. Note the trash that has been scattered by animals.

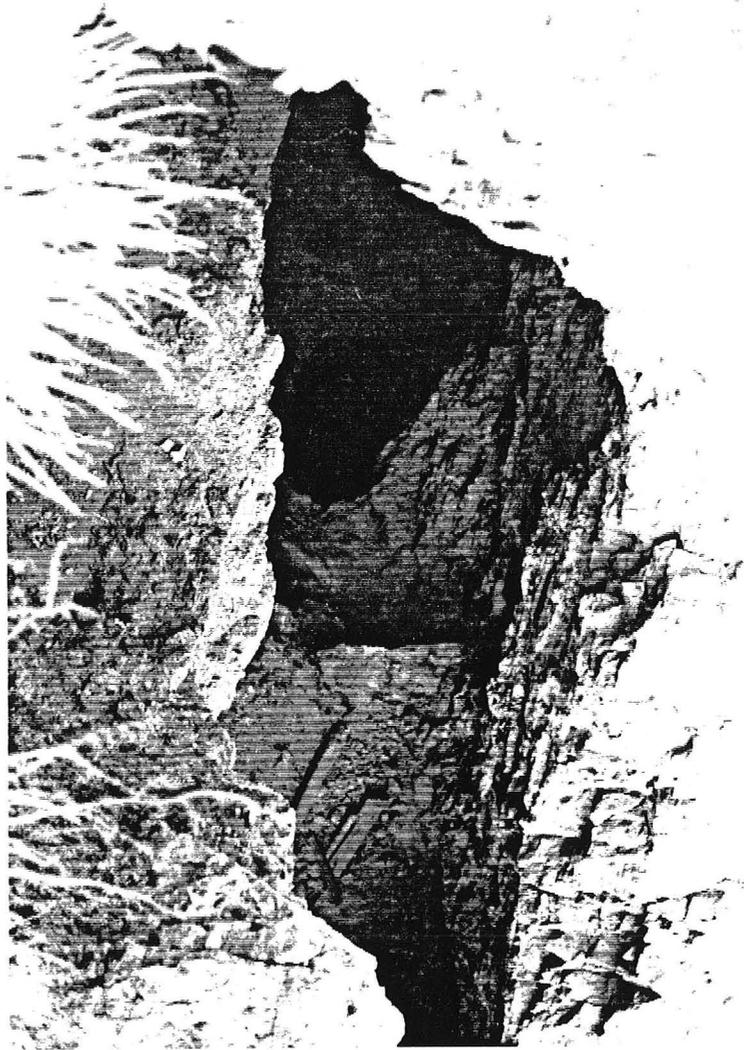
Photo 24 Philadelphia No. 2 Shaft. View of surface expression of stopes that break to the surface. Such stopes have obliterated the older shafts, and are largely inaccessible due to the presence of water at a depth of about 58 ft below the surface, which would be about 20 ft below the deepest pillar visible in the photo. The stopes generally dip flatter than appears here; the steep dip is a result of the camera angle.

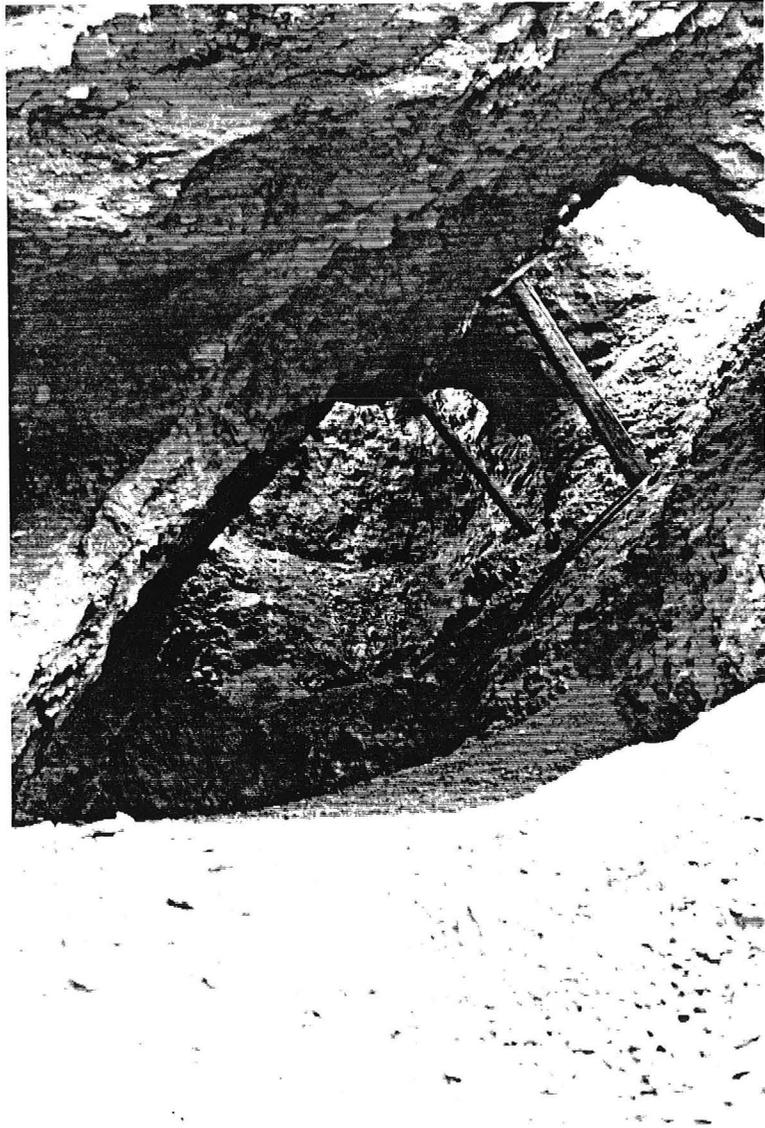
Photo 25 Philadelphia No. 2 Shaft. View down the strike of one of the shallow stopes that break to the surface. The depth below surface is about 20 ft here. The R-1 Shaft probably occupied a position near the center of the photo. The water line probably supported a pumping operation that occurred in the 1980s.

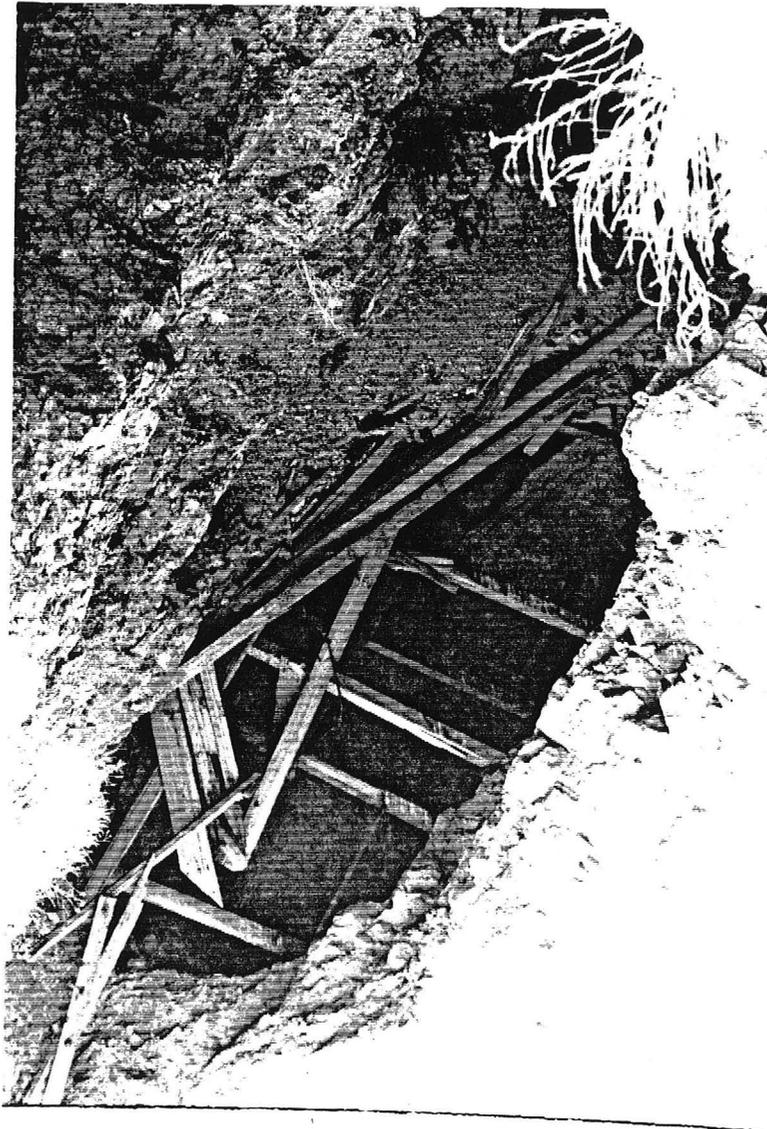
Photo 26 Philadelphia No. 2 Shaft. Another view of the stopes breaking to the surface. This is facing the southernmost extension of these stopes. The timber probably occupies the position of the R-A Shaft.
