COLUMBUS & LEAD CARBONATE

Reconstruction Finance Corporation ✓
Preliminary Development Loan

C-ND-Phoenix 75

REPORT OF SUPERVISING ENGINEER

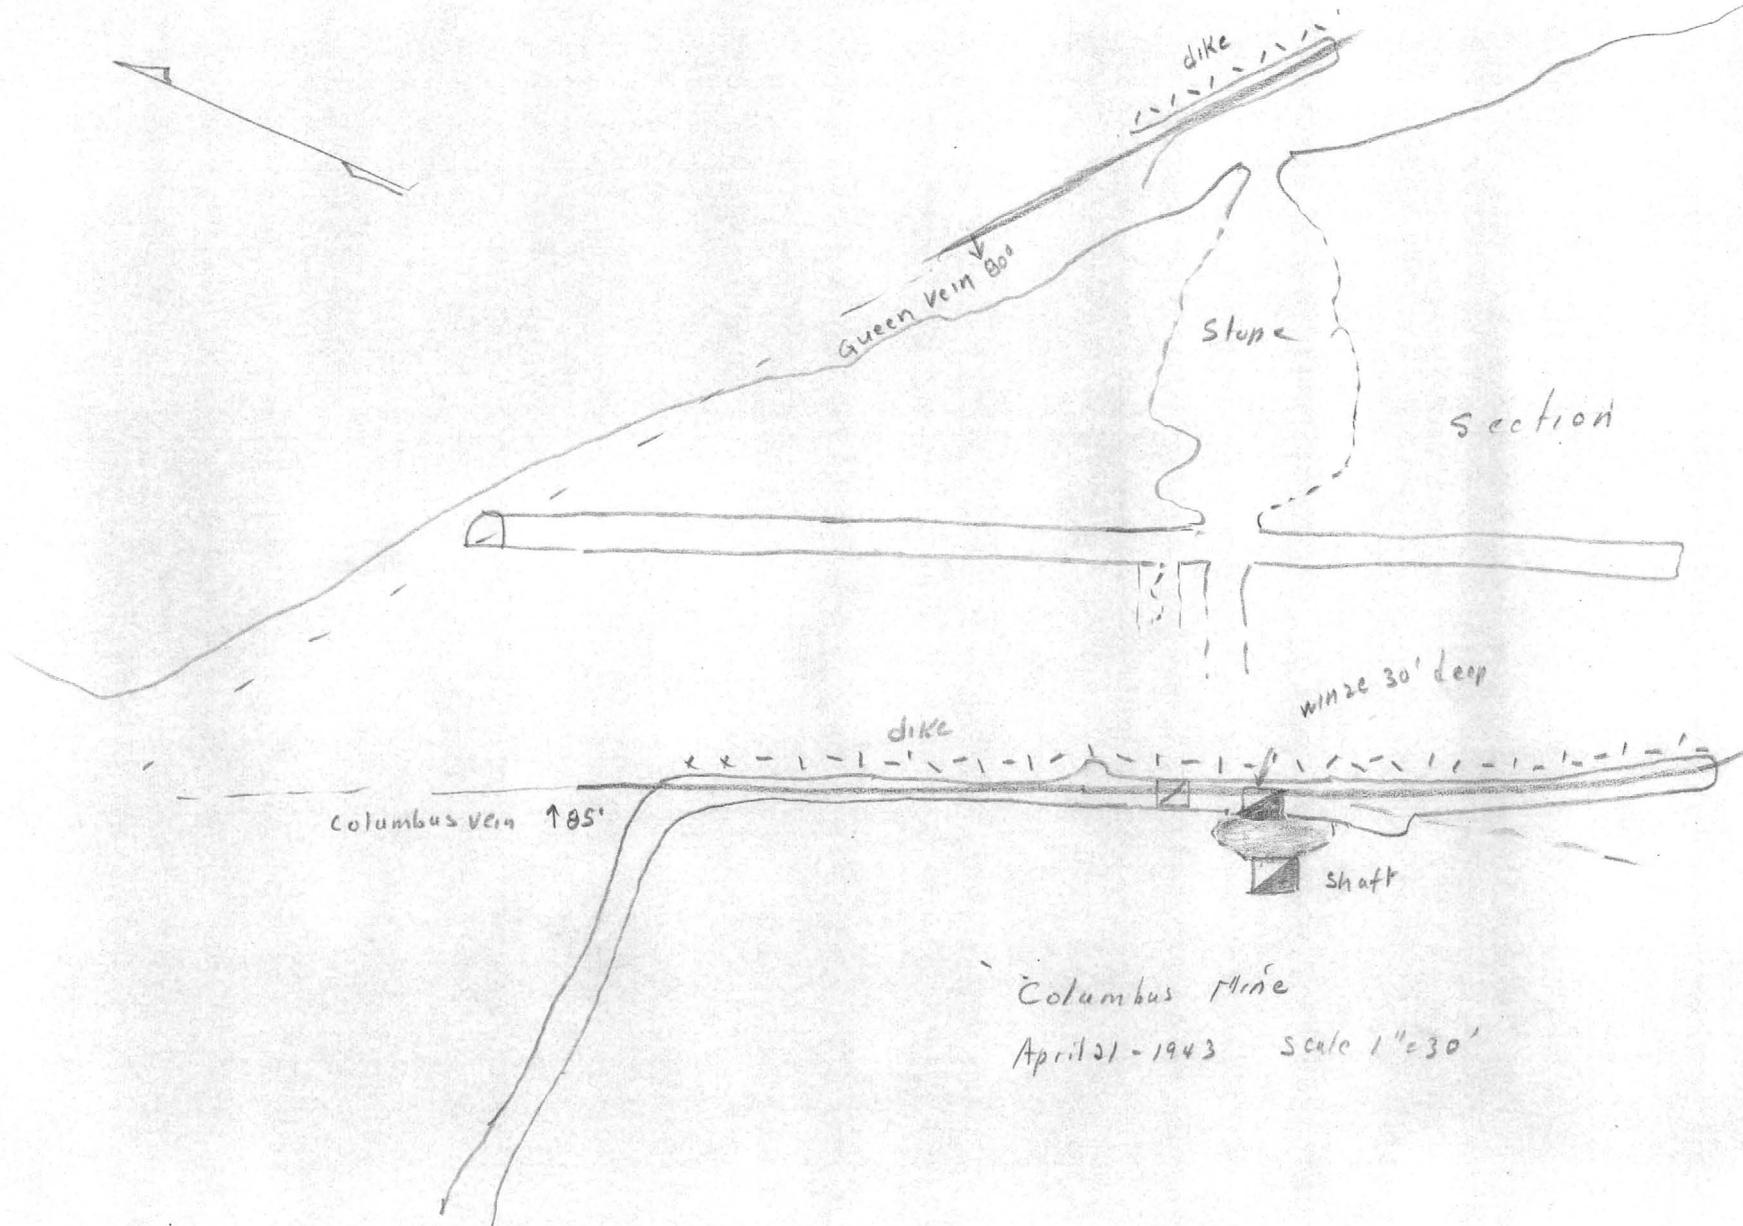
Columbus Mine

approximately N 20° W and dips 80°- 85° East. The principal working on this vein consists of a crosscut 60' to the vein and some 170' of drifting on the vein. A small shoot of ore was encountered in the tunnel and a raise was put through to the surface and the ore was stoped on both sides of the raise. Samples Nos. 1 and 2, containing soft oxidized material, were cut in the north end of the stope in its lower part.

Samples No.s 3, 4, 5, 6, 7 and 8 were out across the back of the drift and were taken at 10' intervals on each side of the stope raise. The material was mostly hard, glossy quartz containing a sprinkling of sphalerite and a little pyrite. It is too low grade to be classed as ore.

A winze just north of the stope raise was said to have exposed several feet of good ore. The winze, however, has been filled in to the level of the track and the reports concerning it can not be verified.

A winze directly beneath the raise has been sunk to a depth of 30' below the level. It is claimed to show good ore in the bottom, but the winze contained 10' of water at the time of the examination and the part above water was tightly logged. The operators claimed that they were unable to keep the water down with a hand pump because of a spring (?) in the bottom. The rate of rise in the shaft appeared to be quite small and the inability to get the water out for the examination can be blamed upon a lack of energy and will-power on the part of the operators. Judging from assay returns from sampling above the winze, it does not seem likely that anything particularly interesting exists at the bottom.

Sampling of the most favorable of the vein exposures does not disclose the presence of any commercial ore in either of the properties and there is no evidence upon which to base the expectation that further development would make available substantial amounts of strategic metals.

An additional loan to the project is not recommended.
