Reconstruction Finance Corporation Arizona Records

DEPARTMENT OF MINERAL RESOURCES
STATE OF ARIZONA
FIELD ENGINEERS REPORT

Mine PAPAGO CHIEF. Cu., SiO₂ Date July 19, 1943
District Barboquivari Engineer Earl F. Hastings
Subject: Reconstruction Finance Corporation Mine Loan

RECONSTRUCTION FINANCE CORPORATION
MINING SECTION
REPORT OF SUPERVISING ENGINEER

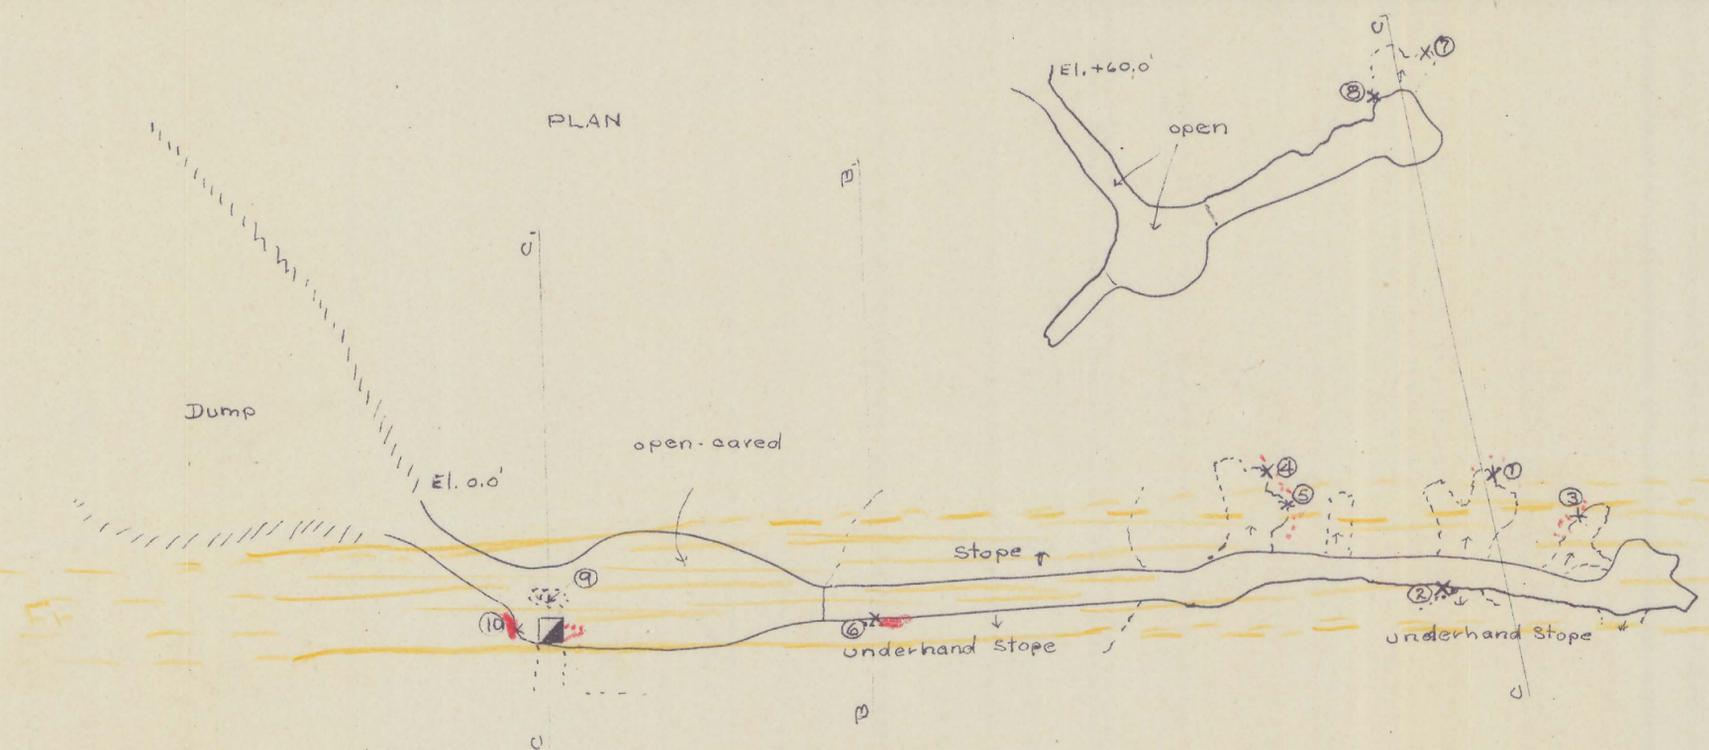
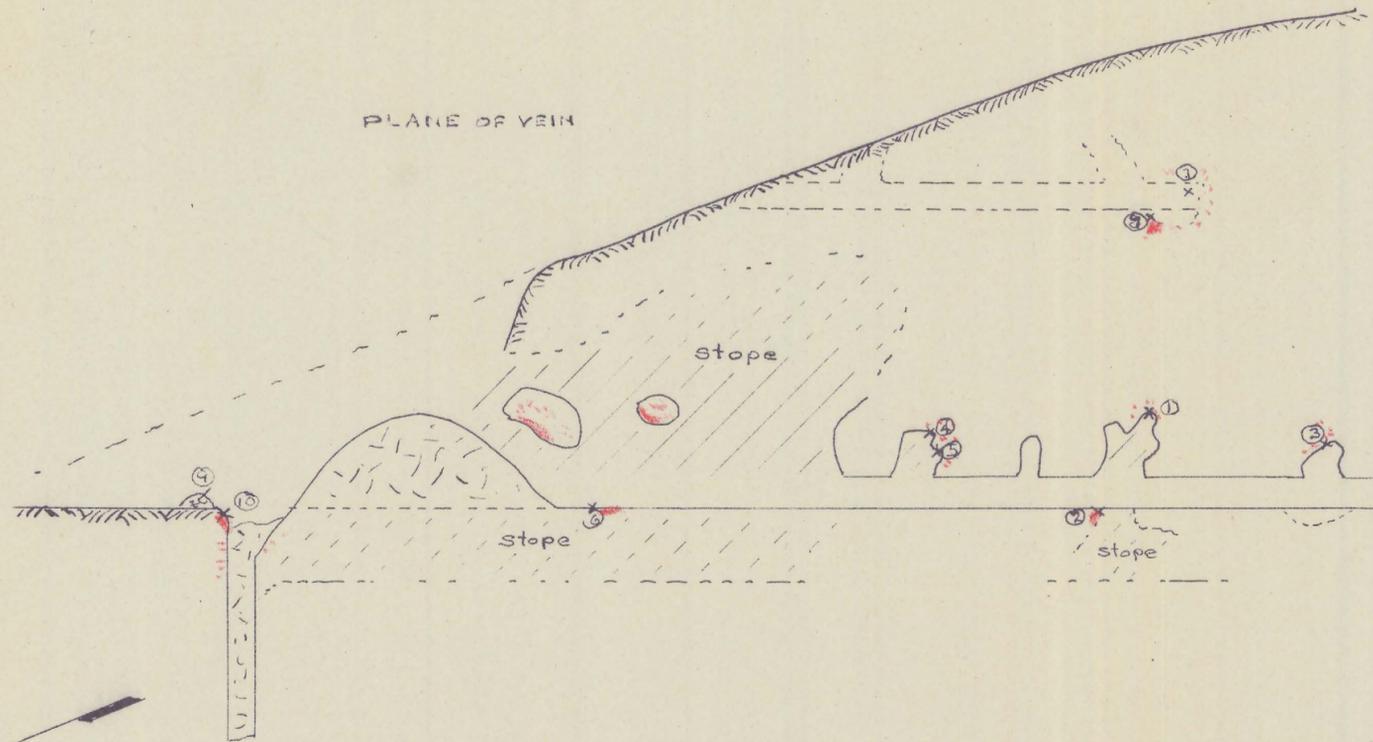
PLAN

Samples 1,3,4 and 5 represent the better exposures in 3 small stopes in the inner part of the mine. The showings are low-grade and lack continuity.

No. 2 (.42 oz. Au., 24.5 oz. Ag., 6.41% Cu) was taken on the edge of the underhand stope near the end of the tunnel. It is said that a high grade shoot was mined below here. The sample contained chalcopyrite and bornite with some tetrahydride and chalcocite.

Sample No. 6 (.14 oz Au., 7.8 oz. Ag., 3.64% Cu) was cut in a pillar on the lower side of the drift. The vein here is a dense very hard gray quartz band containing a fair amount of chalcopyrite intermixed with some bornite. The stope above this point was mined some 5 to 7 feet wide and the underhand stope has about that same width.

Sample No. 10 was cut across a good showing of ore on the north edge of the shaft in the open cut at the entrance to the tunnel. The material was mostly oxidized and the ore was not continuous northward from this point. The cut was filled with a high pile of caved material and the shaft, said to be 45 feet deep, was open for only several feet. The operators had cleaned out to 20 ft. and stated that good ore was present in both ends to this depth but the walls had caved and filled the shaft again. A good showing of sulphide ore could be seen however in the south wall but could not be sampled because of the condition of the workings.

PLANE OF VEIN

Sample No	Width	O ₂ Au	O ₂ Ag	%Cu
1	35"	.06	10.7	2.33
2	16"	.42	24.5	6.41
3	60"	.02	2.1	1.70
4	60"	.03	2.5	1.15
5	28"	.07	2.0	1.45
6	13"	.14	7.8	3.64
7	24"	.14	6.4	2.32
8	21"	.09	14.9	4.11
9	Muck	.05	5.6	2.80
10	25"	.05	18.4	9.51
