ARIZONA DEPARTMENT OF MINES AND MINERAL RESOURCES FILE DATA

PRIMARY NAME: COPPER SQUAW MINE

FIELD ENGINEERS REPORT

Mine Copper Squaw

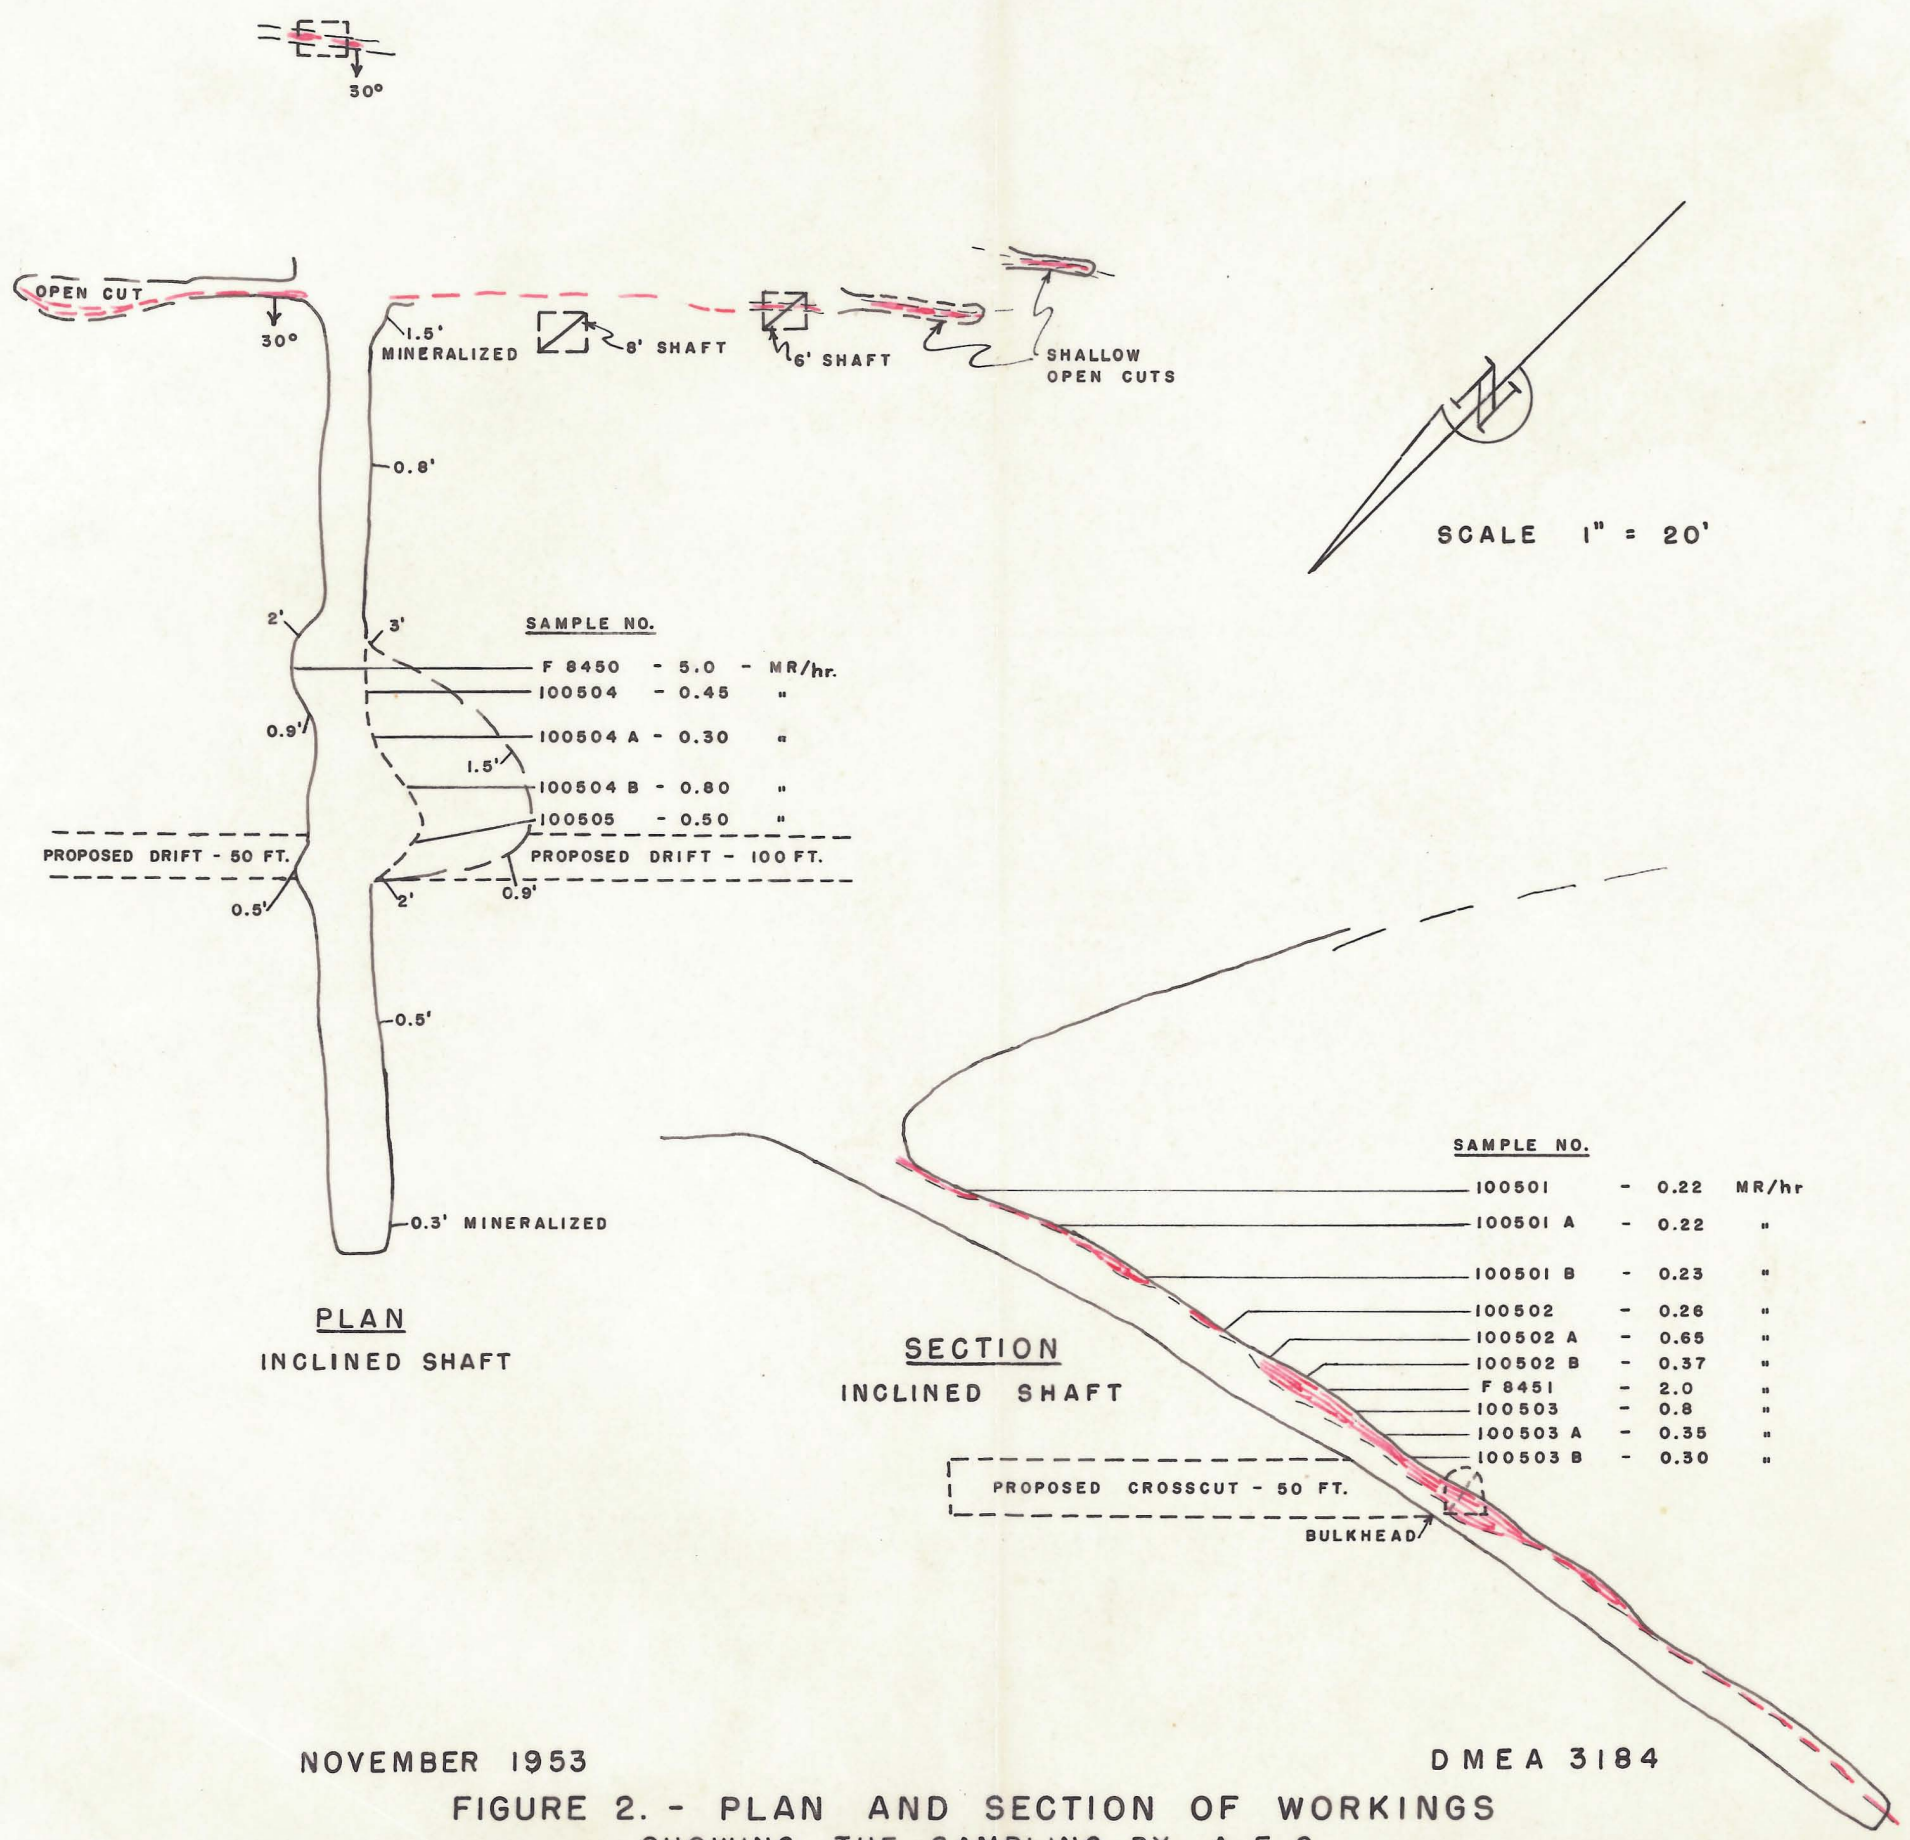
FIGURE 2. - PLAN AND SECTION OF WORKINGS

SHOWING THE SAMPLING BY A. E. C.
