PRIMARY NAME: HUSTLER 1-16 CLAIMS

GEOLOGIC INVESTIGATION OF HUSTLER MINING CLAIMS

GILA COUNTY, ARIZONA

C. J. Lowery

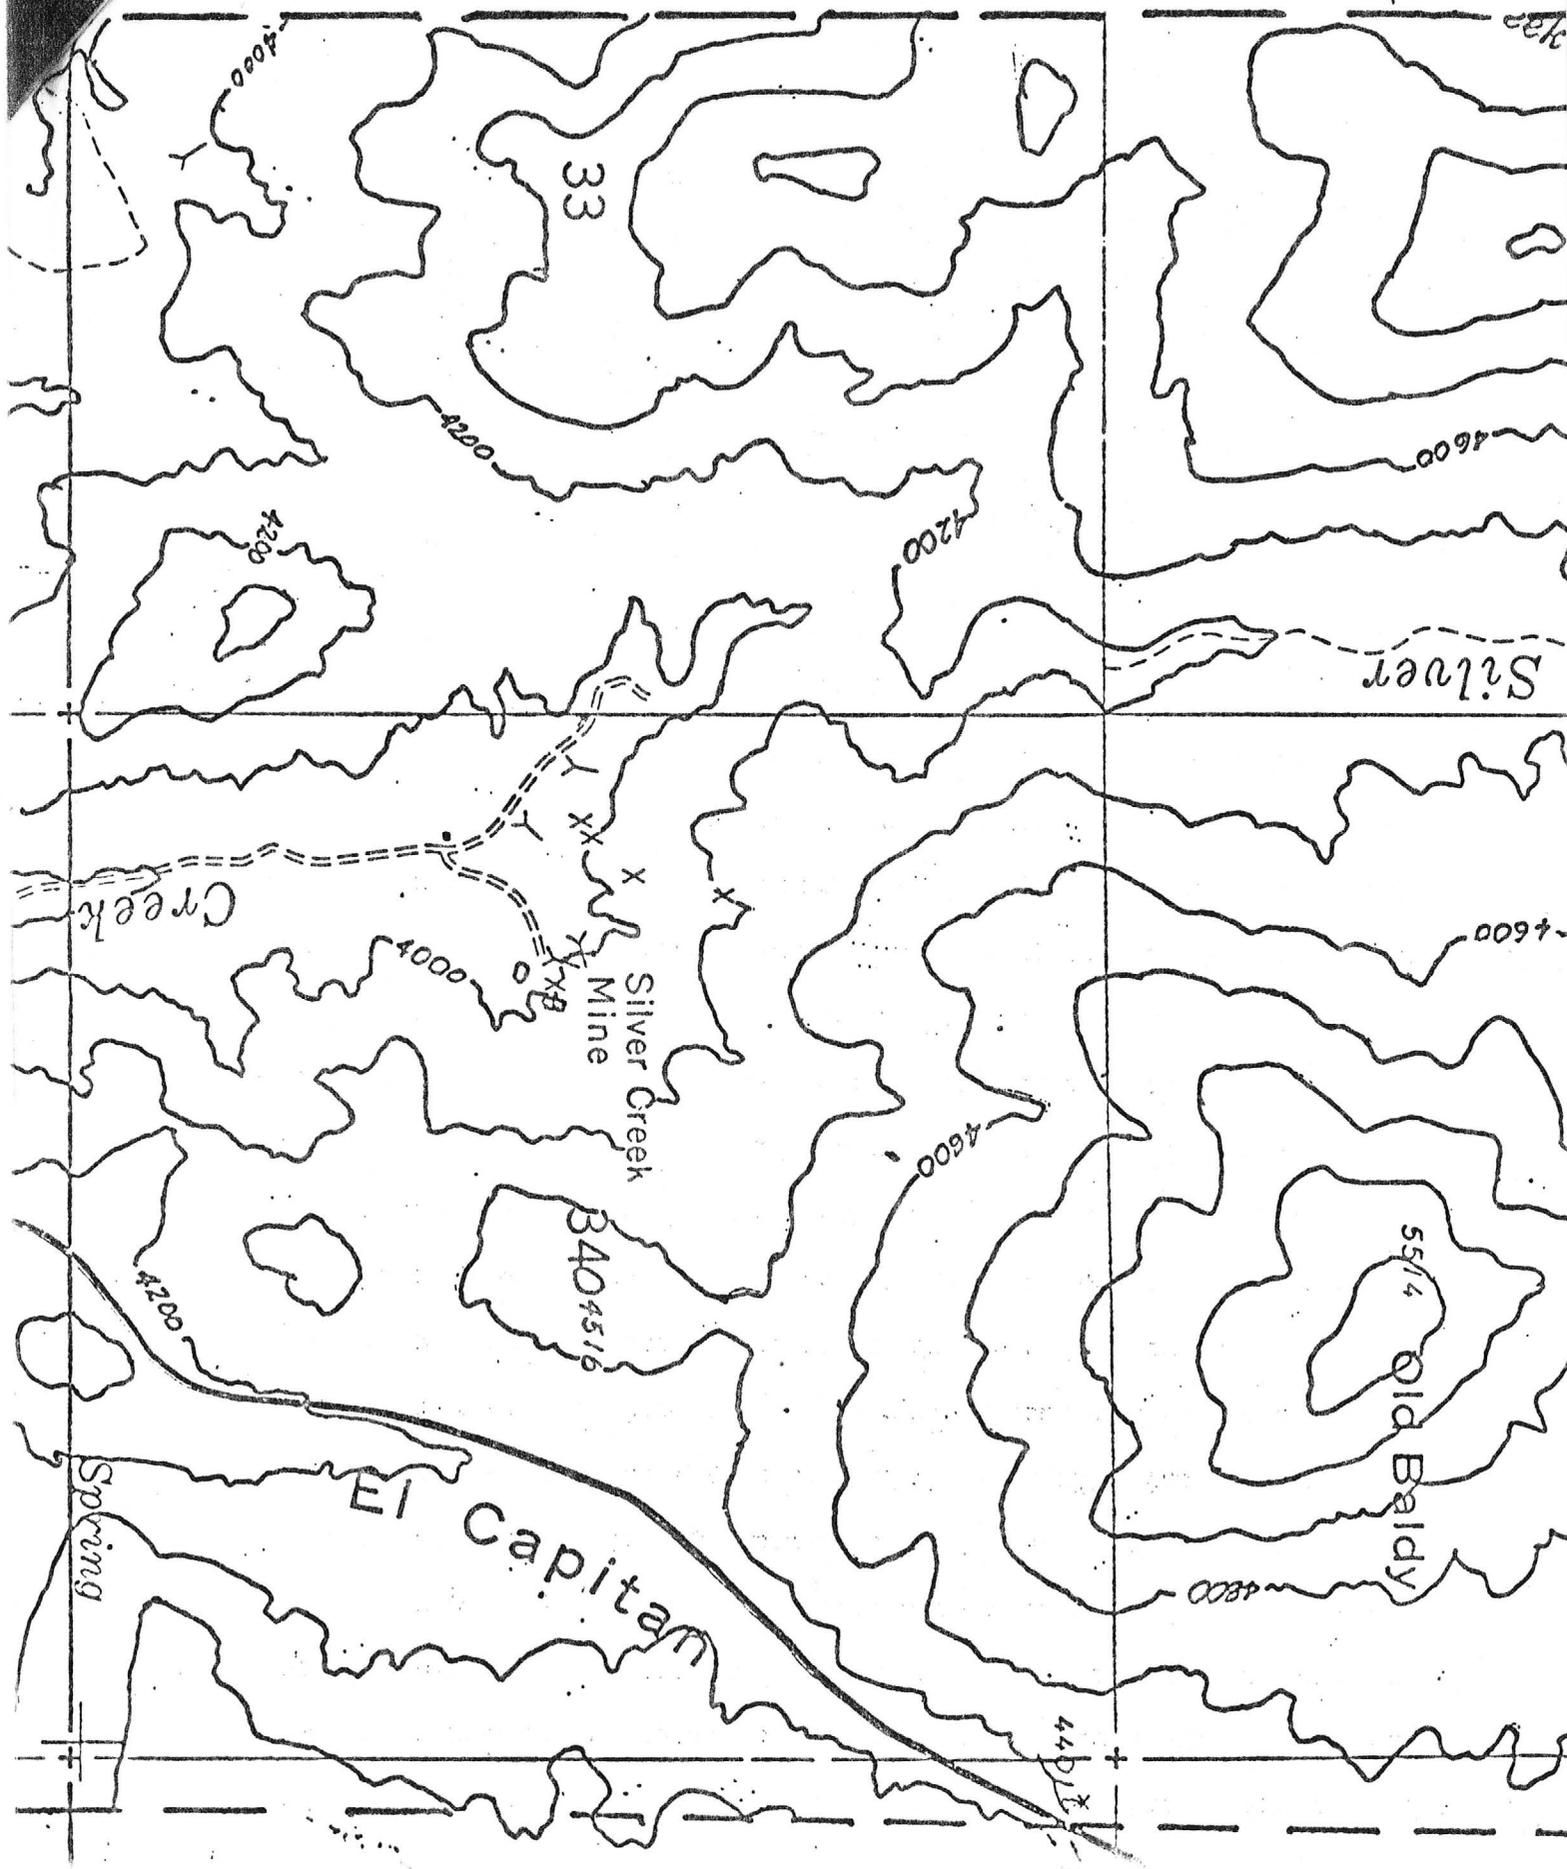
Figure 1 - - Map showing location of mine tunnels and bench

Old mining and exploration tunnels #1, 2, 3, and 4 (Figure 1 & 2) contain water. The water comes from springs occurring in these tunnels. Estimated water available in storage in these tunnels is:

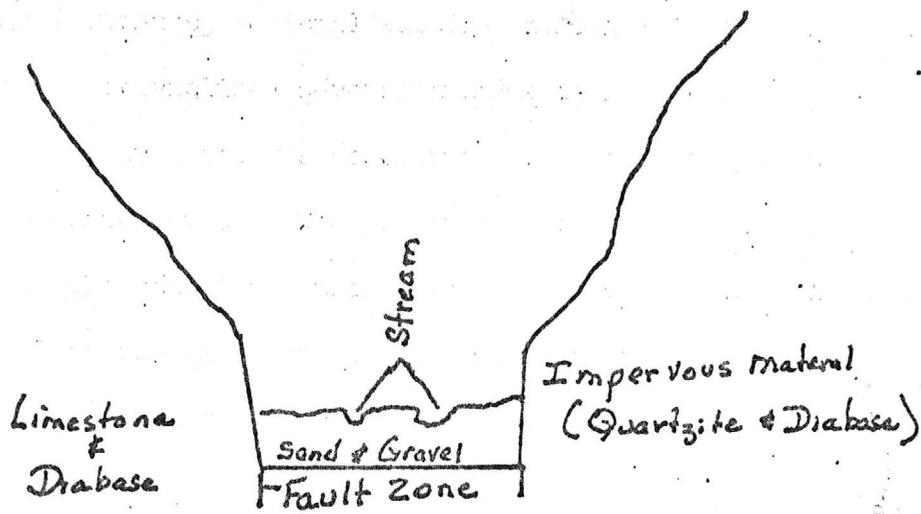
Figure 3-- Cross section of Stream Channel

The subsurface flow in the stream channel is actually small due to the narrow channel and the rocks that it cuts through (figure 3). Dolomitic limestone, quartzite, gabbro, diabase, granite, and granite pegmatite dikes are poor reservoir storage material due to their density and lack of pore space. Clays and shales act as impervious material.

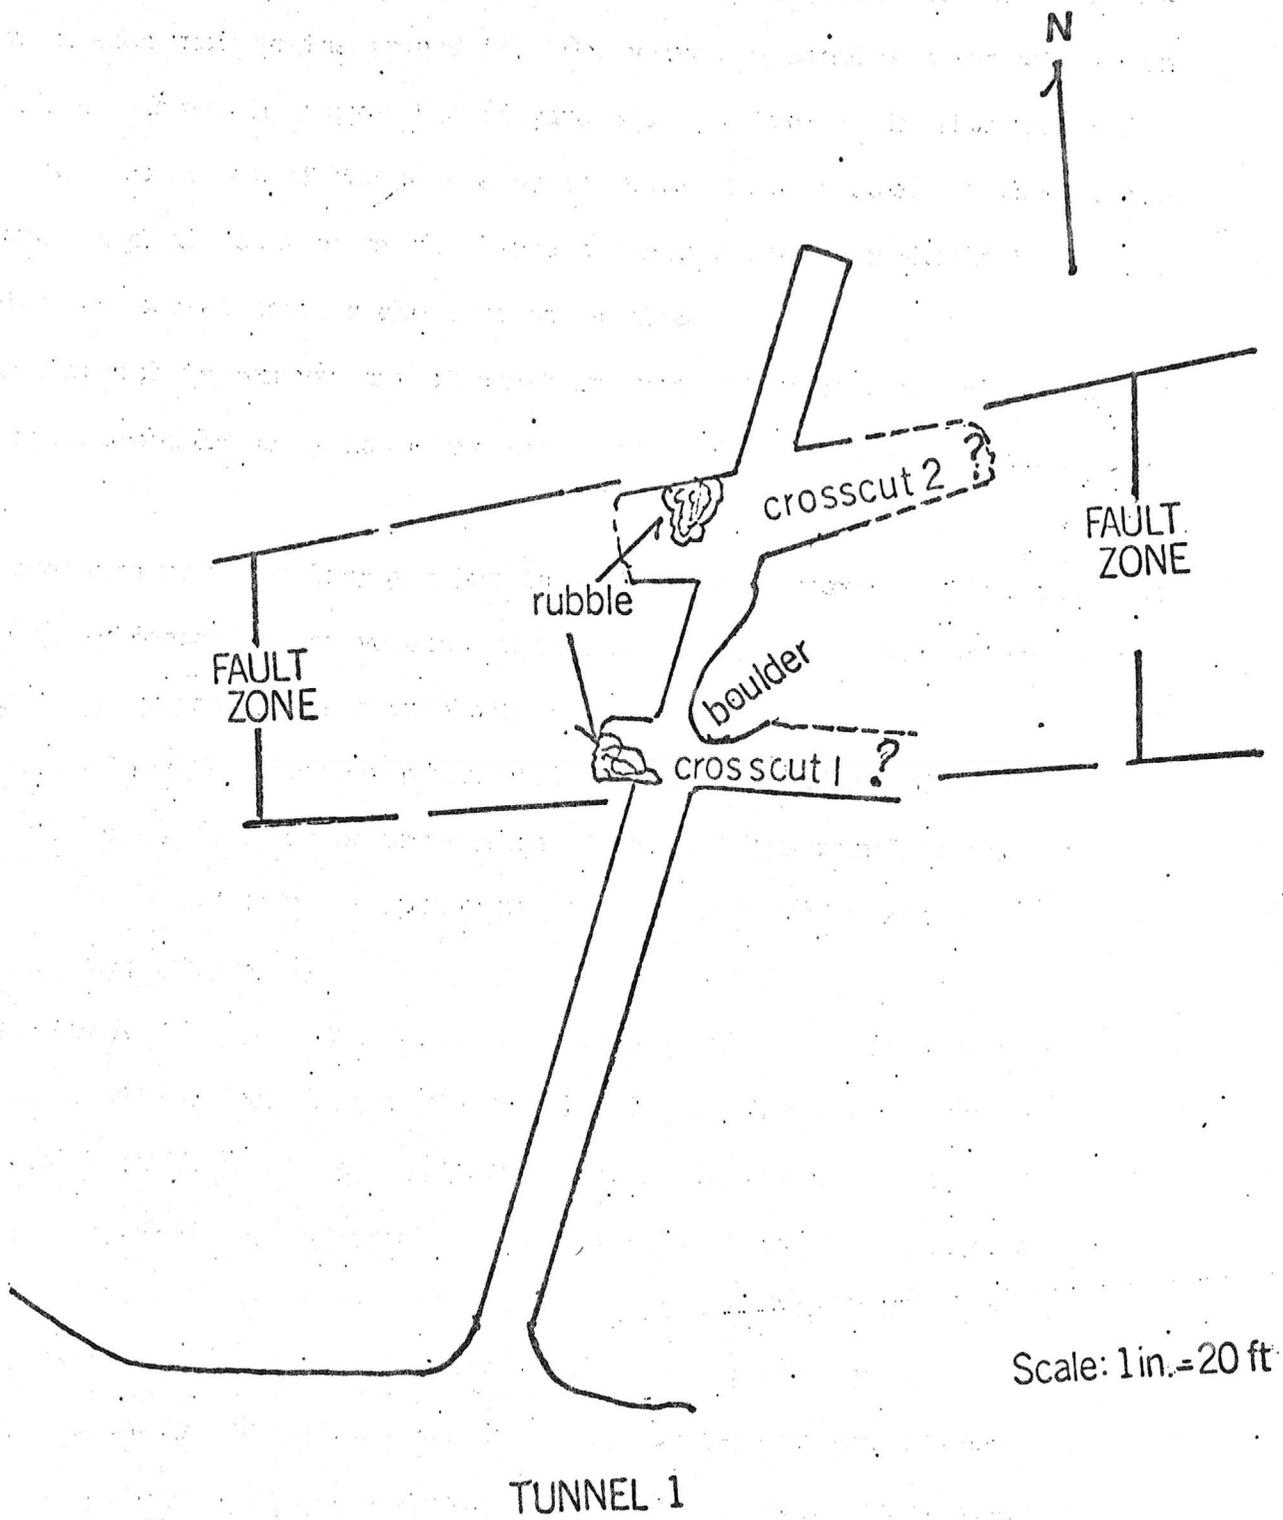
... encountered in tunnel.

cave in. Crosscut 2 on the west had a lot of rubble as well as remnants of an old pulley system. The stability of the fault is very fragile. It will undoubtedly cave in when work begins around it. Ore values of samples taken of muck in main tunnel are shown in assay table (figure 5). The muck is in situ material that has been eroded out of fault zone by the water passing down and through the fault. The original location of the large mineralized boulder should have a large, rich ore pocket that is close to the surface.

When material is removed out of creek in front of tunnel, the slide face of Tunnel 1 will probably break loose and slide into creek without any drilling or shooting.

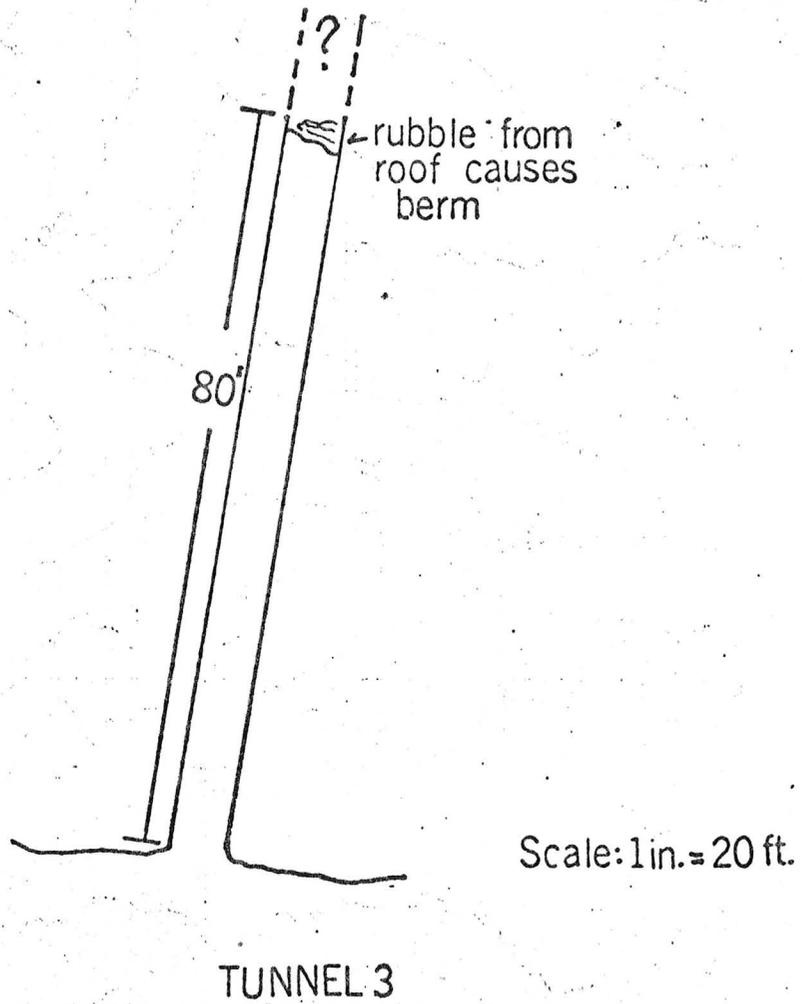
Figure 6 -- Map of tunnel 3 showing berm of caved material.

Tunnel #3 - - 25,000 + gallons in tunnel in front of berm. There is no way of estimating amount behind berm because we do not know the length of tunnel behind the berm. However, the water is up to the top of the berm and running over the top.

Tunnel 3 has a large berm of caved material from the roof about 80 feet from entrance (figure 6). It has occurred along a fault. The tunnel behind berm may have had ore removed from it prior to the cave in as evidenced by the assay of sample of muck (figure 5).

Water will have been removed from Tunnel 3 by the completion of Tunnel Creek ore removal and the muck in the tunnel will be pumped out so that it can go through mill concentrator. Water decanted from muck can also be used in water system for mill. The muck in Tunnel 3 is about 14 inches deep. There is about 100 cubic yards of material forward of the berm to be pumped out for mill. Tunnel #1 has about 3 feet of muck in tunnel to be pumped out and into mill for usage. When the water and muck is being removed it will weaken structure of Tunnel 1. When all ore is removed from Tunnel Creek it will cause the toe of the old slide above Tunnel #1 entrance to give way causing slide to come down blocking Tunnel #1. All work in tunnel must be completed before then. The muck in tunnels 1 & 3 should be pumped into a stock tank for storage until time to remove to mill. There is about 300 cubic yards of material to be pumped out of tunnel for the mill plus water.

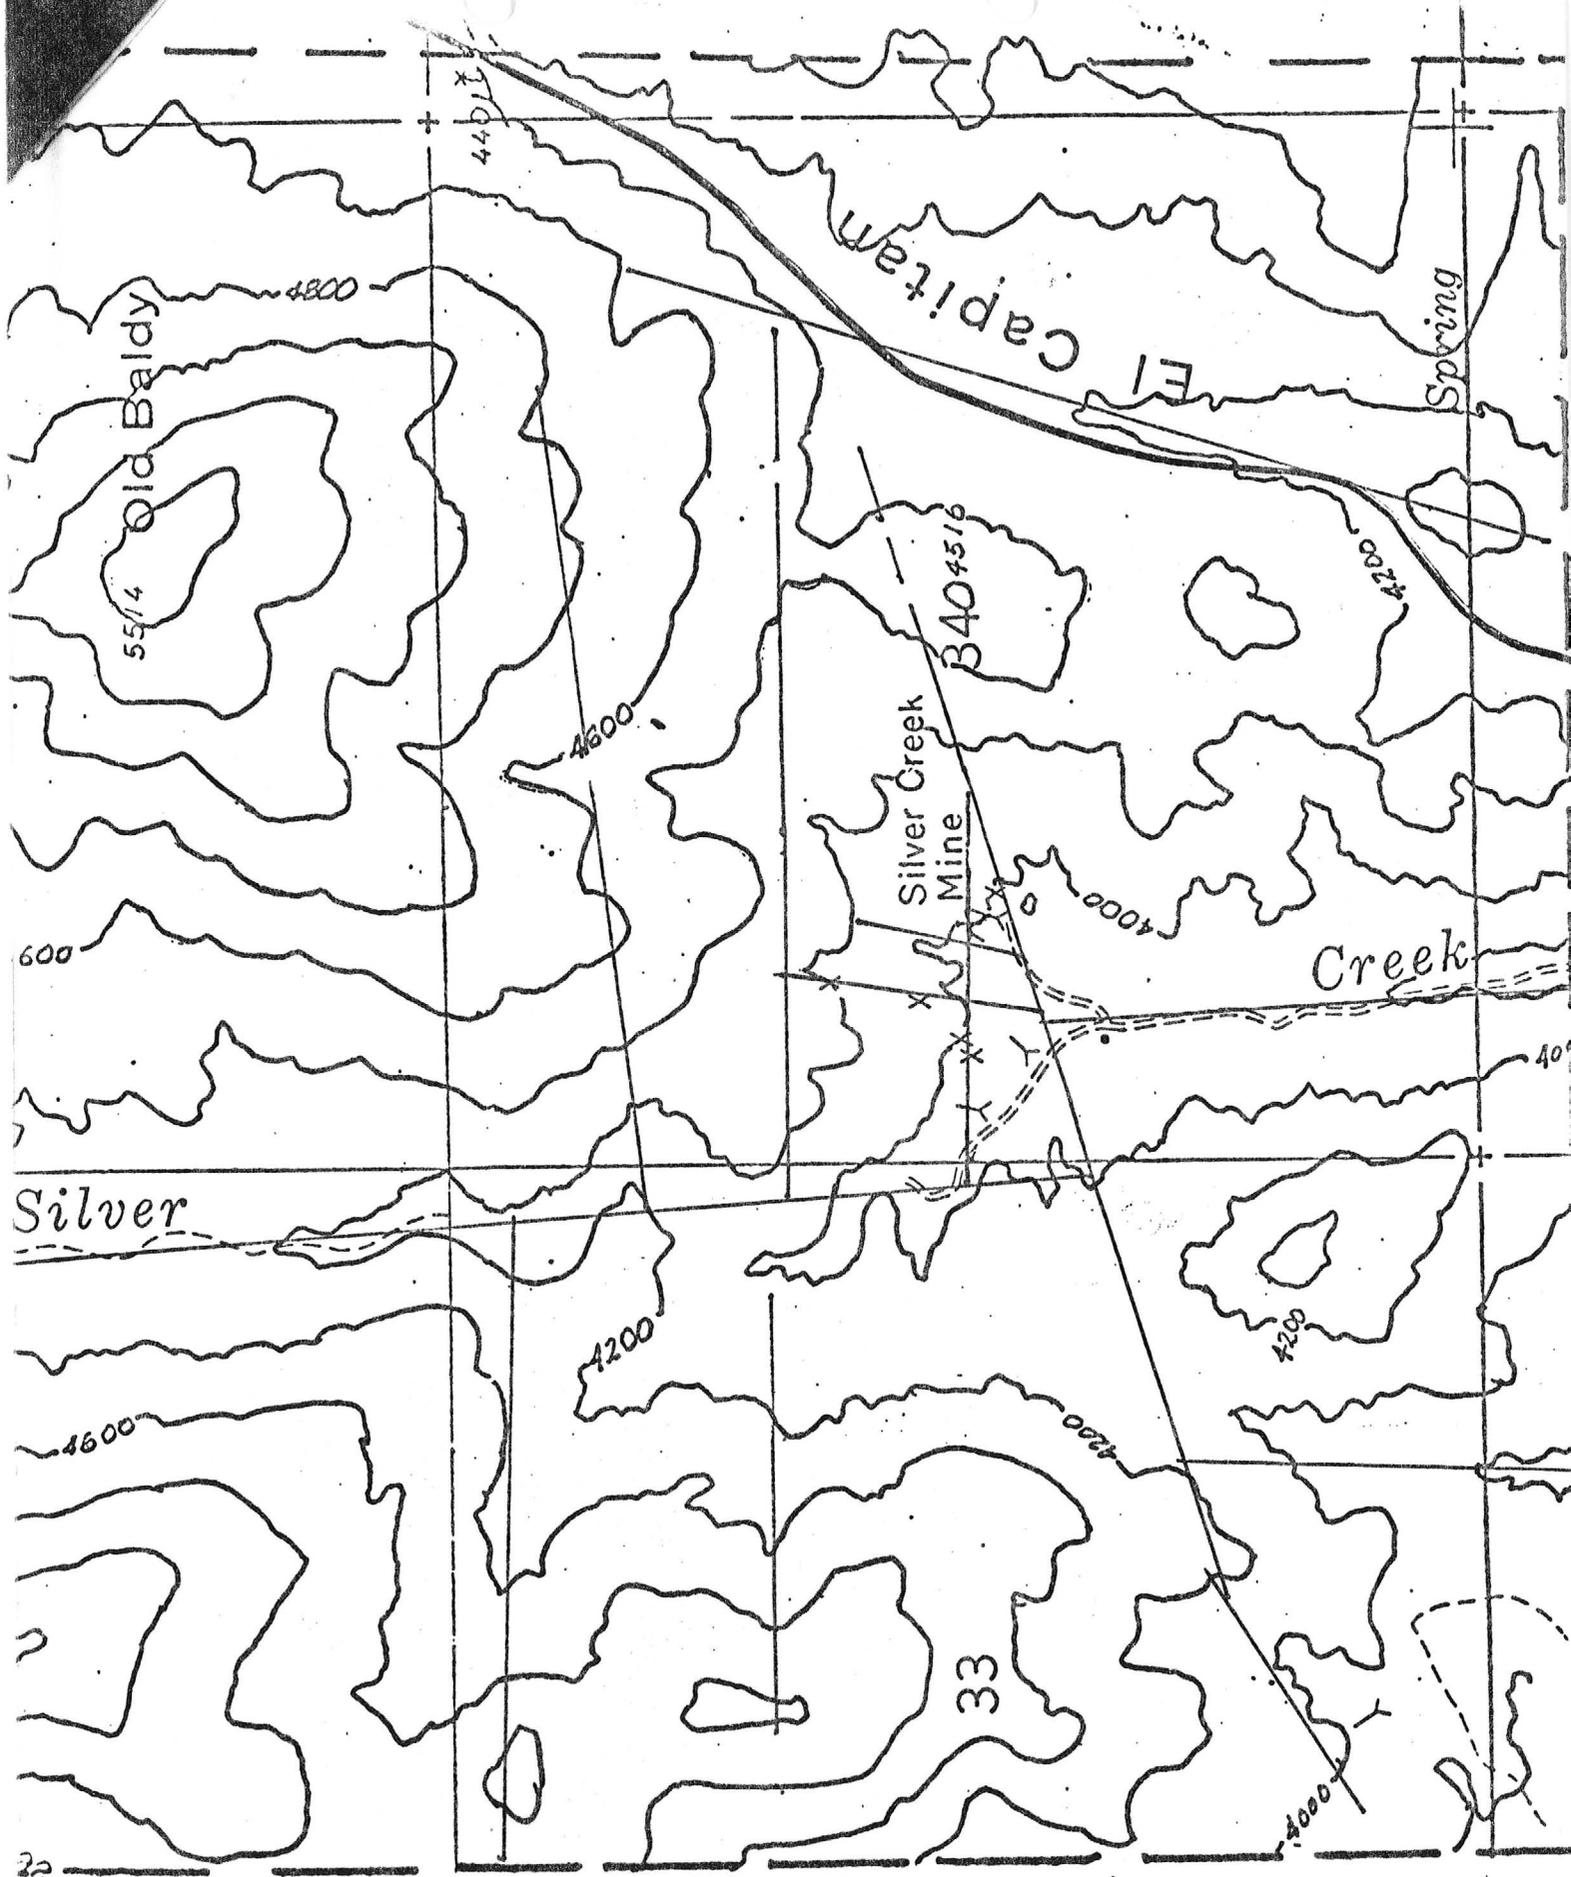
Figure 7 - - Map showing fault system. Figure 7(b) photographs of faults.

Silver Creek follows a fault that for purposes of identification in this report will be called Silver Creek Fault (figure 7). The creek that runs in front of tunnels 1 and 3 shall be designated Tunnel Creek. It too runs along a fault, which extends east-west for several miles. This fault shall be designated Tunnel Creek Fault. Silver Creek Fault has been cut by Tunnel Creek Fault causing a lateral displacement of approximately 150 feet to the east. Further study of the fault system in the area shows the north-south faults occurred first and the east-west faults occurred later cutting across the north-south fault system with lateral displacement along the north-south faults. The blocks faulted and moved, some in a rotational manner. There are numerous small "en echelon" faults associated with both large faults. Hydrothermal

activity apparently accompanied both periods of faulting thus accounting for both hypogene and supergene mineralization occurring concordently. The block on the south side of Tunnel Creek and east side of Silver Creek has been shifted to the east. This block also was the hanging wall block of the Tunnel Creek fault. The mineralization in this instance is in the foot wall of the fault. The faulting occurring within the fault system of the area is extremely complex.

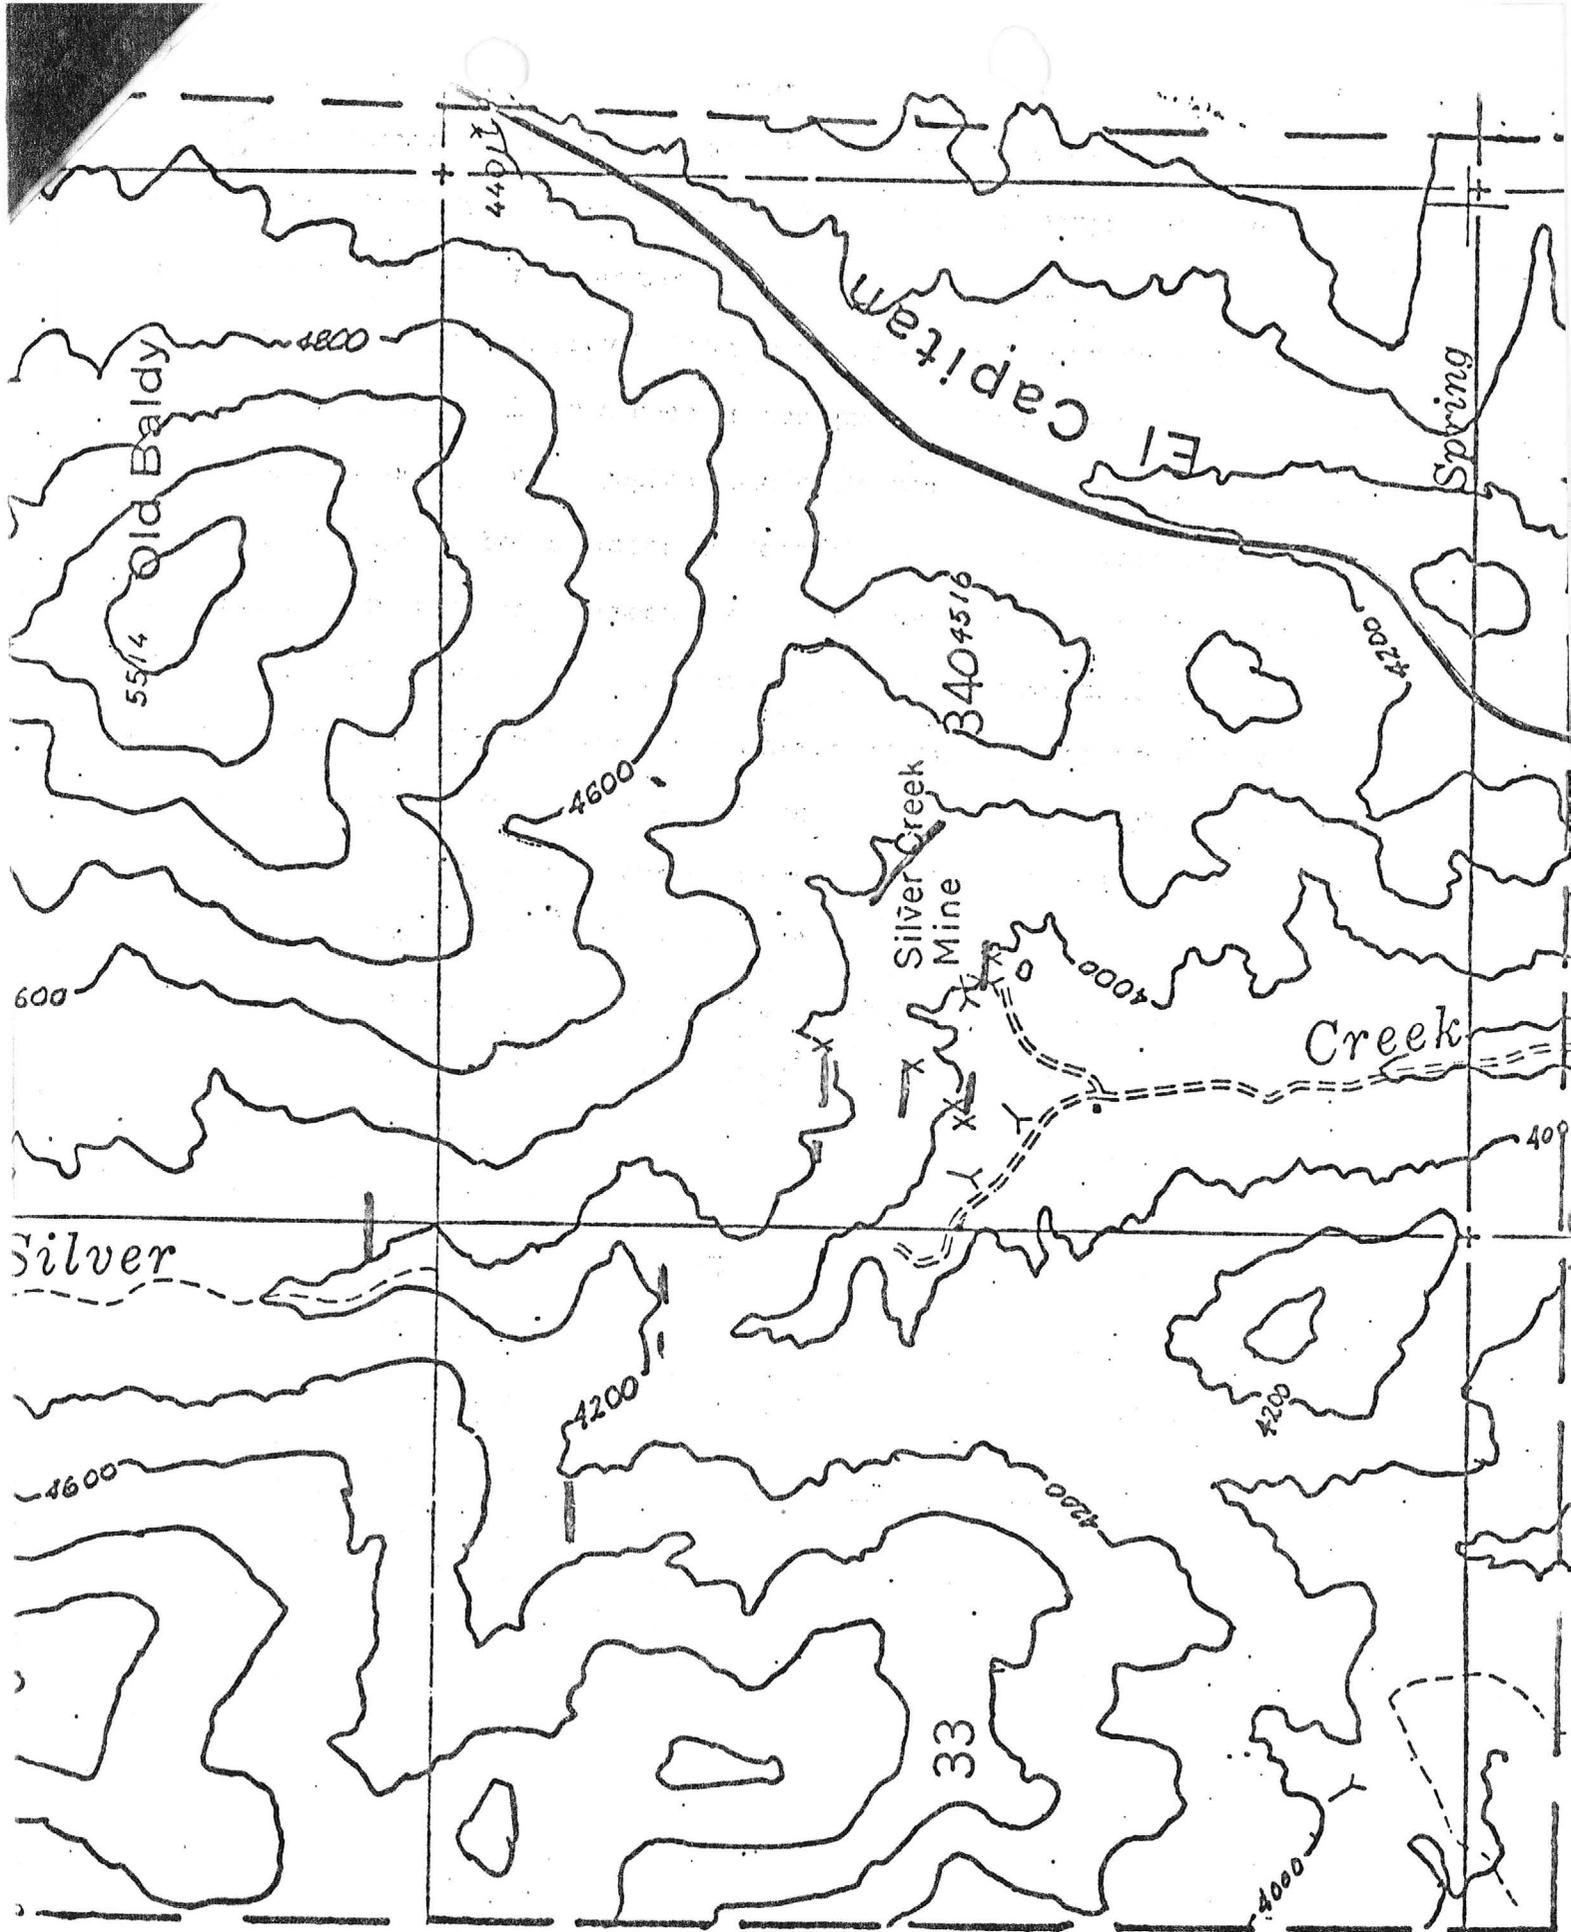
Figure 8 - - Map showing veins now located on Hustler mining claim.

The ore veins will be staked on the surface when work begins. Any staking prior to that time will be knocked down by livestock in area. The stakes shall be placed showing location to be drilled and blasted (figure 8). Extensive mapping of veins requires several months.
