ARIZONA DEPARTMENT OF MINES AND MINERAL RESOURCES FILE DATA

PRIMARY NAME: KATE WATERS

**Report**  
**on the**  
**Kay Water**  
**in**  
**Yuma County, Arizona**

**January 25th, 1974**

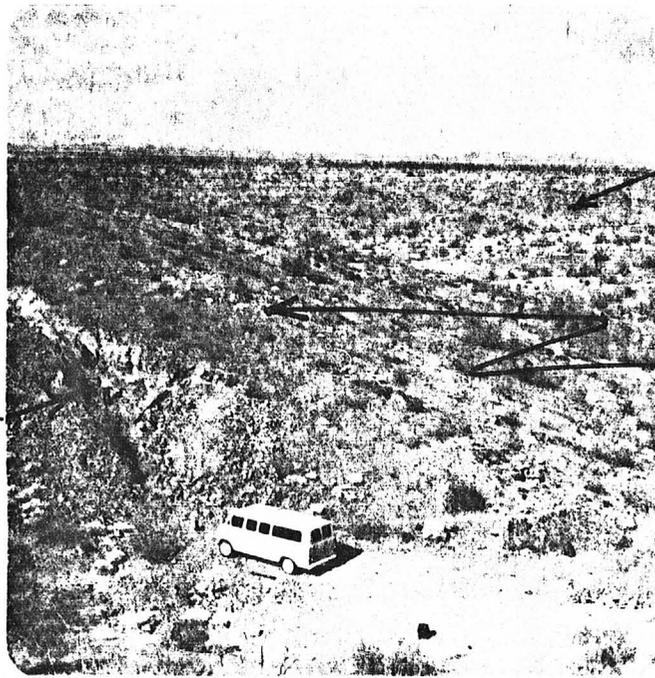
KEY WATERS N.E. Zone.

similar, untested  
formations  
Looking N

- Mineralized  
Hill - Sample KW6

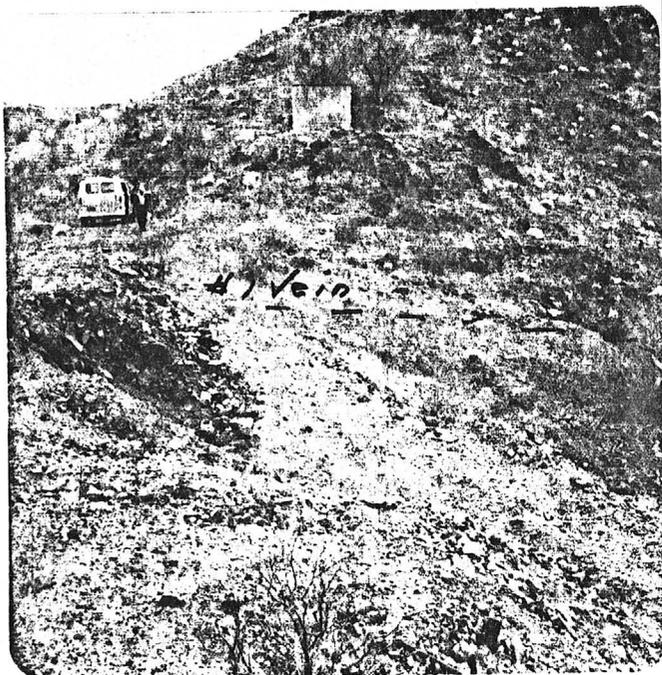
#5 Vein at "A" - Winze  
Sample KW
