PRIMARY NAME: RIO DEL MONTE MINE

R E P O R T

RIO DEL MONTE MINES

ELLSWORTH MINING DISTRICT
YUMA COUNTY, ARIZONA

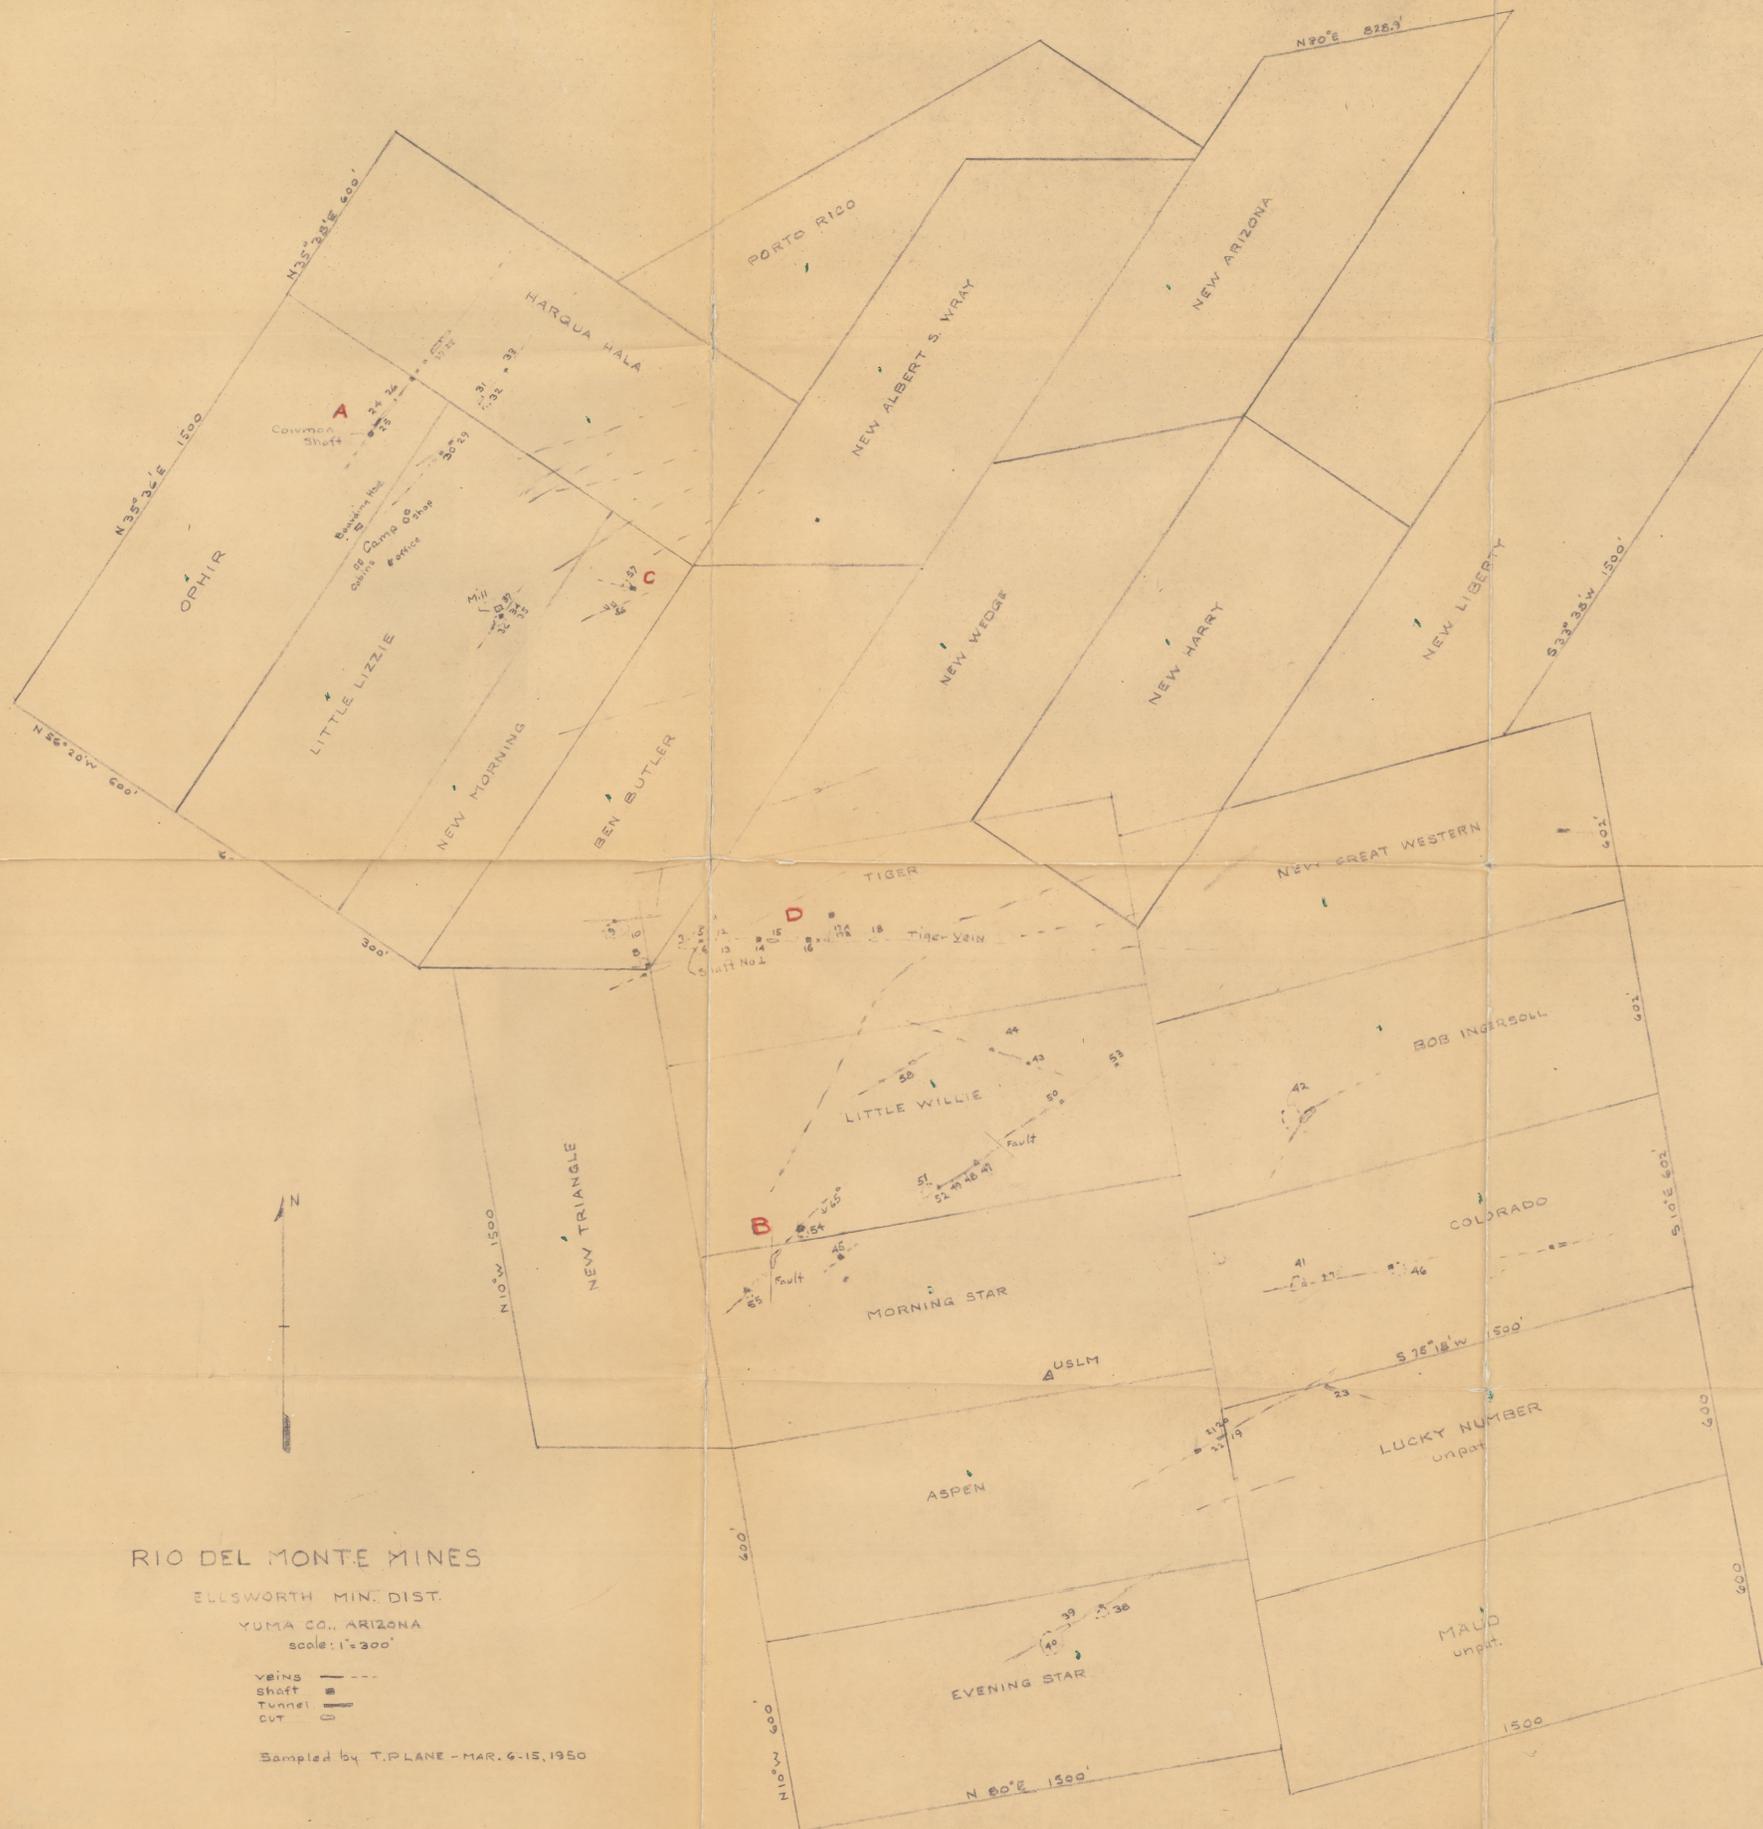
RIO DEL MONTE MINES

Sampled by T. PLANE - MAR. 6-15, 1950

Sample No	Width	Oz Au	Oz Ag	Value	% Cu	% Pb	Remarks
1	50'	.05	1	84	1.11	.30	No. 1 Shaft 96 Level - Rice Edrift
2A	30'	.01	1	.44	.15		Hw of vein at Xcut
2B	102'	.02	2	.80	.12		FW
3	64'	Tr	Tr	-.05			vein at shaft
4	50'	.01	1	.44	.05		face w drift
5	Dump	.03	1	1.14	.39		North Dump 62 tons
6	"	.06	4	2.64	.30		South " 20 "
7	"	.01	2	.53	.20		west " 200 "
8	"	.07	5	2.90	.20		Shallow Shaft SW of No. 1
9	"	.07	8	3.17	.20		Deep Shaft W dump
10	"	.03	2	1.23	.16		" " " 20 "
11	56'	.15	3	6.04	.15		vein - end of cut near No. 2 shaft
12	102'	.12	2	4.38	.41		vein - in cut
13	Dump	.04	2	1.58	.15		Dump from cut - 100 tons
14	"	.02	1	.79	.05		Dump at deep shaft - 12 tons
15	90'	.04	2	1.58	.20		vein in cut E of deep shaft
16	Dump	.03	1	1.14	.20		Dump at deep shaft No. 2 - 50 tons
17A	10'	.01	Tr	.35	1.31		FW of vein in cut
17B	42'	.01	Tr	.35	.10		Hw
18	Muck	.02	Tr	.70	.40		End of West Tiger vein - 40 tons
19	44'	Tr	Tr	-.10			Face of Aspen Tunnel

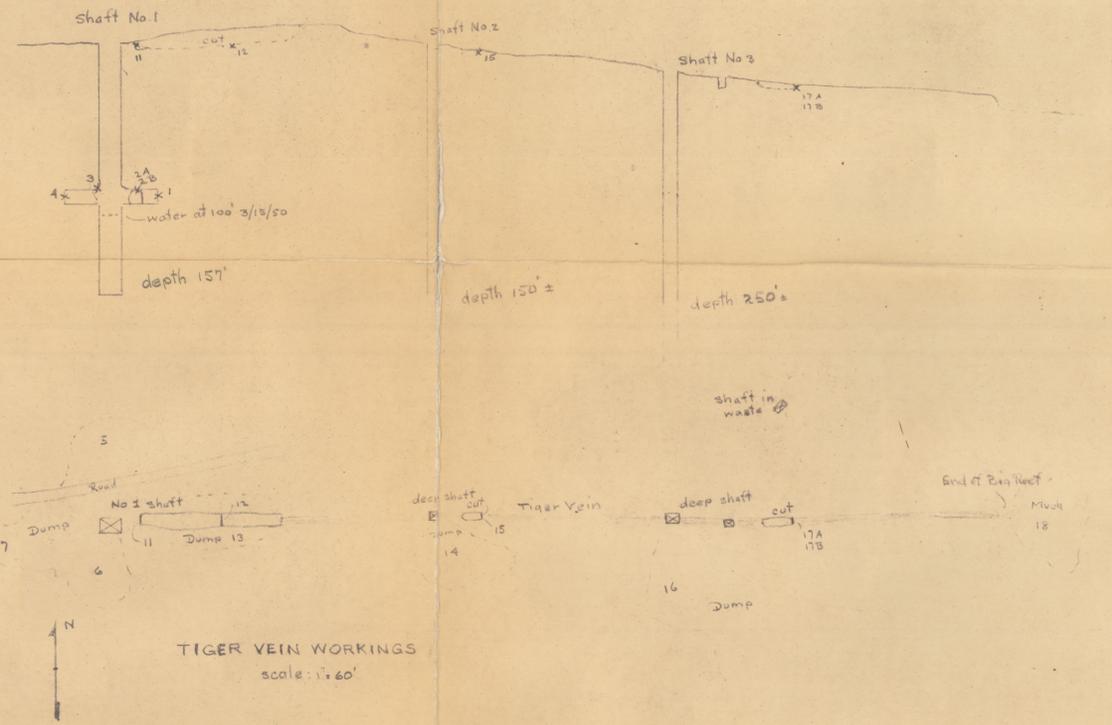
TIGER VEIN WORKINGS
scale: 1" = 60'

Area D The Tiger vein is the largest and one of the most persistent veins on the property and it has been developed more intensively than any of the other veins. The croppings of this vein which varies from 4 to 12 ft wide extend as a high massive reef of white quartz for a strike distance of some 400 ft and it is traceable by less prominent croppings for a much greater distance, with however several breaks and changes in strike, in an easterly direction. Development consists of three steeply inclined shafts ranging from 157 to 250 ft in depth and several shallow shafts and pits and trenches along the vein. Also a deep vertical shaft was sunk in the country rock about 100 ft northerly from the deepest shaft and this evidently was intended to be a working shaft. A spectrographic analysis of the dump material here shows the presence of a very small amount of gallium.

cut just east of No 1 shaft where two assays showed \$6.06 gold-silver with .15% cu and \$4.38 gold-silver with .81% cu with vein widths of 50" and 102". A good assay is said to have been obtained from the bottom of No 1 shaft now under water.

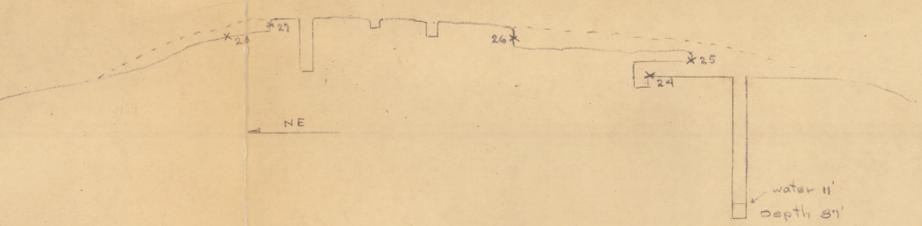
COWMAN VEIN WORKINGS
scale: 1" = 60'

Area A Sampling of the Cowman shaft workings (samples Nos 24, 25, 26) indicates the probable existence here of a shoot of ore of moderate grade - between \$9 and 10 gold and silver value and about 3 lbs copper per ton. The Cowman shaft is vertical and is 87 ft deep and is open and in good condition but not

accessible. The vein can be seen in the walls of the shaft and is reported to be present in the bottom with width about the same throughout. A logical program of development here would be to sink the shaft another 20 ft and open a level at 100 ft and drift in both directions on the vein.

Sampling of the Cowman Shaft workings indicates a probable shoot of ore and further development is recommended here.
