ARIZONA DEPARTMENT OF MINES AND MINERAL RESOURCES AZMILS DATA

PRIMARY NAME: SPIKE 1-8

FIELD ENGINEERS REPORT

Mine Spike 1-8 and Jolly 1-11

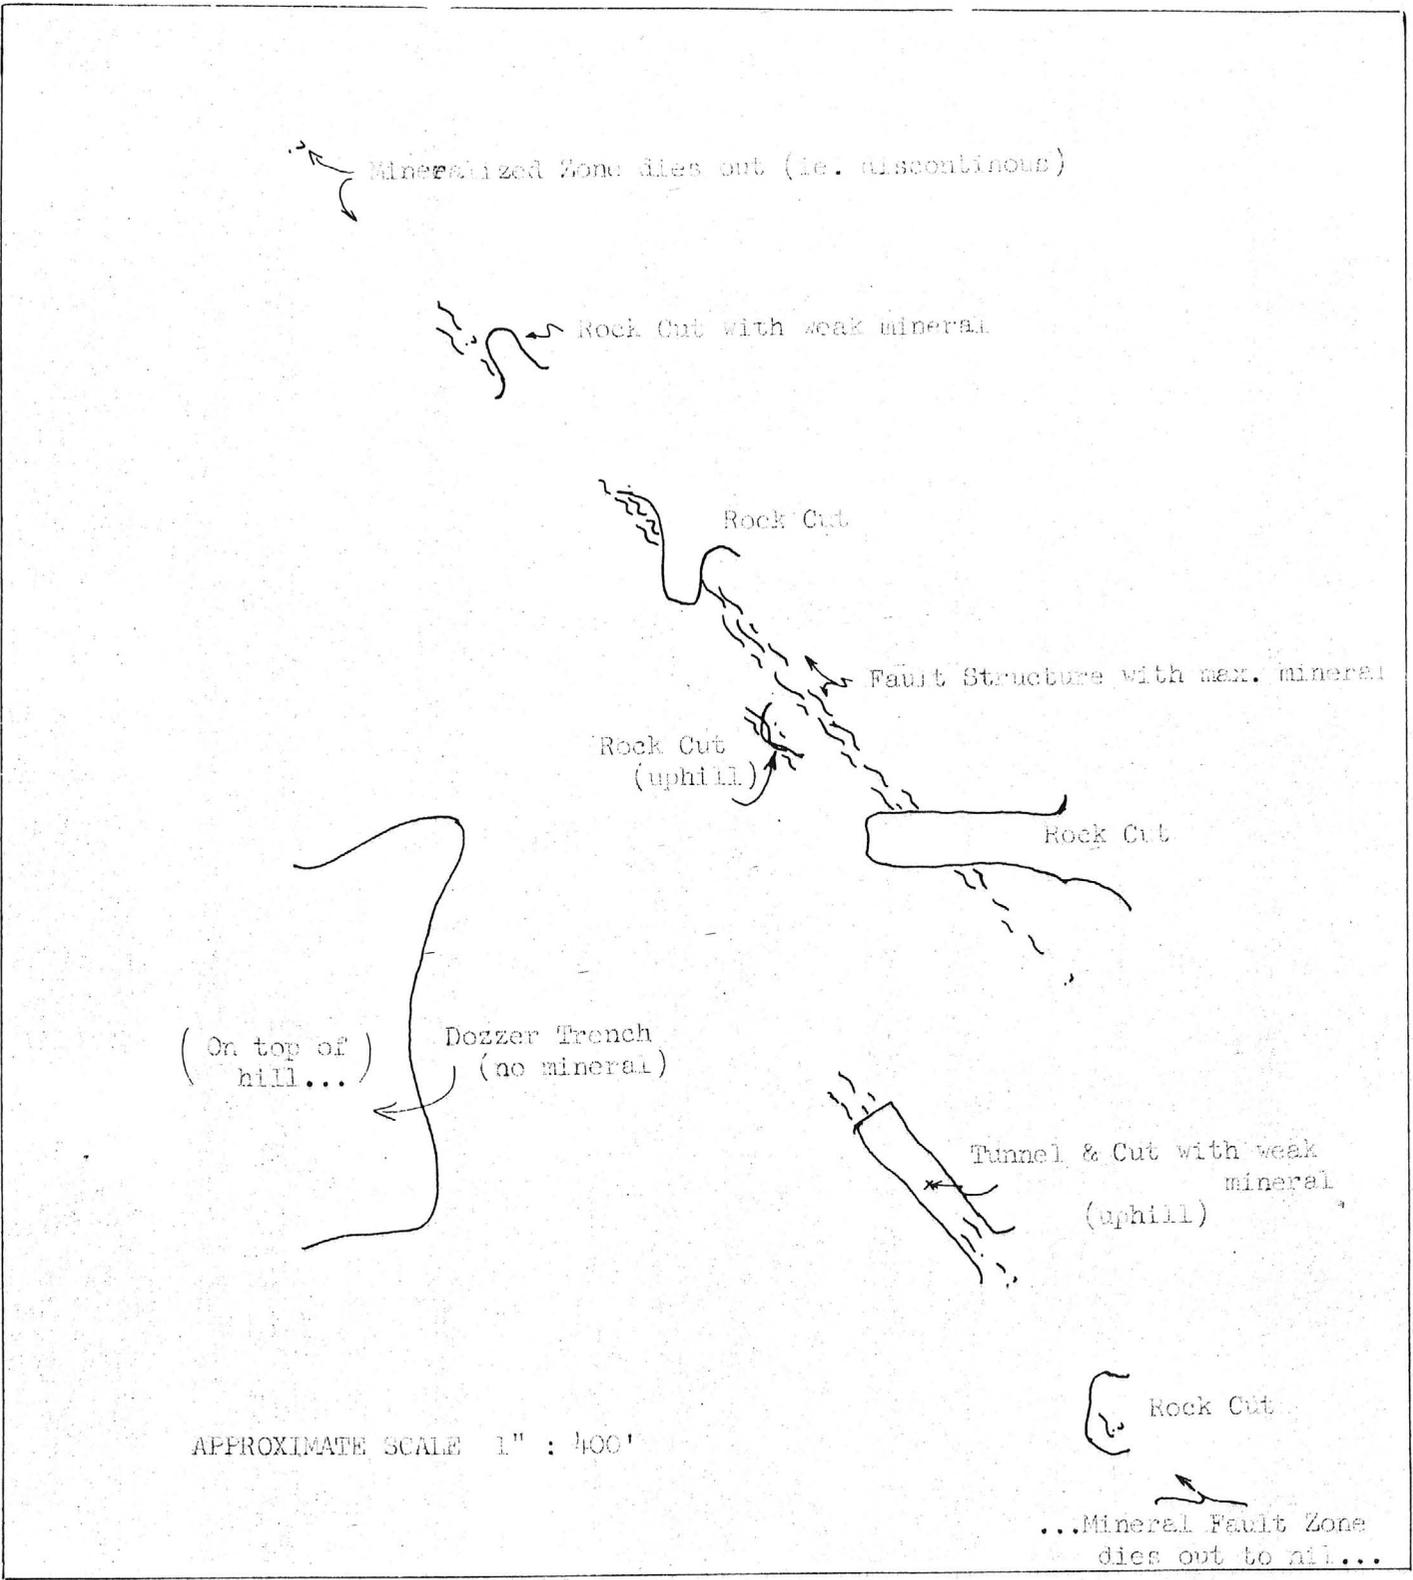
DISTRIBUTION OF EXPLORATION WORK ON
 COPPER PROSPECT IN SWANSEA MINE AREA

Some rock trenching, tunneling and dozer work was done 2 to 3 years ago as illustrated on the enclosed sketch. No samples were collected for assays because of the obvious discontinuous nature of the pertinent structure.

Nothing should be done with this prospect due to the following facts:

1. Mineralization of the area is associated with specularite interbeds in limestone whereas the prospect is associated with a fault zone.
2. The mineralization in the fault zone is discontinuous.

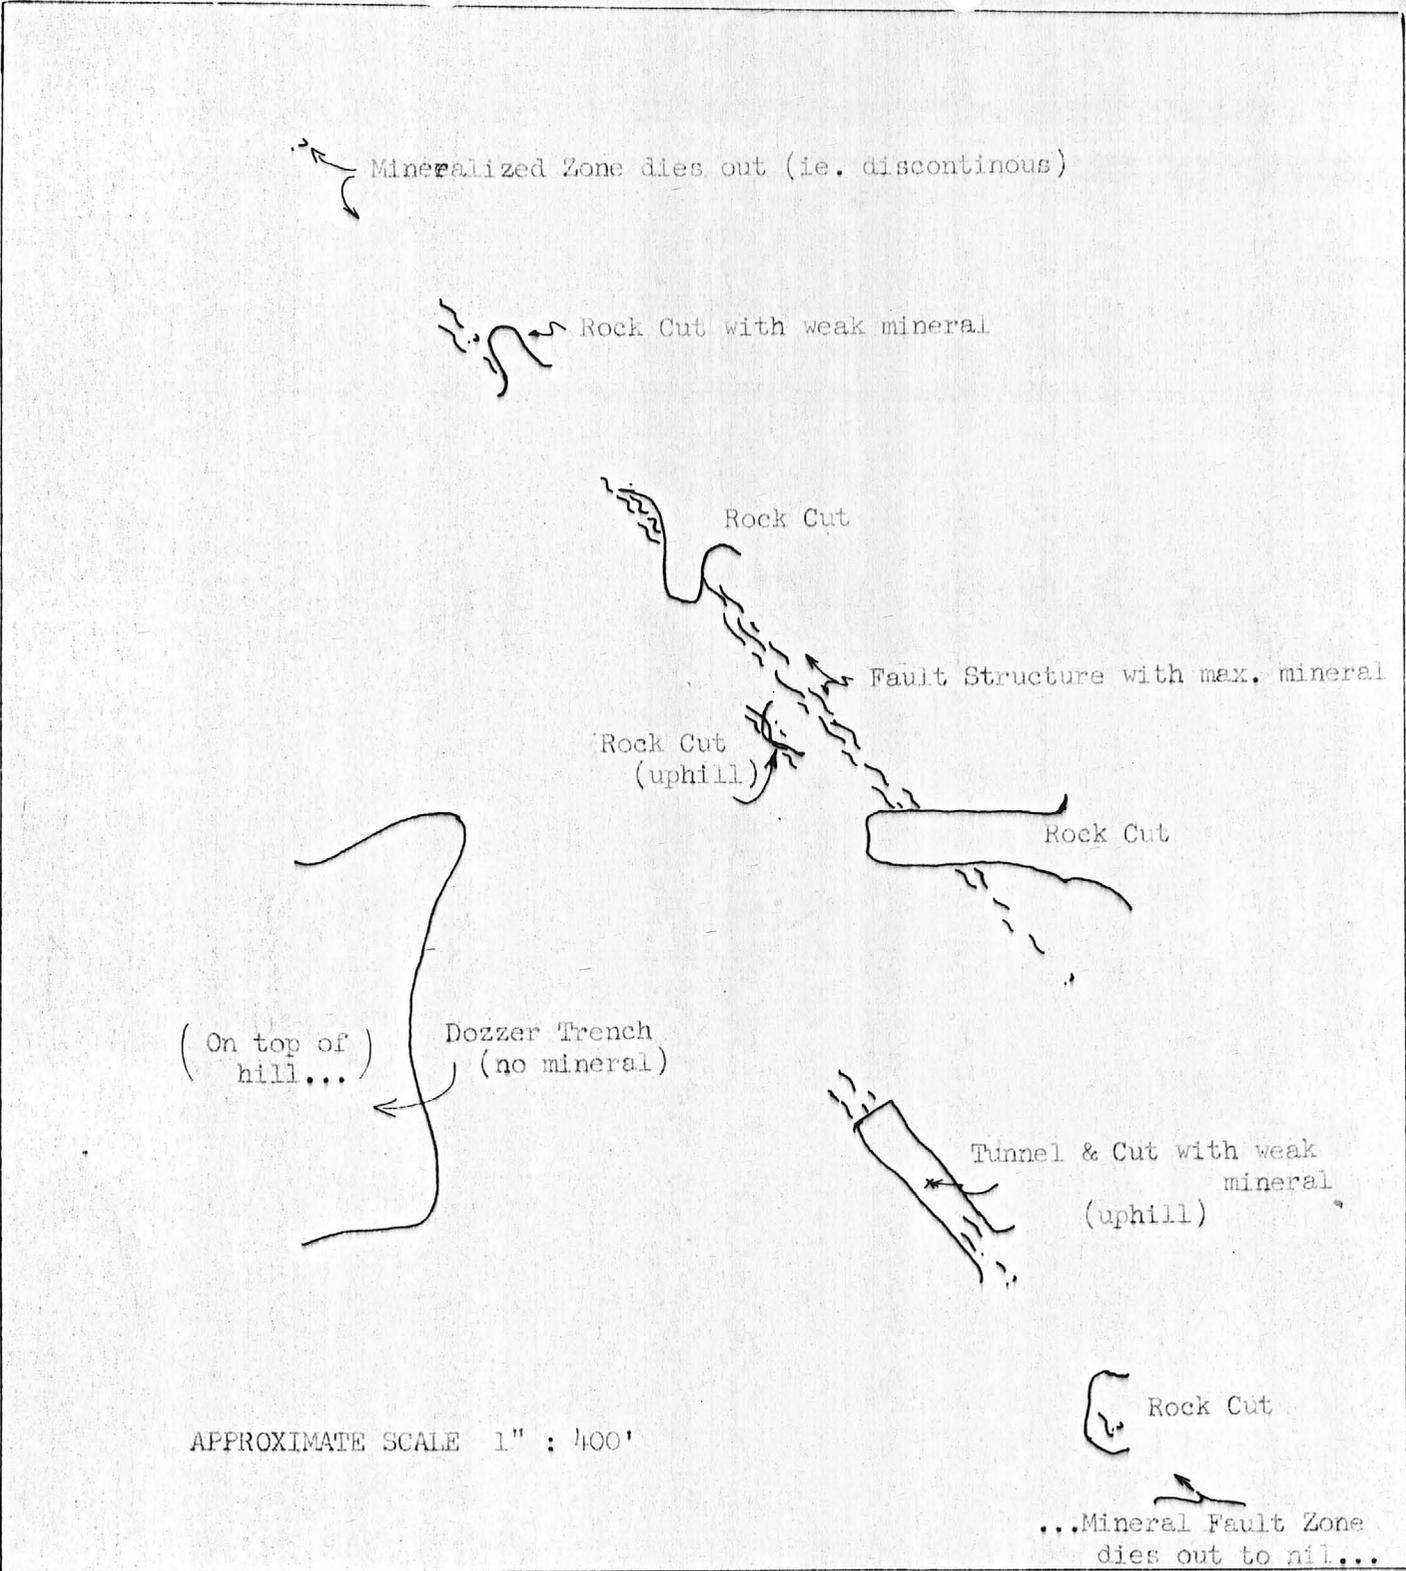
DISTRIBUTION OF EXPLORATION WORK ON
 COPPER PROSPECT IN SWANSEA MINE AREA

Some rock trenching, tunneling and dozer work was done 2 to 3 years ago as illustrated on the enclosed sketch. No samples were collected for assays because of the obvious discontinuous nature of the pertinent structure.

Nothing should be done with this prospect due to the following facts:

1. Mineralization of the area is associated with specularite interbeds in limestone whereas the prospect is associated with a fault zone.
2. The mineralization in the fault zone is discontinuous.
