DEPARTMENT OF MINERAL RESOURCES
STATE OF ARIZONA
FIELD ENGINEERS REPORT

Mine KEYSTONE COPPER Cu., Zn. Date September 9, 1943
District Cochise (Johnson) Engineer Earl F. Hastings
Subject: Reconstruction Finance Corporation
 Mine Loan

RECONSTRUCTION FINANCE CORPORATION
MINING SECTION
LIQUIDATION REPORT

RECONSTRUCTION FINANCE CORPORATION
MINING SECTION
PROGRESS REPORT OF SUPERVISING ENGINEER

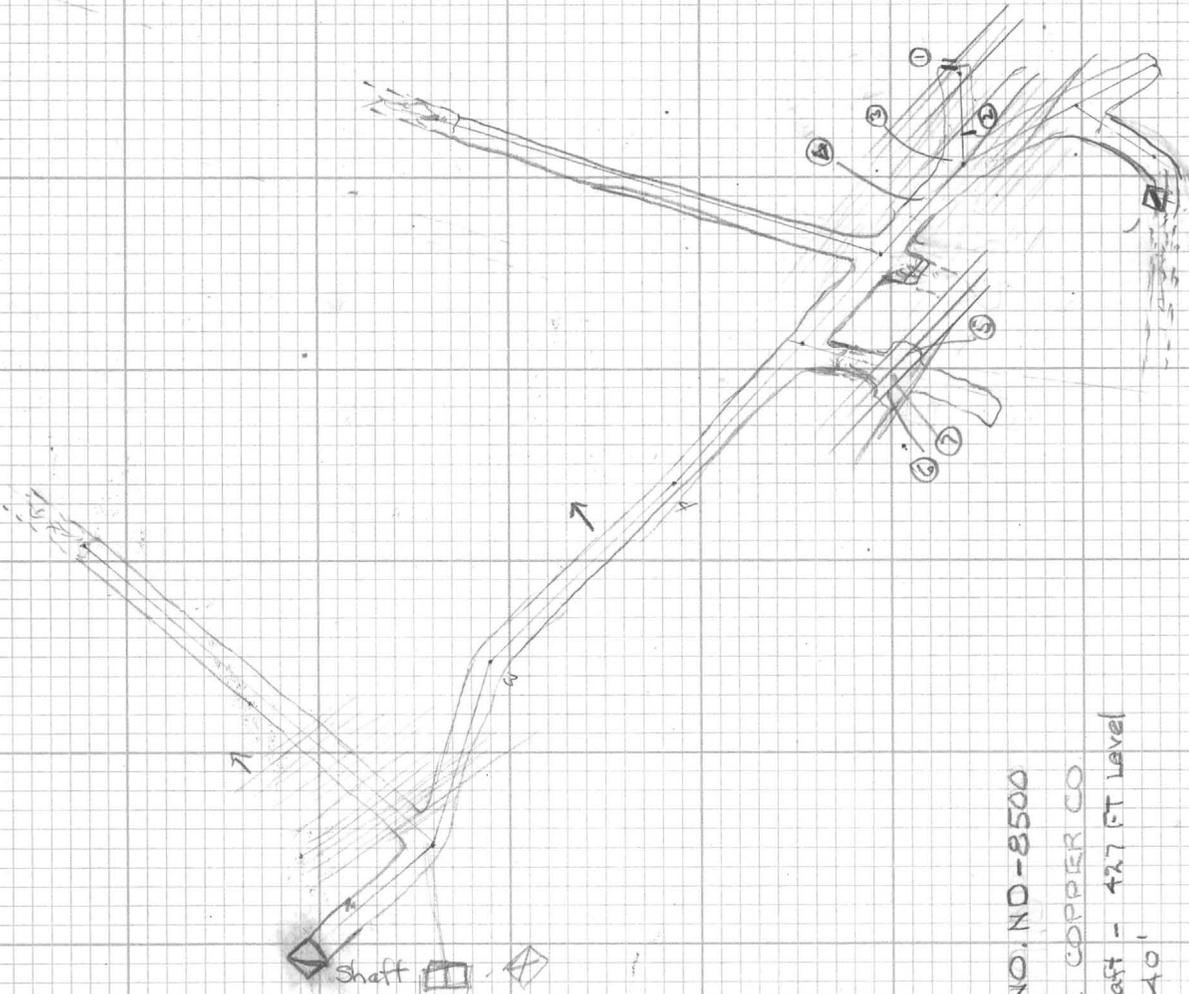
DOCKET NO. ND-8500
KEYSTONE COPPER CO
Hagerman Shaft - 427 FT Level
1" = 40'

- ③ S 44° E 54'
- ④
- ⑤ S 48° E 40' to drift

Drift S 8° W
 Drifts N 12° E
 63 to drifts

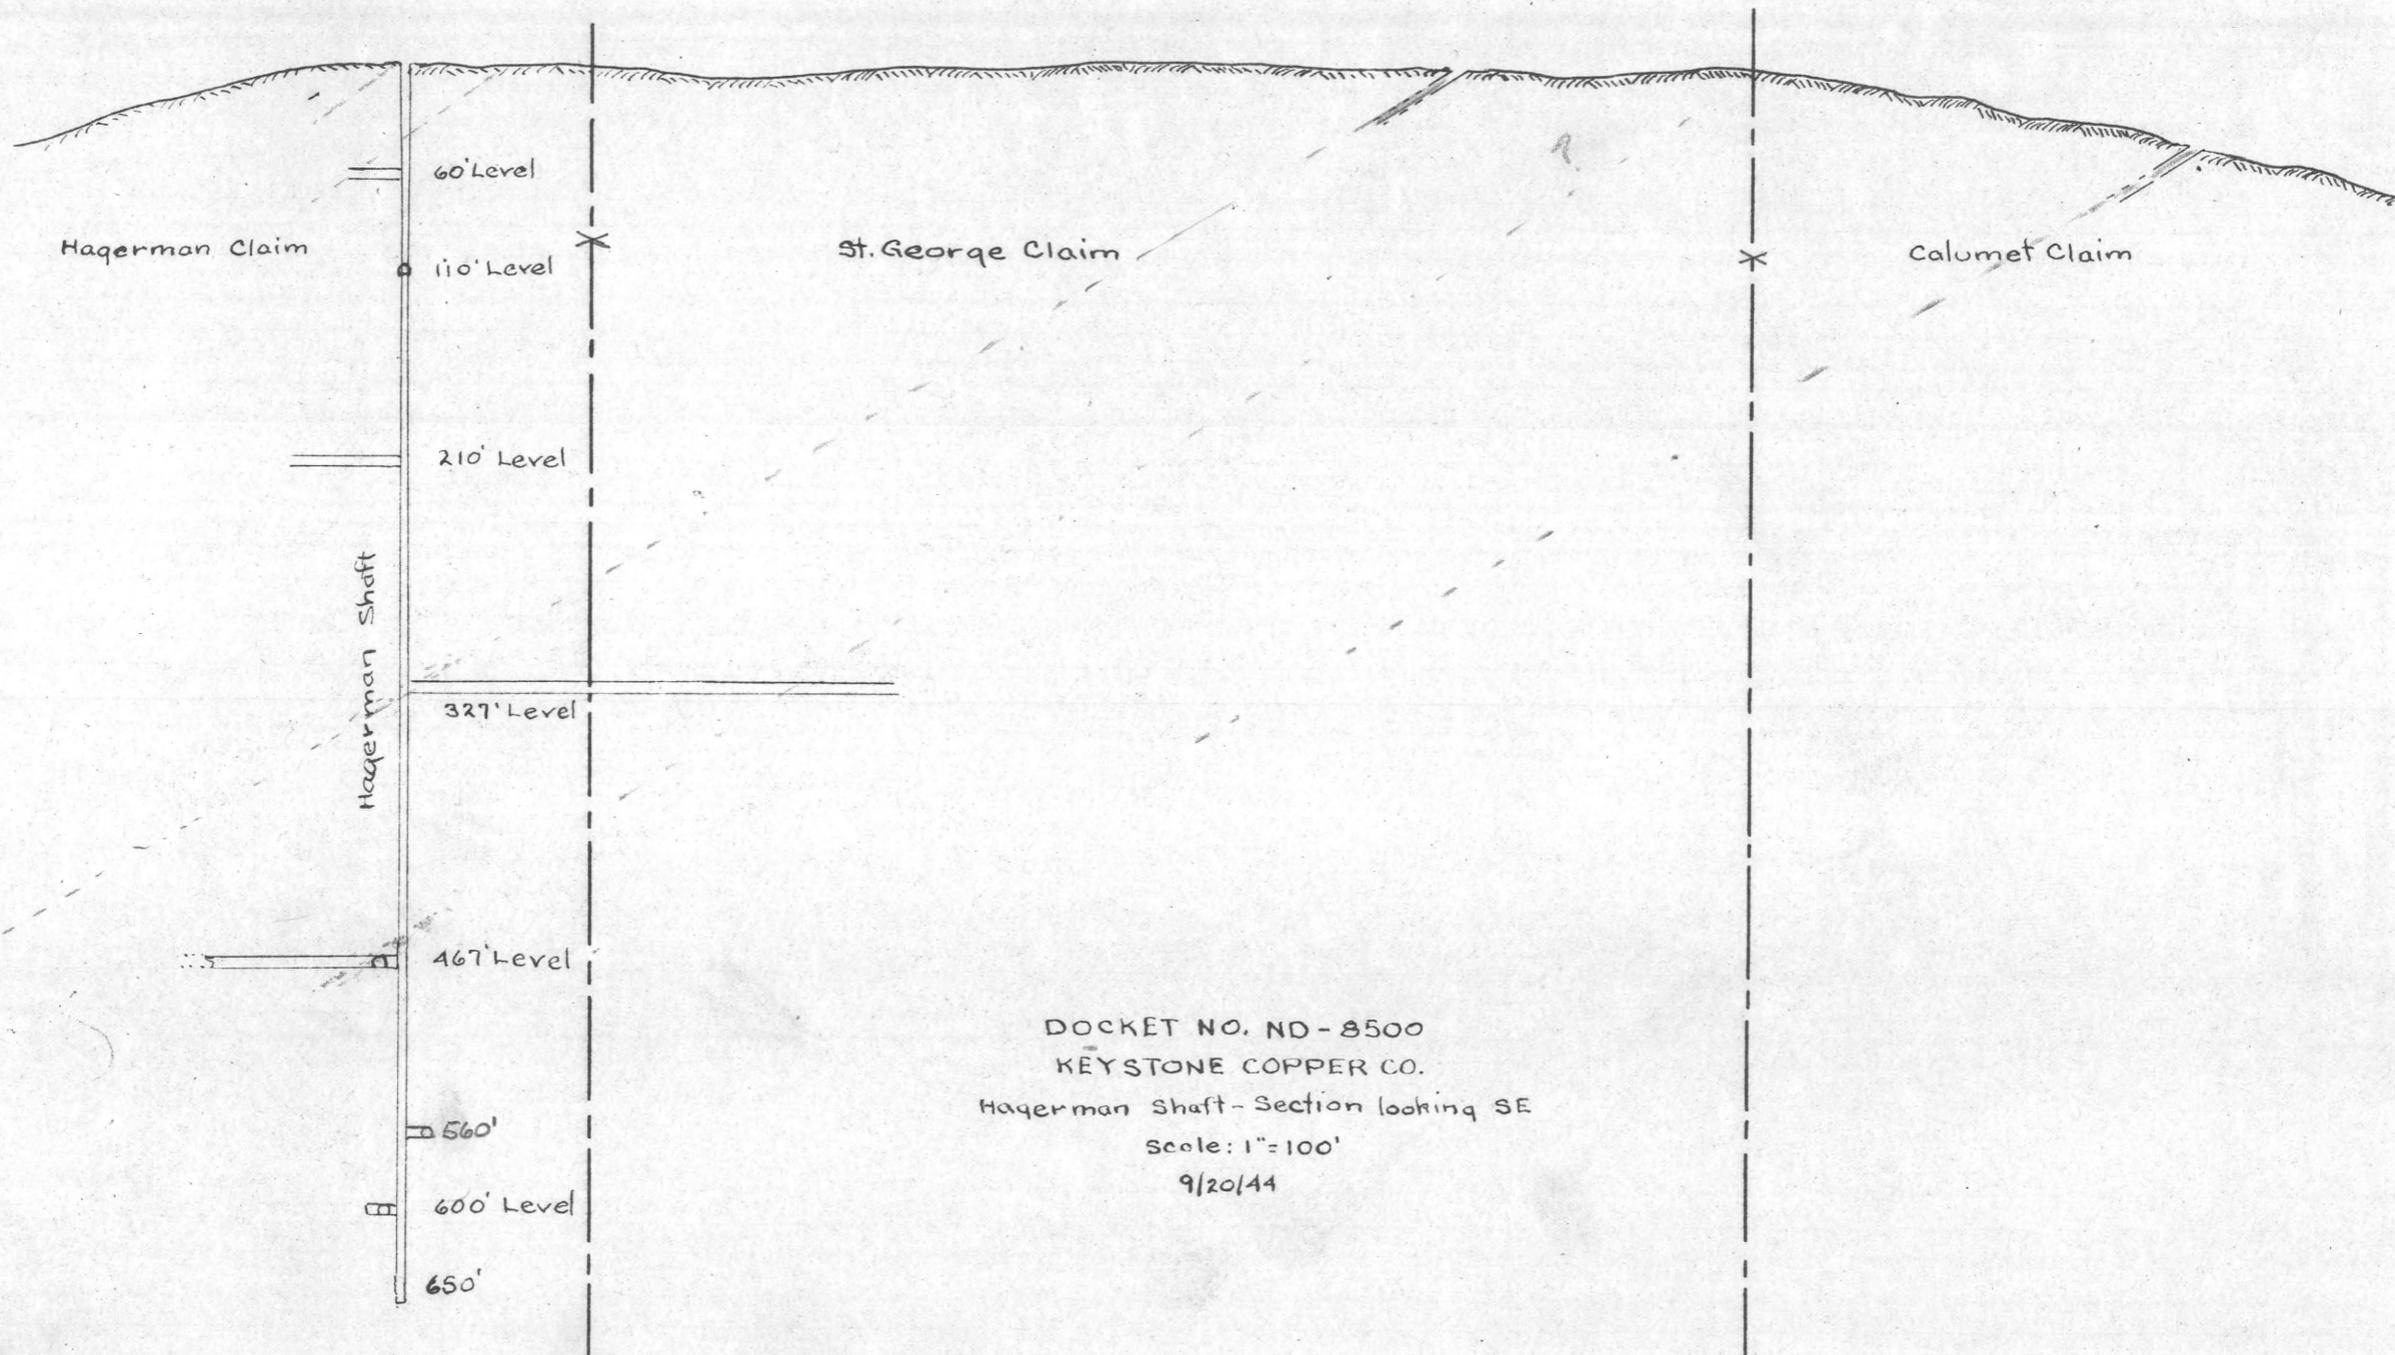
DOCKET NO. ND-8500
 KEYSTONE COPPER CO.
 Hagerman Shaft - Section looking SE
 Scale: 1" = 100'
 9/20/44

The vertical Hogeman shaft ~~was~~ ^{the} sunk to intersect and explore the downward projection of the ^{apartments bed which} ~~was~~ ^{and possibly} ~~mined~~ on the St. George claim. The ~~shaft~~ ^{bed} was apparently encountered at about 330 ft in the shaft and a level was run out on it. This ^{marks} ~~is~~ ^{is} all covered now and blocked off with concrete. Apparently nothing of importance was found here. Levels were also run at 467 Ft and 600 Ft., and a stub level was put in some 560 feet above the 600 Ft level.

On the 600 Ft. level a crosscut was driven ^(30 ft) ~~into~~ the horizon wall and a drift was run ^{south easterly} from its end for a distance of 195 ft. At 160 ft [^] a ~~st~~ raise was put up steeply into the horizon wall ^{to a height of 25 feet.} ~~ft from the crosscut.~~ The shaft station and

On the 560 Ft. level a short crosscut and drift were driven into the foot wall. ~~of the~~ level was heavily covered and nothing of interest was visible.

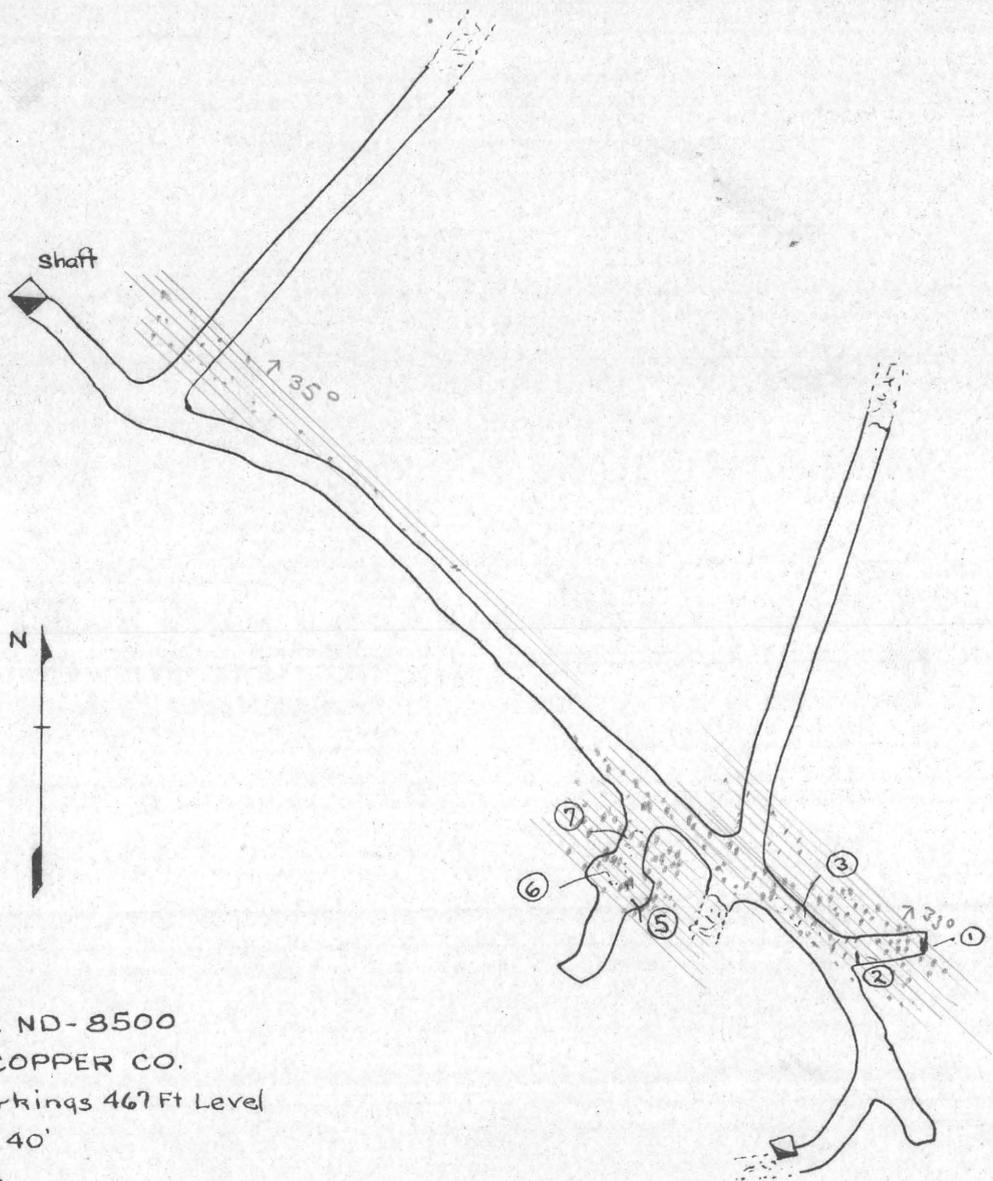
DOCKET NO. ND-8500
 KEYSTONE COPPER CO.
 Hagerman Workings 467 Ft Level
 Scale: 1" = 40'
 9/20/44

On the 467 ft. level (see sketch) a crosscut was run to intersect the projection of the bed which was worked on the surface of the St. George claim and which was said to have been intersected and explored upon the presently inaccessible 327 ft. level. It is said that the crosscut picked up the bed and that it was drifted upon. This work is mostly caved and no maps or reports of a dependable nature regarding the findings are available and no proof exists of ore having been developed.

A little sparse sulphide mineralization is present on this level in a series of beds near the shaft and drifting on these beds which was done at a later date than the above described work encountered an area of low grade copper-zinc sulphide mineralization at about 125 feet from the shaft. Several crosscuts explored the most favorable showings beyond this point and my sampling, shown on my sketch, was done in these more favorable areas. The rock here is a silicified garnetized limestone and is extremely hard. Systematic channel sampling of the area would be a sizable job for a handsteel crew and I doubt if the work could be done without first correcting the present unsafe condition of the shaft. In any event the material was obviously all below ore grade and I am satisfied that my assays are sufficiently representative to prove that a costly sampling job is not justified. Samples Nos. 1 and 2 were chip samples across narrow widths containing the best mineralization to be seen in the area. The balance of the samples were grabs from the muck which more than half filled portions of the drifts and crosscuts. The last rounds blasted were simply mucked back in the drifts and crosscuts and the muck samples therefore adequately represent the values existing here - probably more truly than would channel samples.

Summarizing: Neither the O.K. nor the Hagerman workings contains a body of ore and neither contains any ore showings sufficiently promising to justify further development.

Sample	Width	%Cu.	%Zn.
1	32"	1.35	2.92
2	33"	1.64	2.35
3	muck	.69	1.90
4	"	.69	2.04
5	"	.85	2.06
6	"	.43	1.75
7	"	.80	1.69

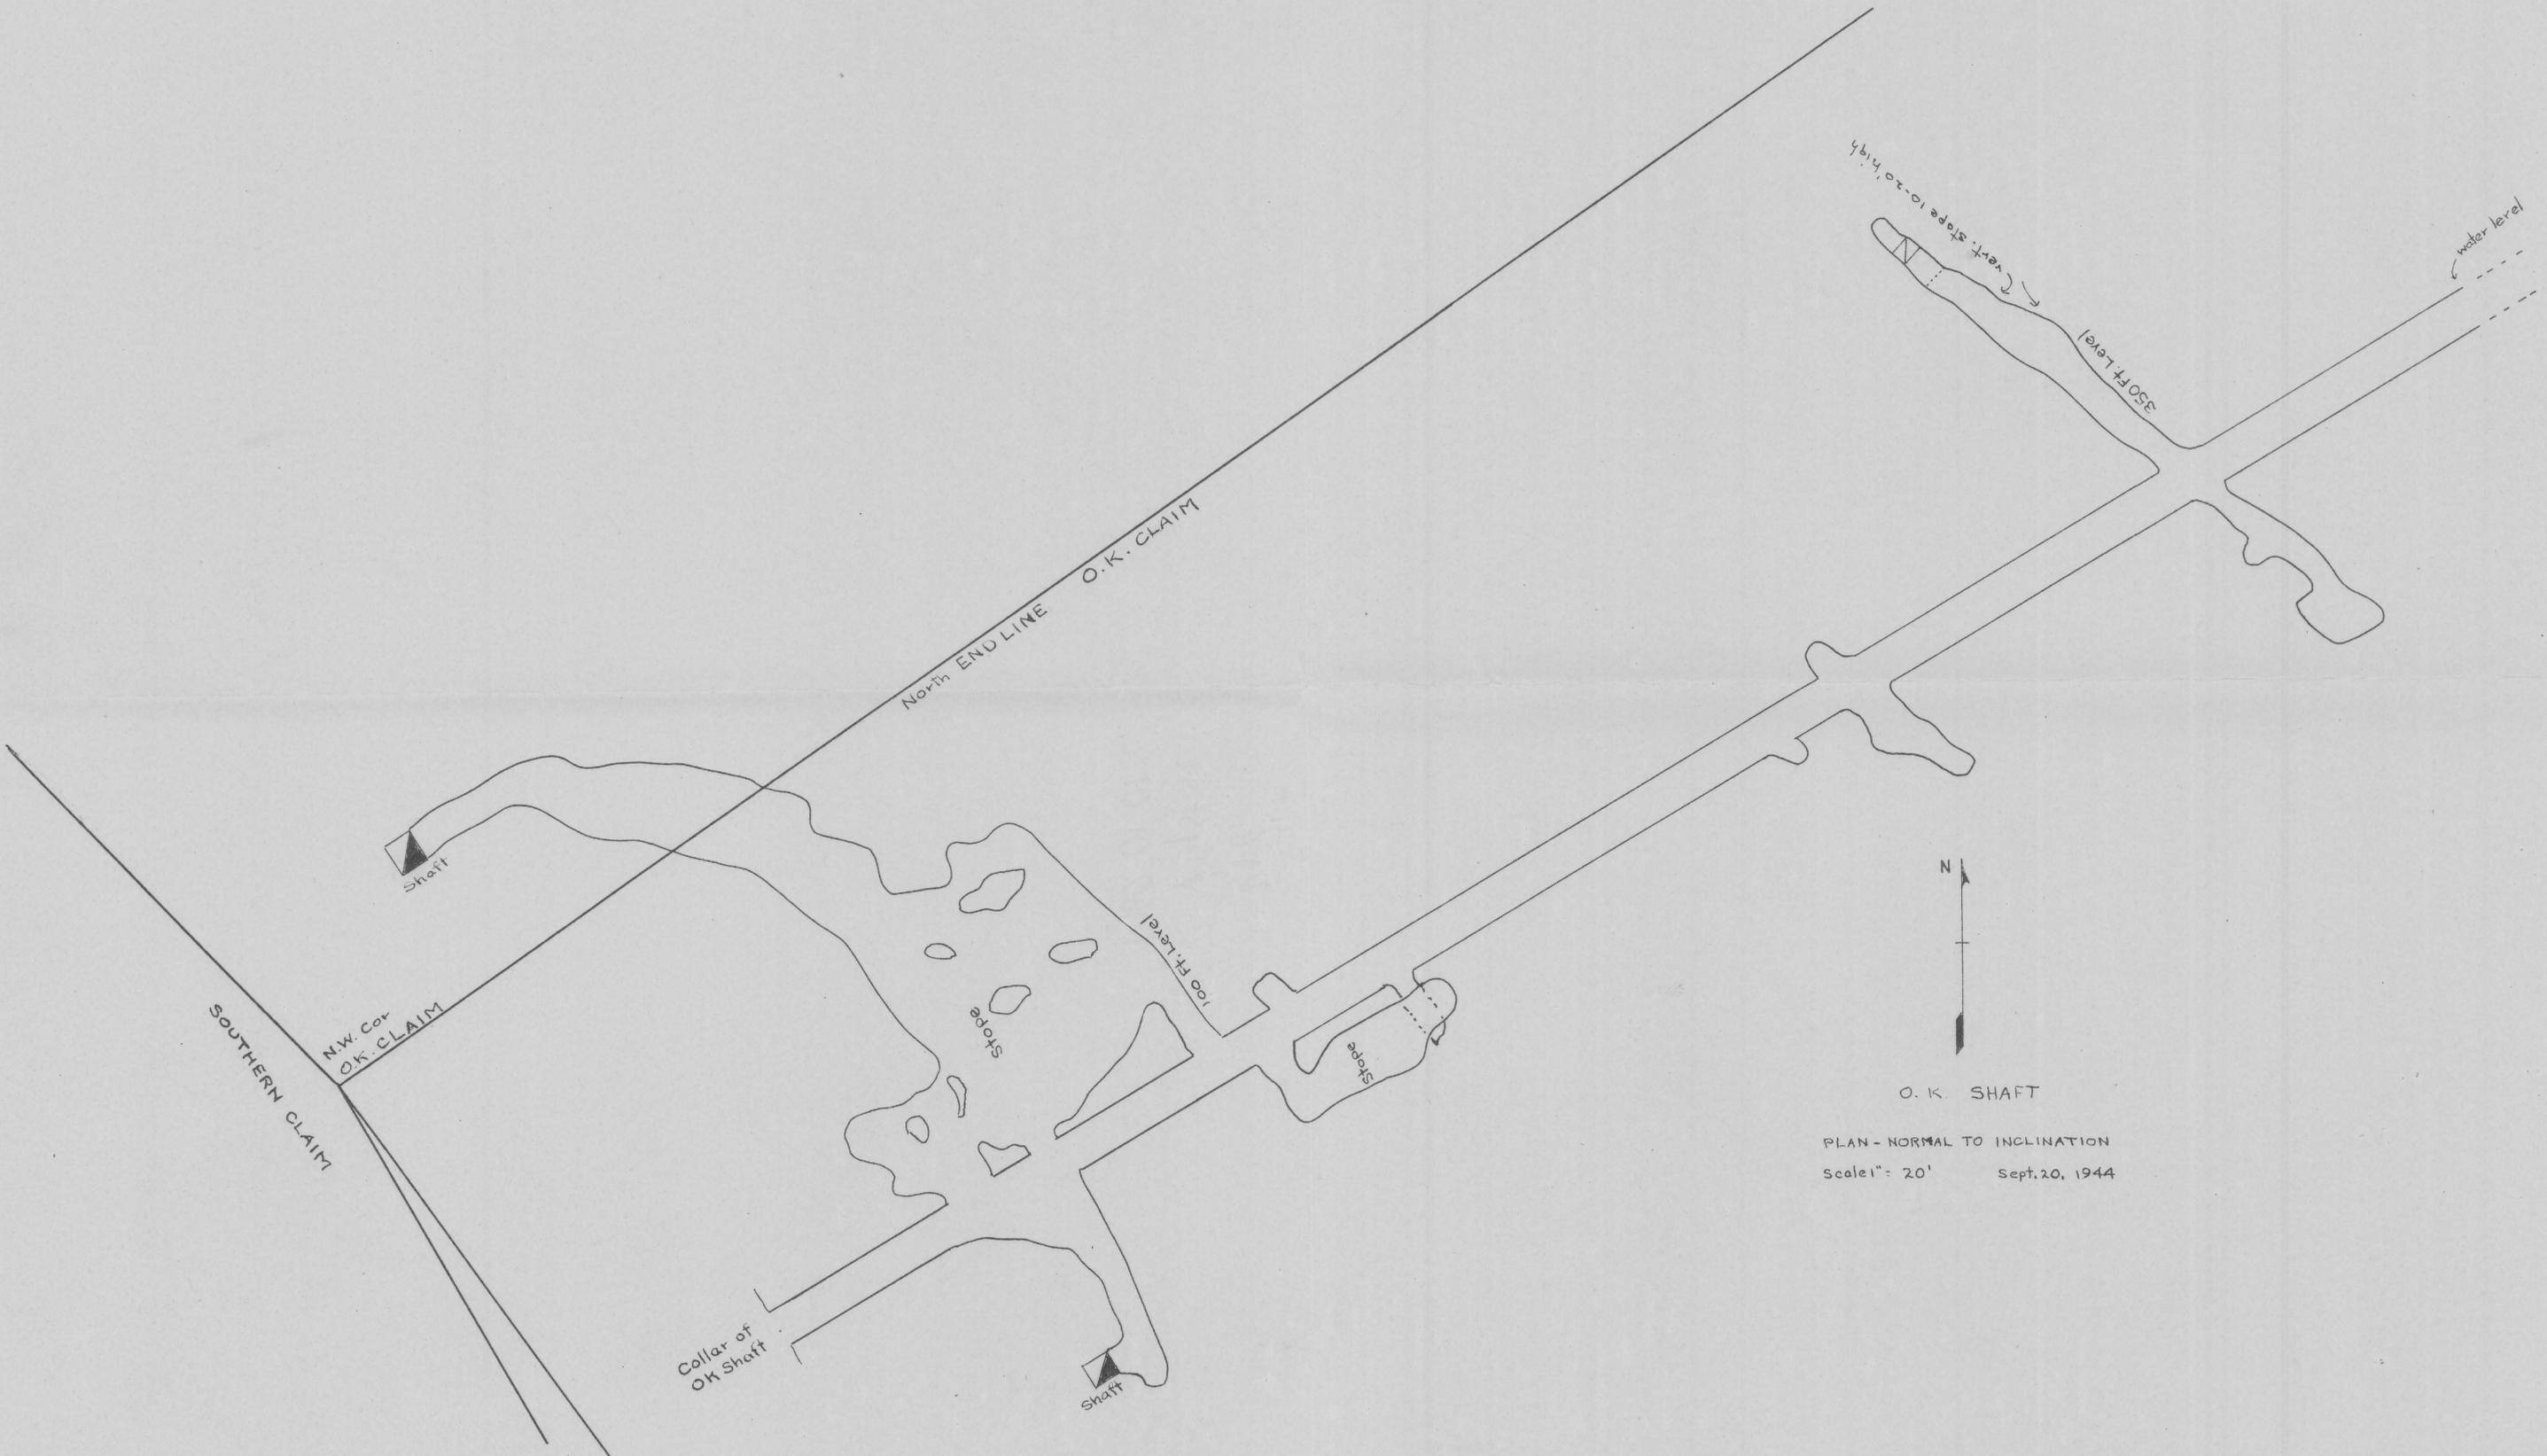
O. K. SHAFT
 PLAN - NORMAL TO INCLINATION
 Scale 1" = 20' Sept. 20, 1944

The O.K., or Miller, shaft located 1700 feet northwesterly from the Hagerman shaft, is sunk on the dip (about 35°) of a 6 foot bed of mineralized limestone. The shaft (see attached copy of map by Mr. Razor) is sunk to a reputed depth of 450 ft. with levels at 400 ft. (?), 350 ft. and 100 ft. and a number of shorter openings at other points. The upper part of the mine has been stoped irregularly near the surface (see map), producing oxidized copper ore, and apparently most of the recorded production of the property, approximately 900 tons of 5.24% copper, was shipped from here. The production was made over a period of 22 years and it is apparent that the ore was closely sorted, and it is questionable whether the operations were profitable. The ore shoot has been mined out, with either waste or spotted fringe material remaining in the ends and a few tons of pillar ore in the back just under the surface. The ore values fade at about the 100 ft. level and do not reappear in the lower part of the mine. A vertical fracture vein of sulphide ore was followed

for a short distance on the 350 ft. level. The ore varied from 1" to 6" in width and some loose chunks seen in the muck on the floor were high grade bornite ore. The showing proved to be too small however to be worth while, and work was discontinued. The water stands at 390' from the surface. A pump is set here and the borrower intended soon after my visit to pump out the sump and examine a level purported to exist at 400 ft.
