A
GEOLOGICAL
and
SAMPLING REPORT
on the
RUTH CLAIMS
Pinal County, Arizona

Richard E. Mieritz
Mining Consultant
Phoenix, Arizona

January 13, 1977

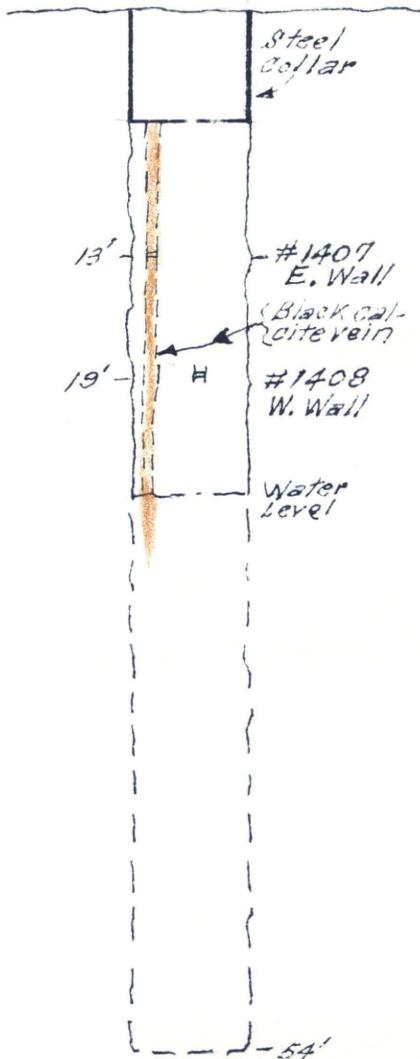
SHAFT No 1 N. 37° E. →

Shaft No. 1 exposes a strong quartz vein in the shaft hanging wall for 11 feet below the collar, at which point it enters the shaft hanging wall because of its flatter dip. Shaft No. 1 also exposes a pyritic, porphyritic altered rock at the bottom of the shaft. Both these occurrences should be further prospected.

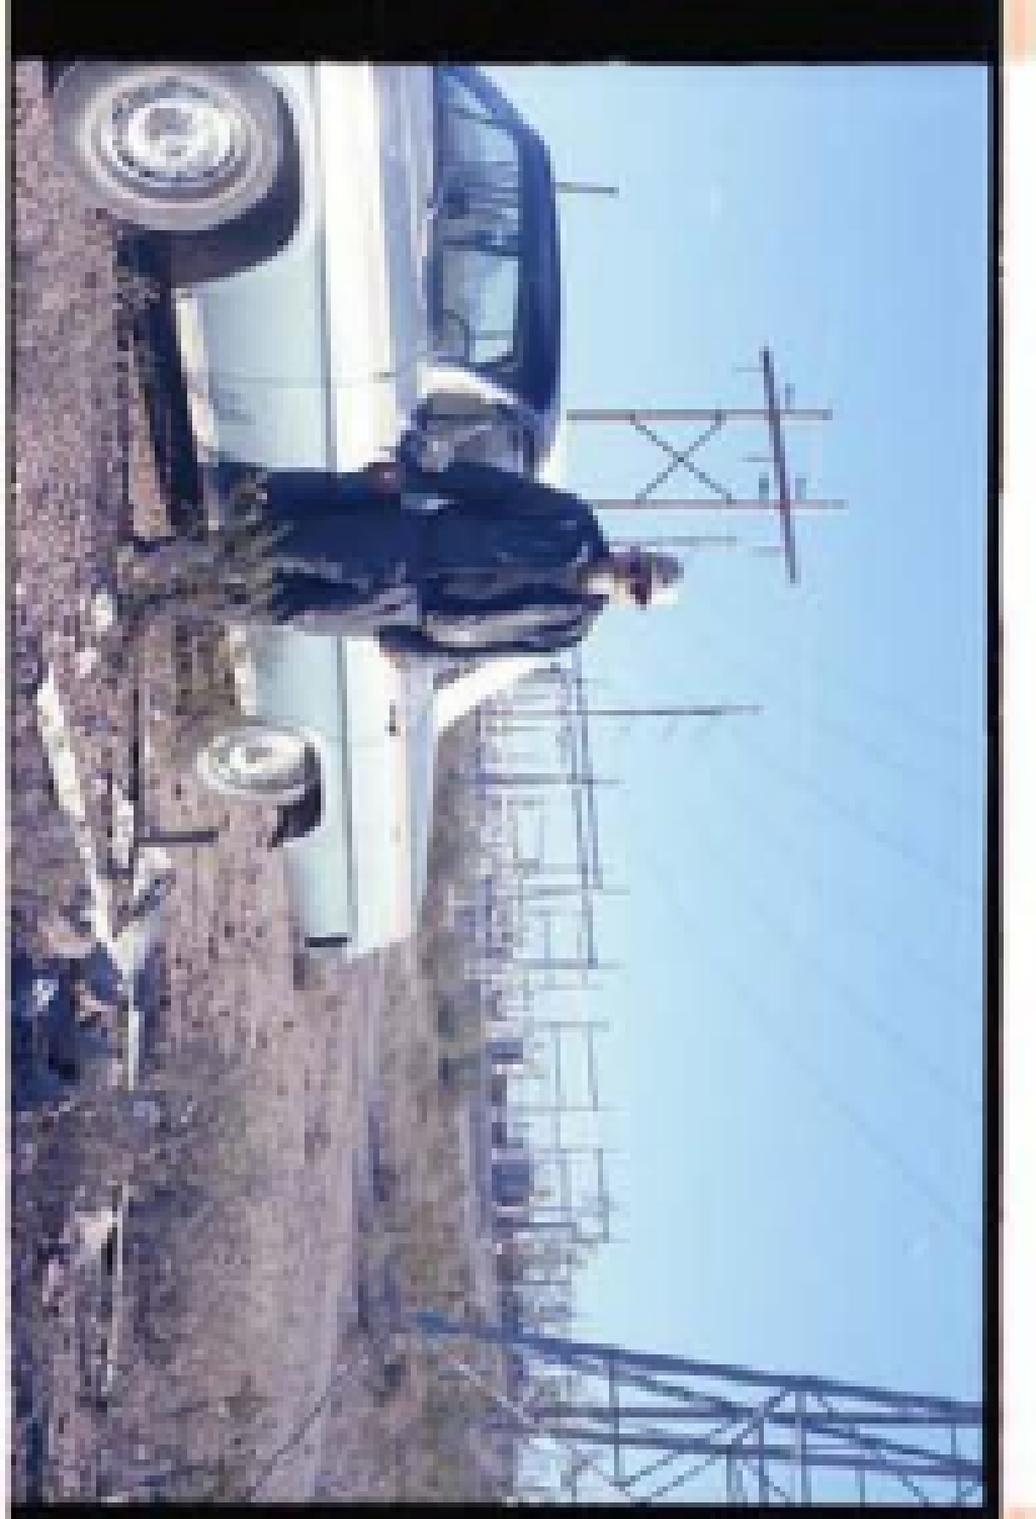
Shows west bank of small pit on western
bank of small wash. Shows fault structure
and caliche on the south bank of Pit. The
Pit is on Claim #1, northwest of Shaft No.1.

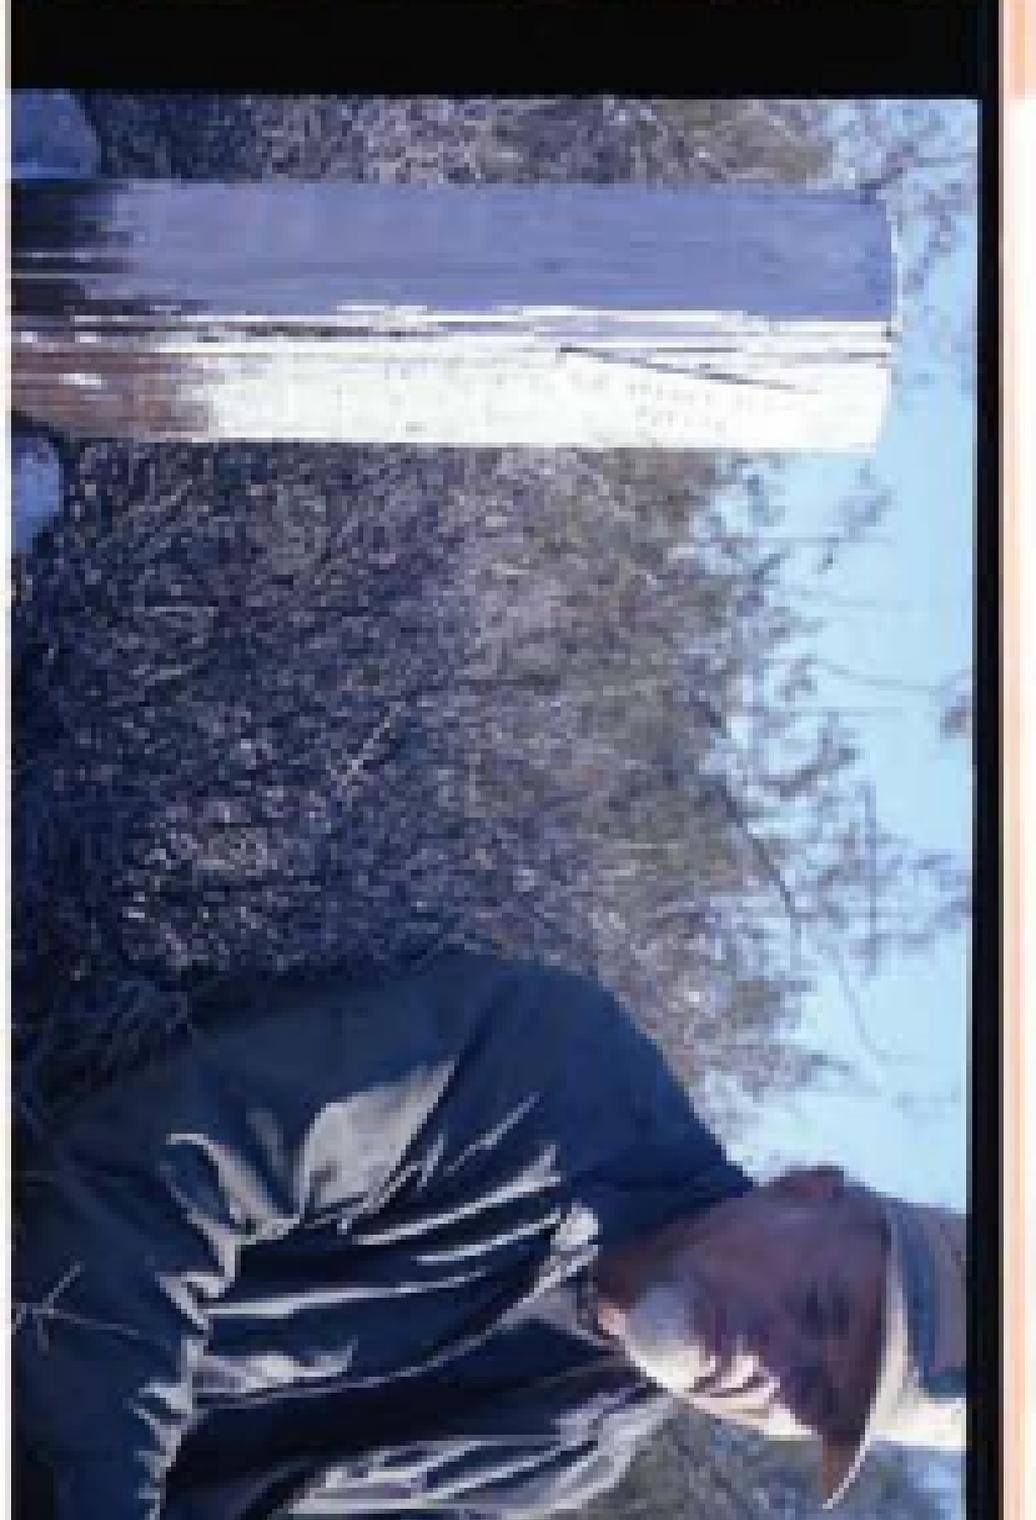
LOOKING NORTH
Shows concrete
collar and en-
trance to Shaft
No. 1, Claim #1.

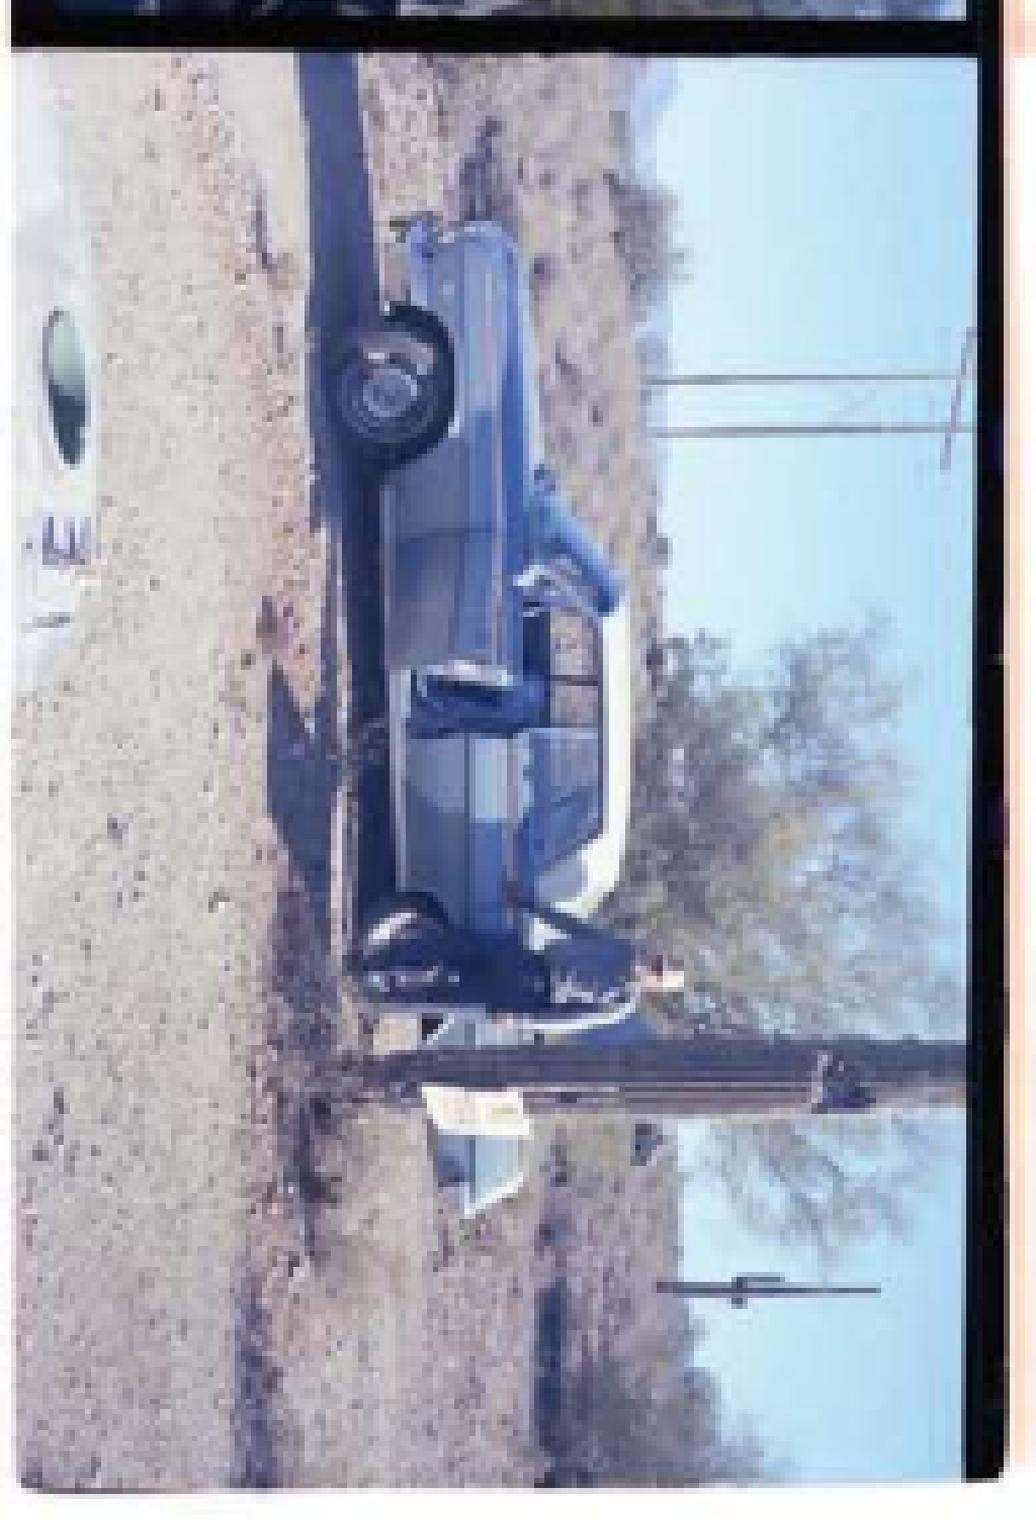
LOOKING NORTHERLY
Shows concrete
collar and en-
trance to Shaft
No. 2, Claim #2.
This Shaft has
water, thus, tank
in distance.
