April 1, 1980

THE GOLD STANDARD MINING PROSPECT
BOUSE MINING DISTRICT, YUMA COUNTY, ARIZONA

Gold Standard Claims

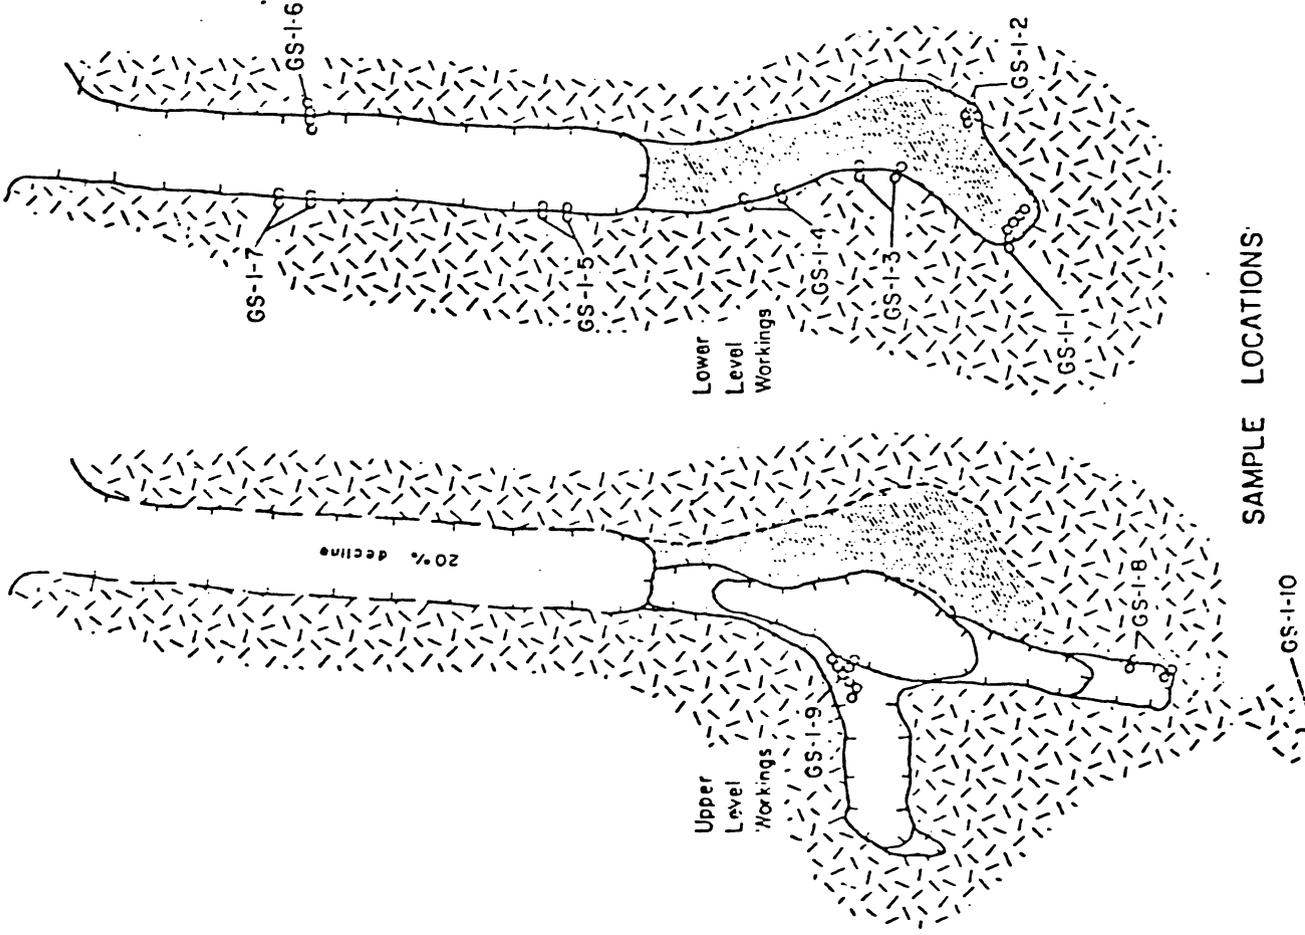
THE GOLD STANDARD PROSPECT

Ten rock chip samples cut from the Gold Standard workings were analyzed for gold, silver, and copper. Sample locations are posted on the sketch map; sample descriptions are appended. Most of the samples were taken perpendicularly across the vein material; however, one of the samples (GS-1-6) was taken from altered wallrock outside the vein zone to test the lateral extent of mineralization.

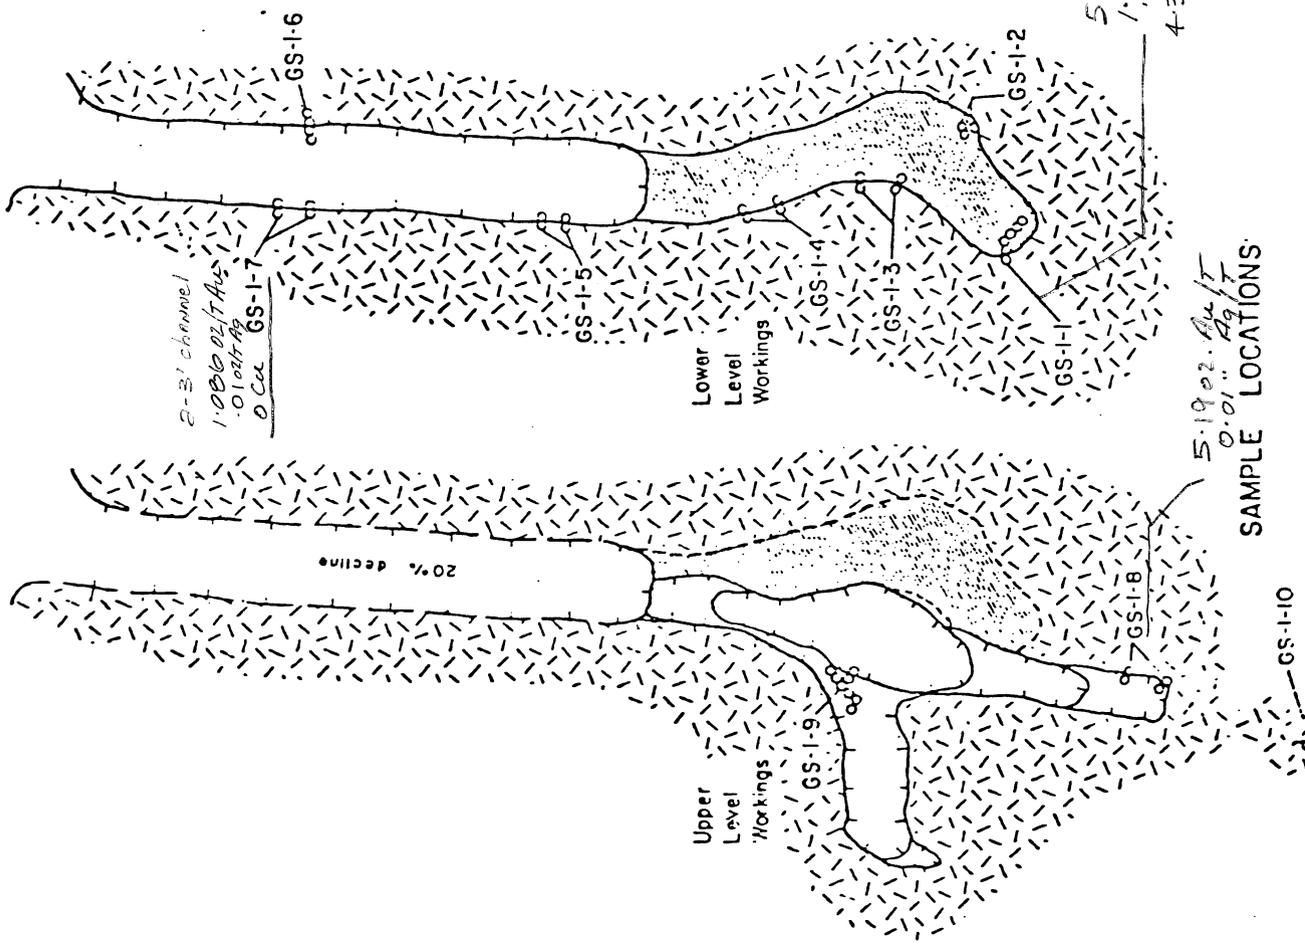
THE GOLD STANDARD PROSPECT

Ten rock chip samples cut from the Gold Standard workings were analyzed for gold, silver, and copper. Sample locations are posted on the sketch map; sample descriptions are appended. Most of the samples were taken perpendicularly across the vein material; however, one of the samples (GS-1-6) was taken from altered wallrock outside the vein zone to test the lateral extent of mineralization.
