NPDES Compliance Inspection Report

NPDES Compliance Monitoring Report

Name of Facility: Zonia Mine

Inspection Date: May 21, 1993

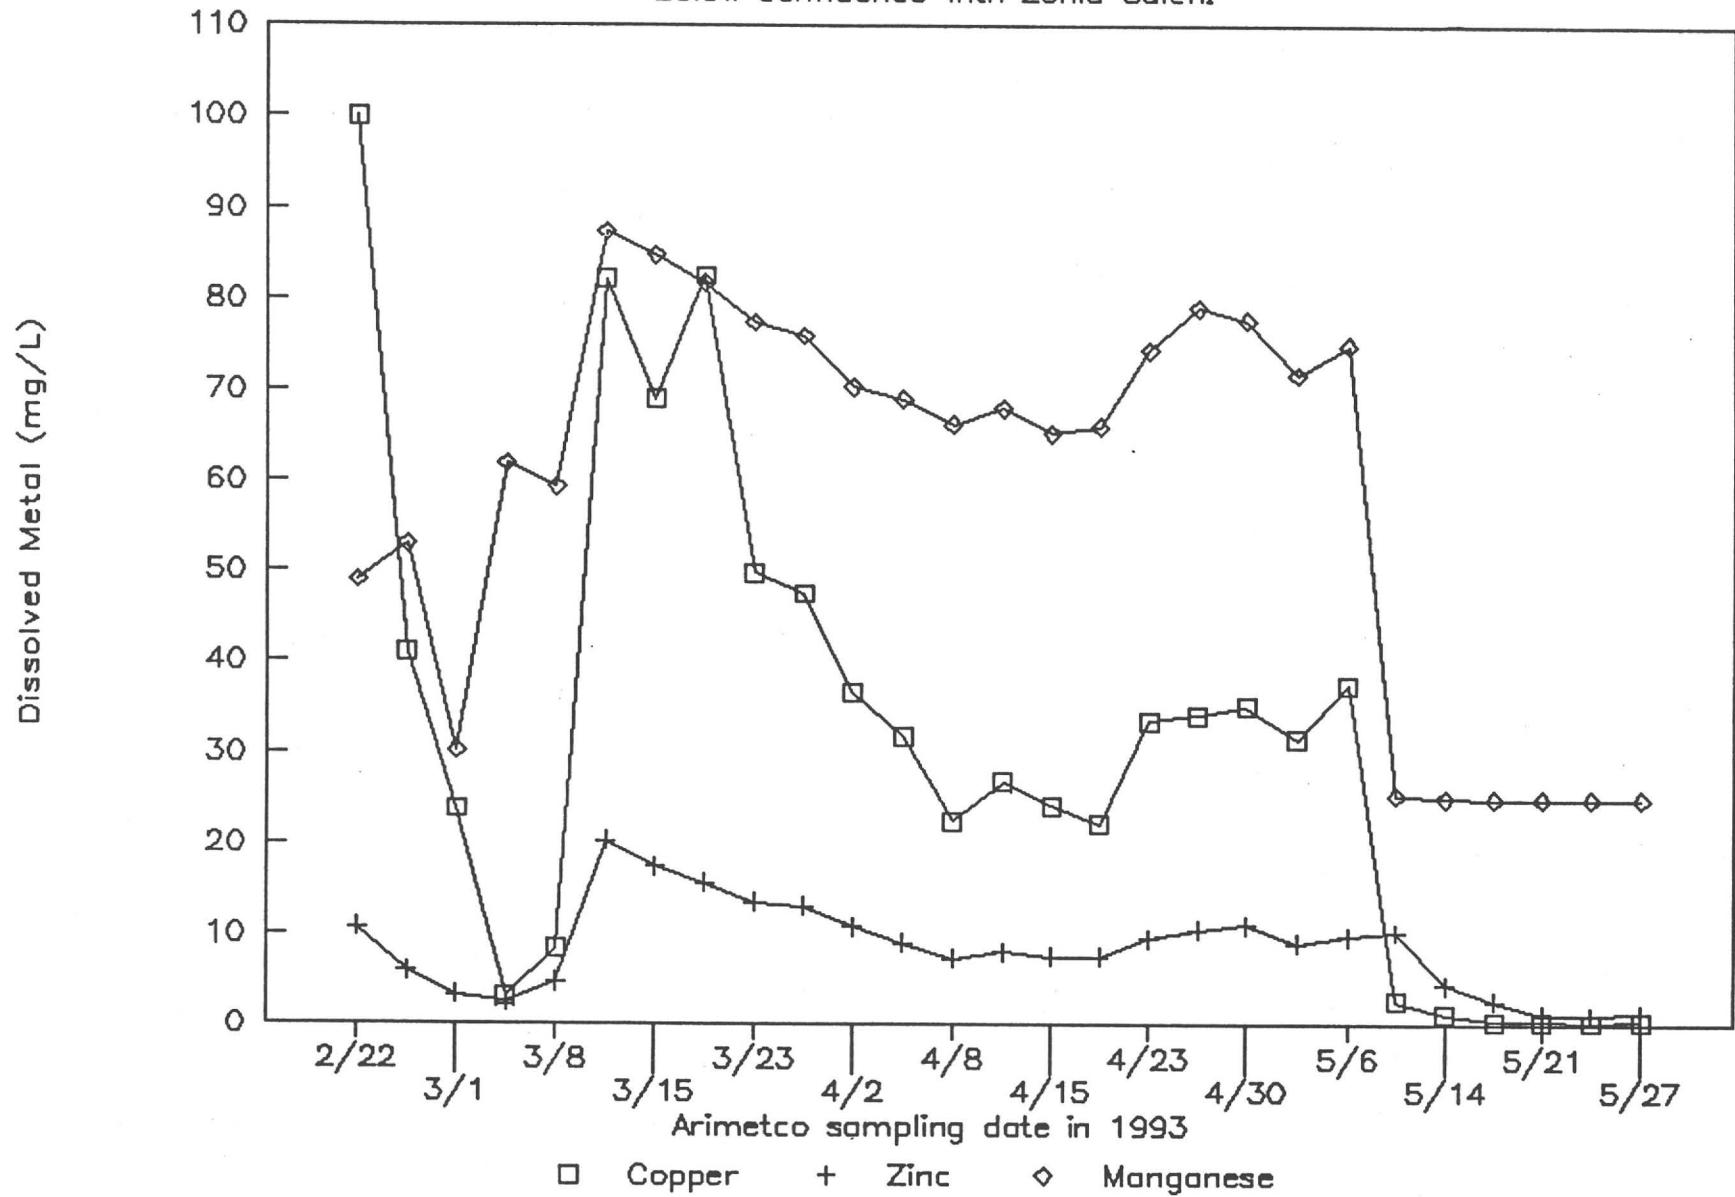
Figure 3. French Gulch metals.

Below confluence with Zonia Gulch.

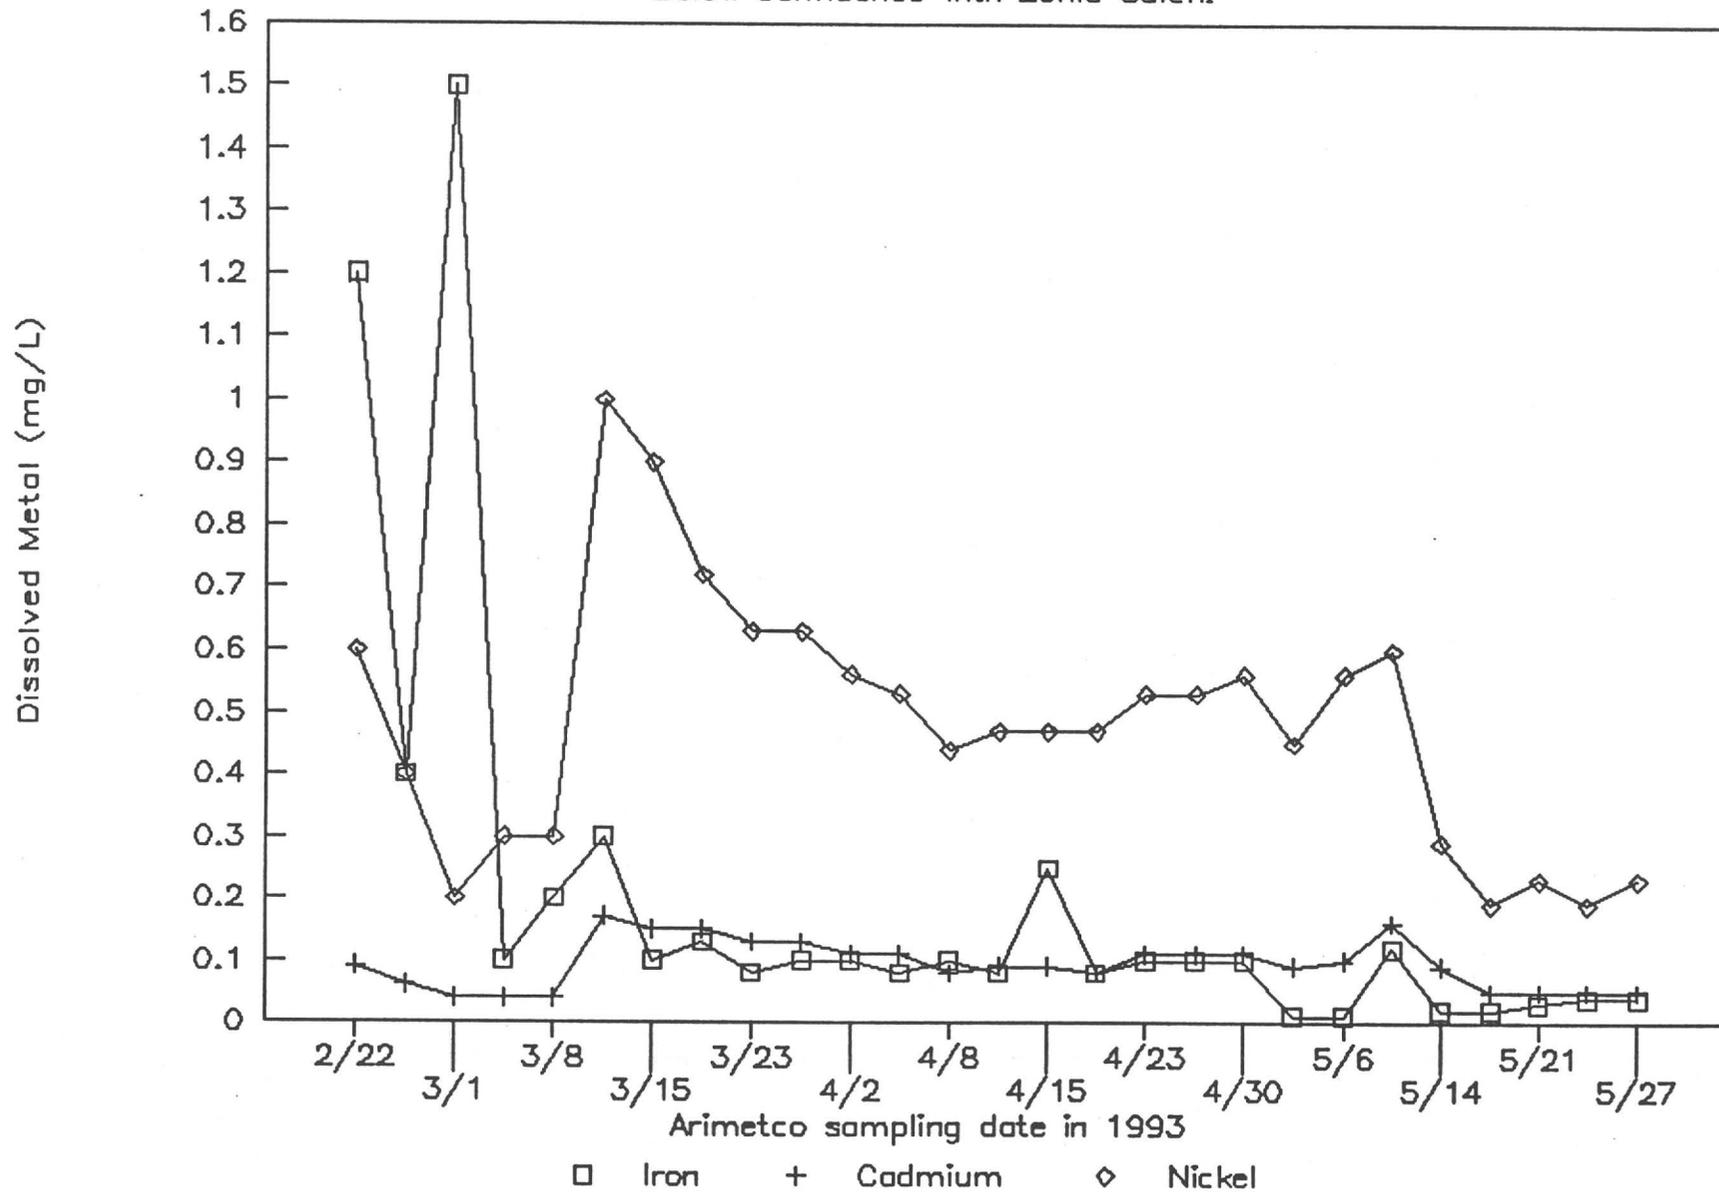
Figure 4. French Gulch metals.

Below confluence with Zonia Gulch.

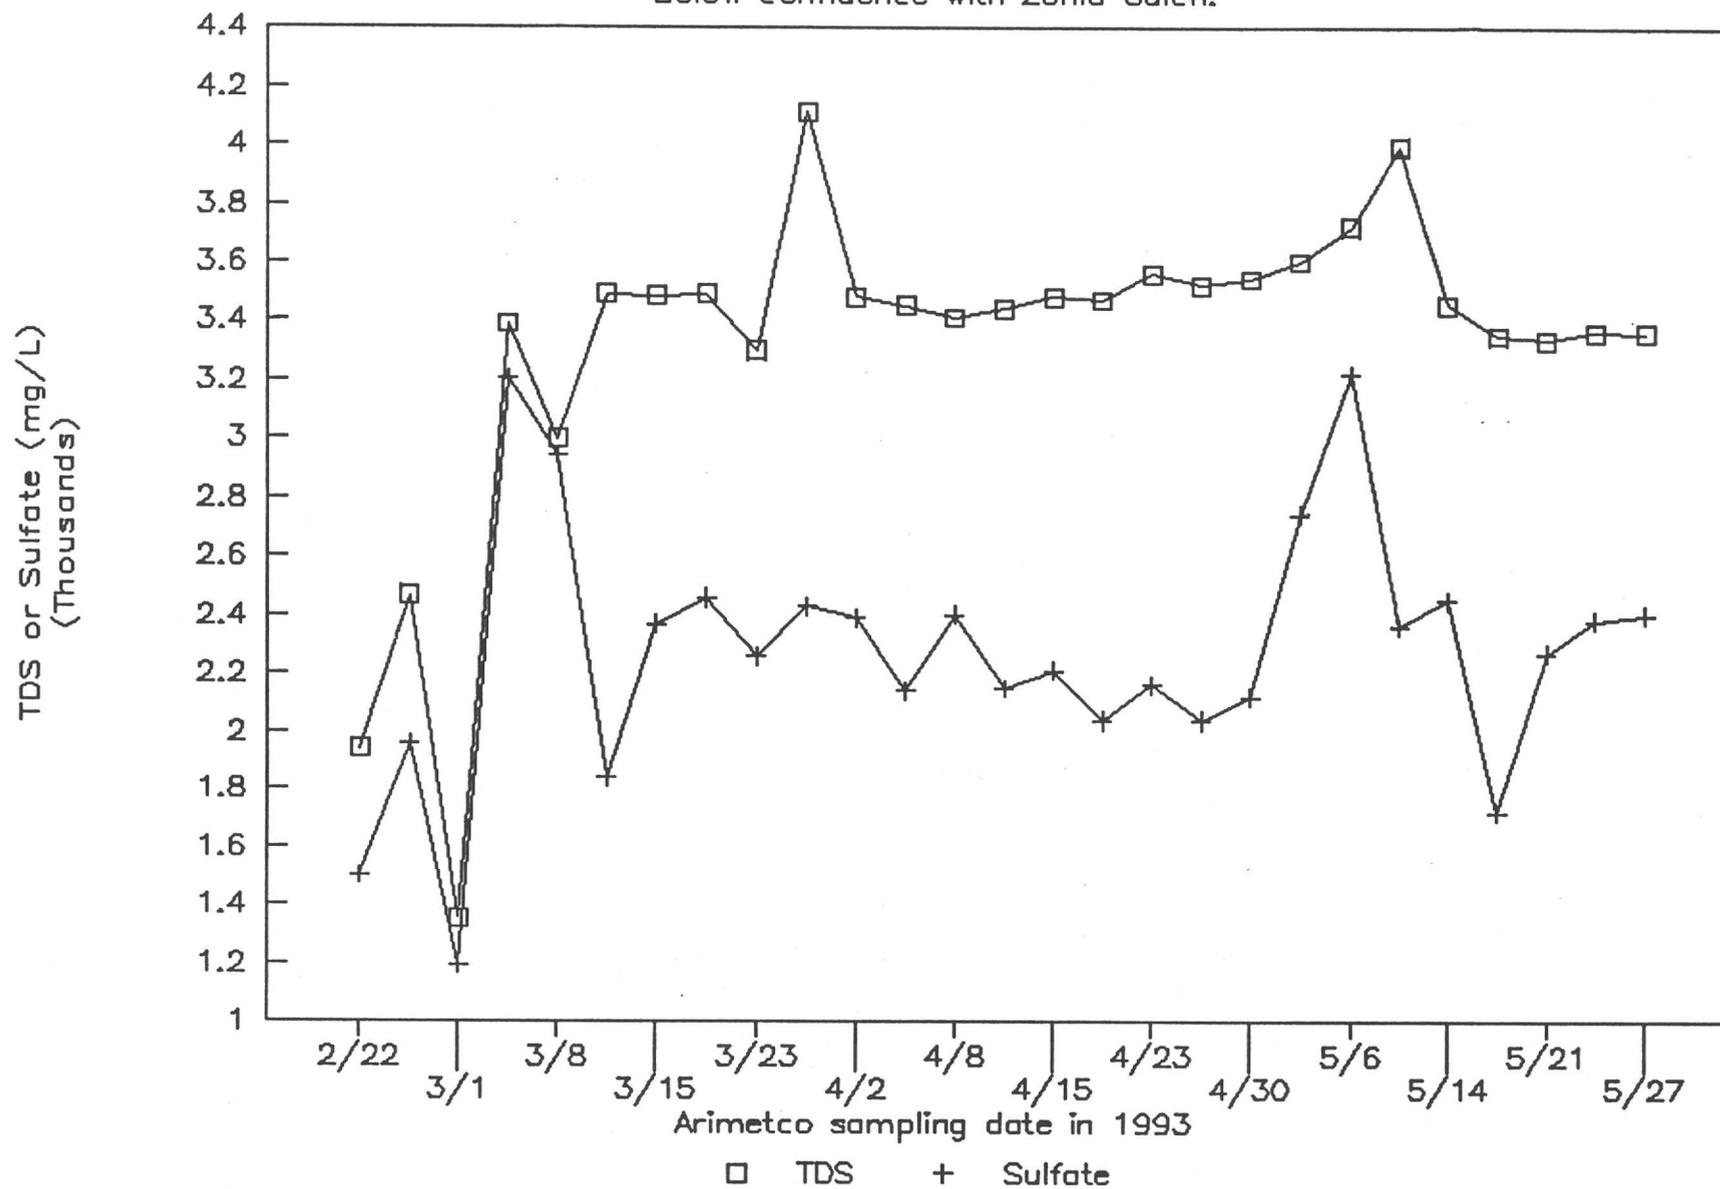
Figure 5. French Gulch TDS & sulfate.

Below confluence with Zonia Gulch.

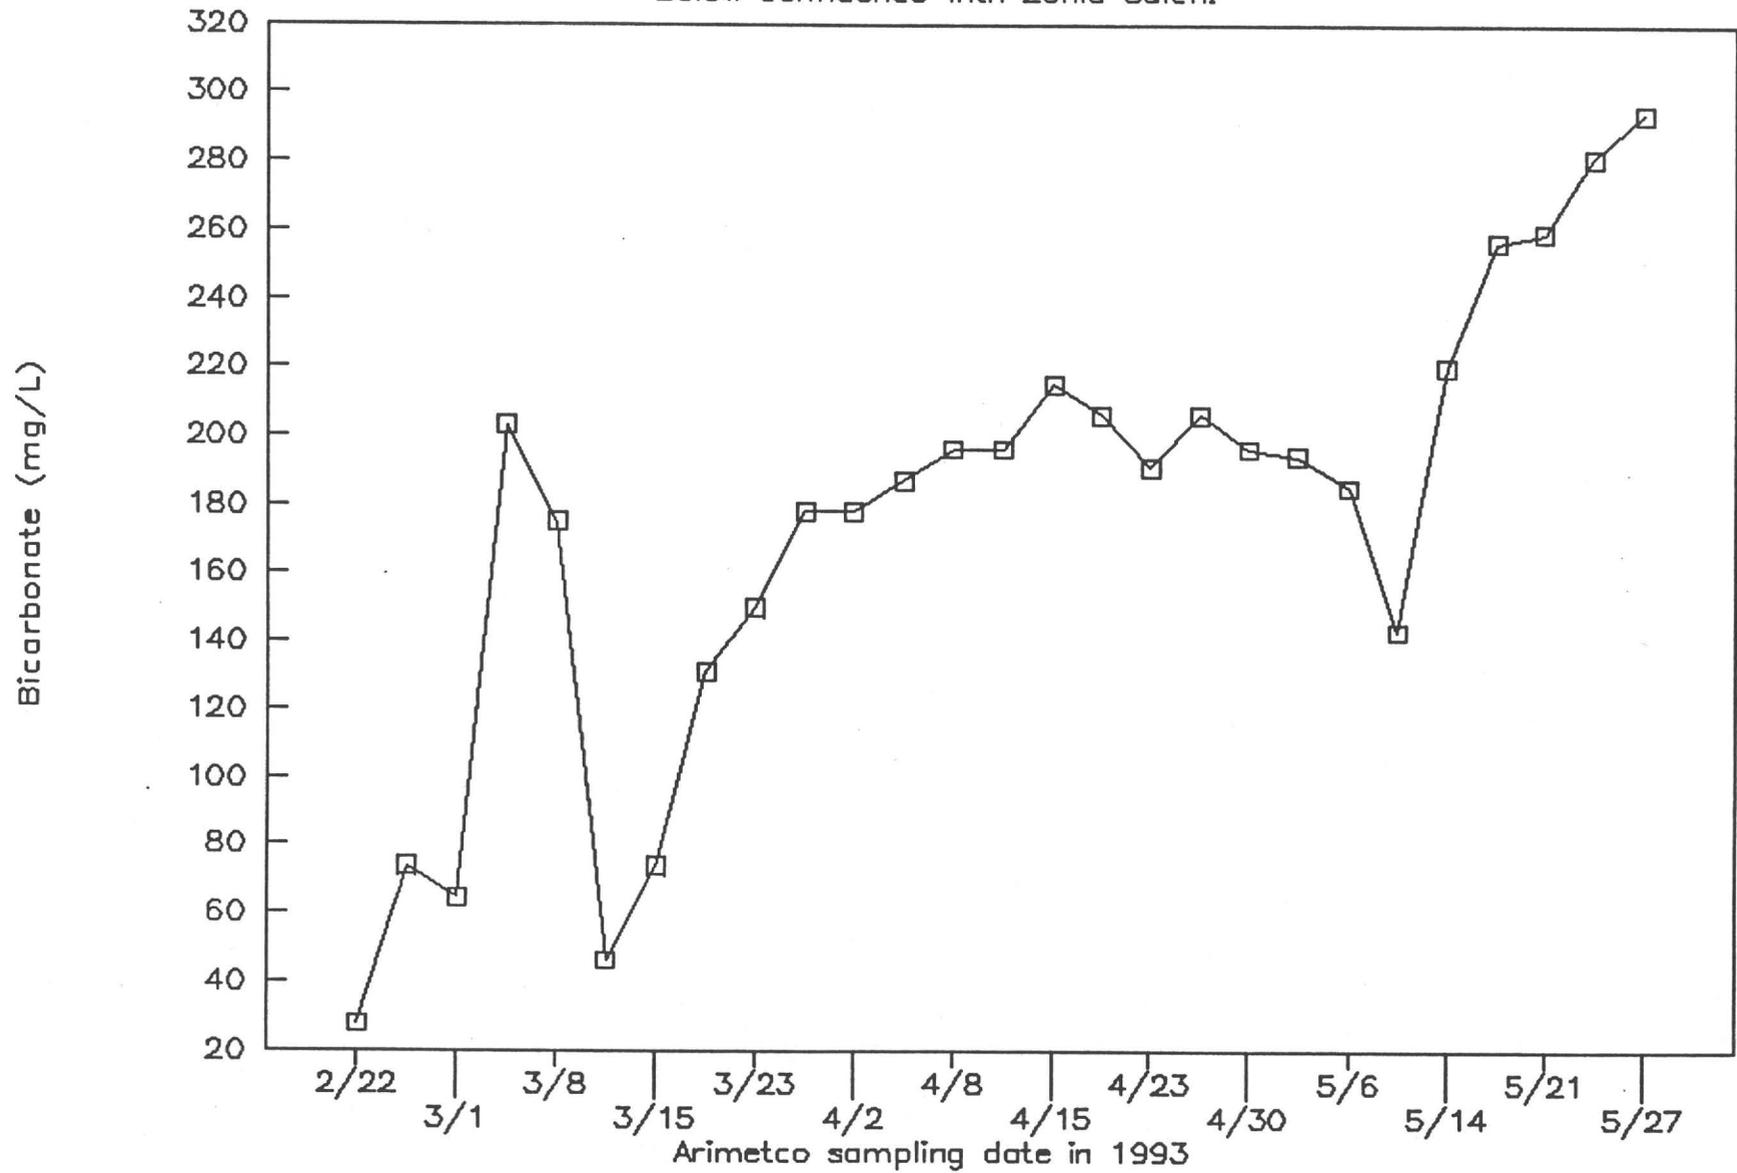
Figure 6. French Gulch Alkalinity.

Below confluence with Zonia Gulch.

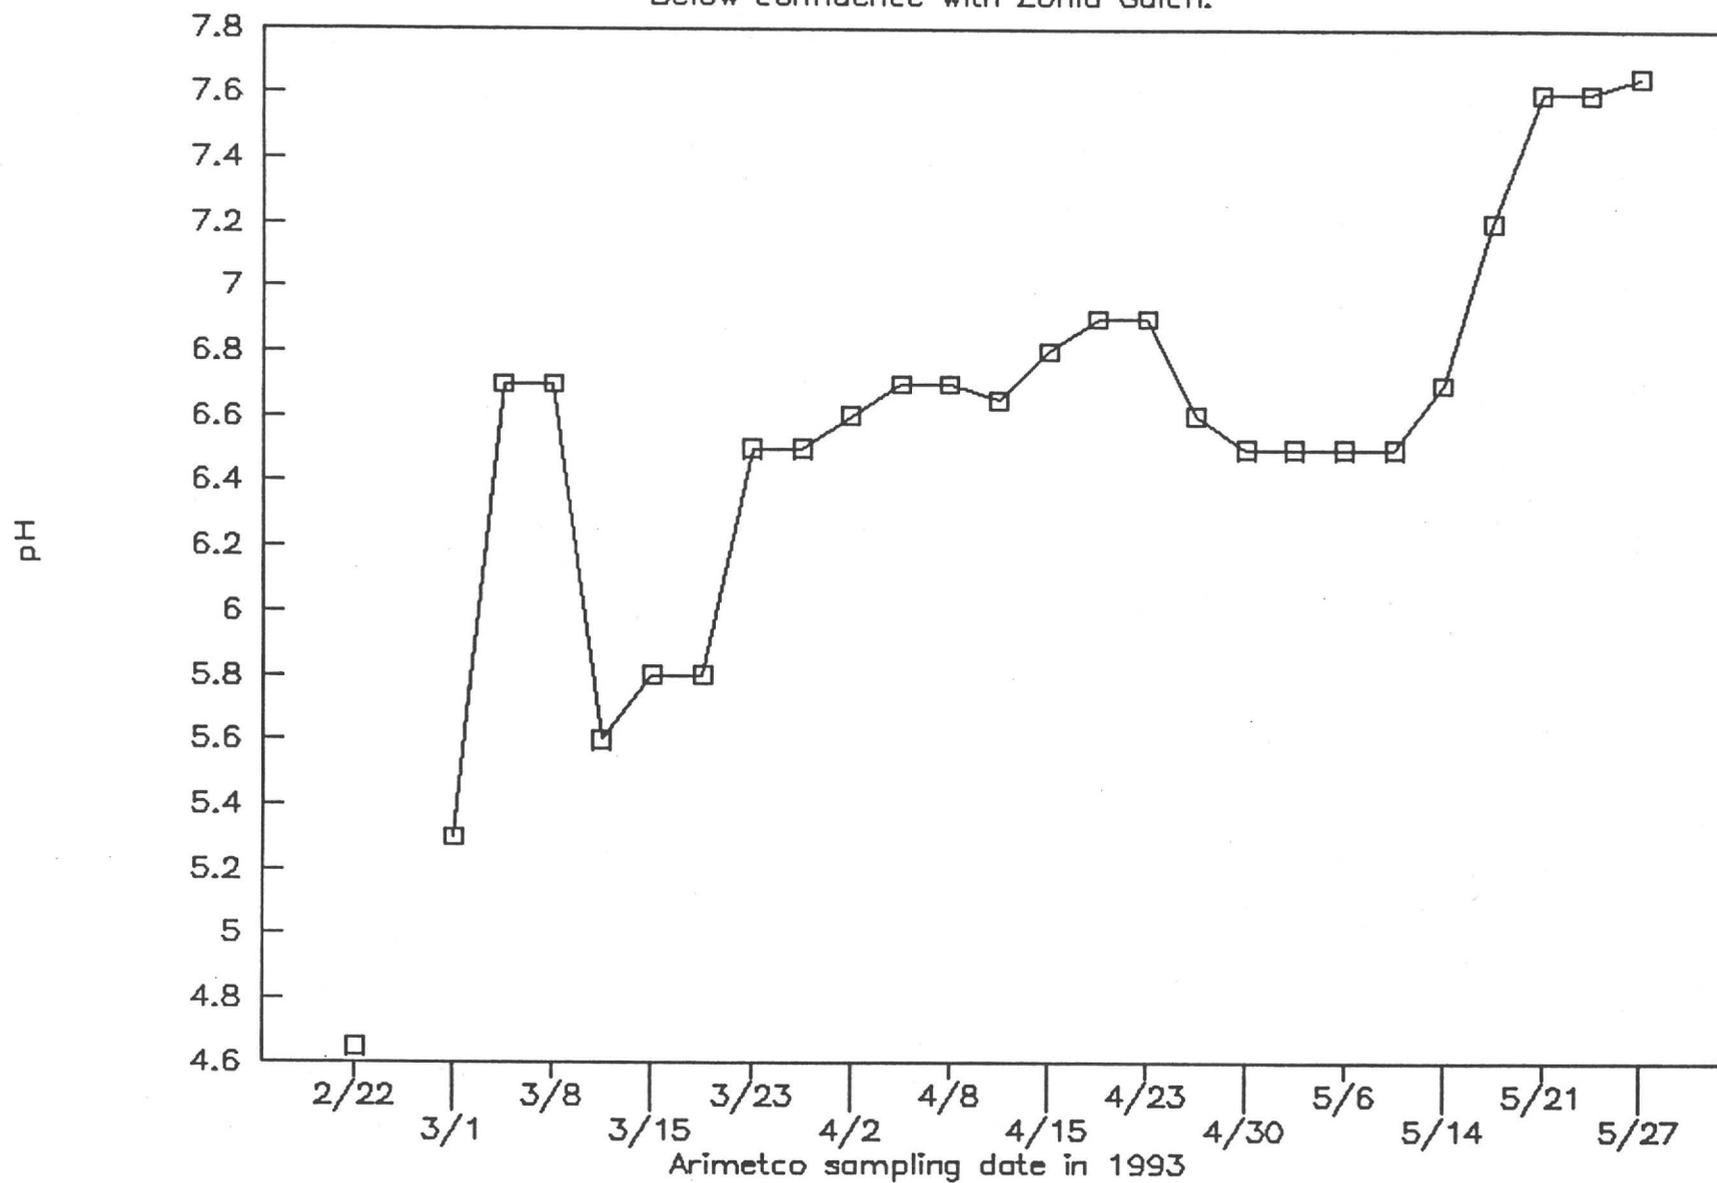
Figure 7. French Gulch pH.

Below confluence with Zonia Gulch.

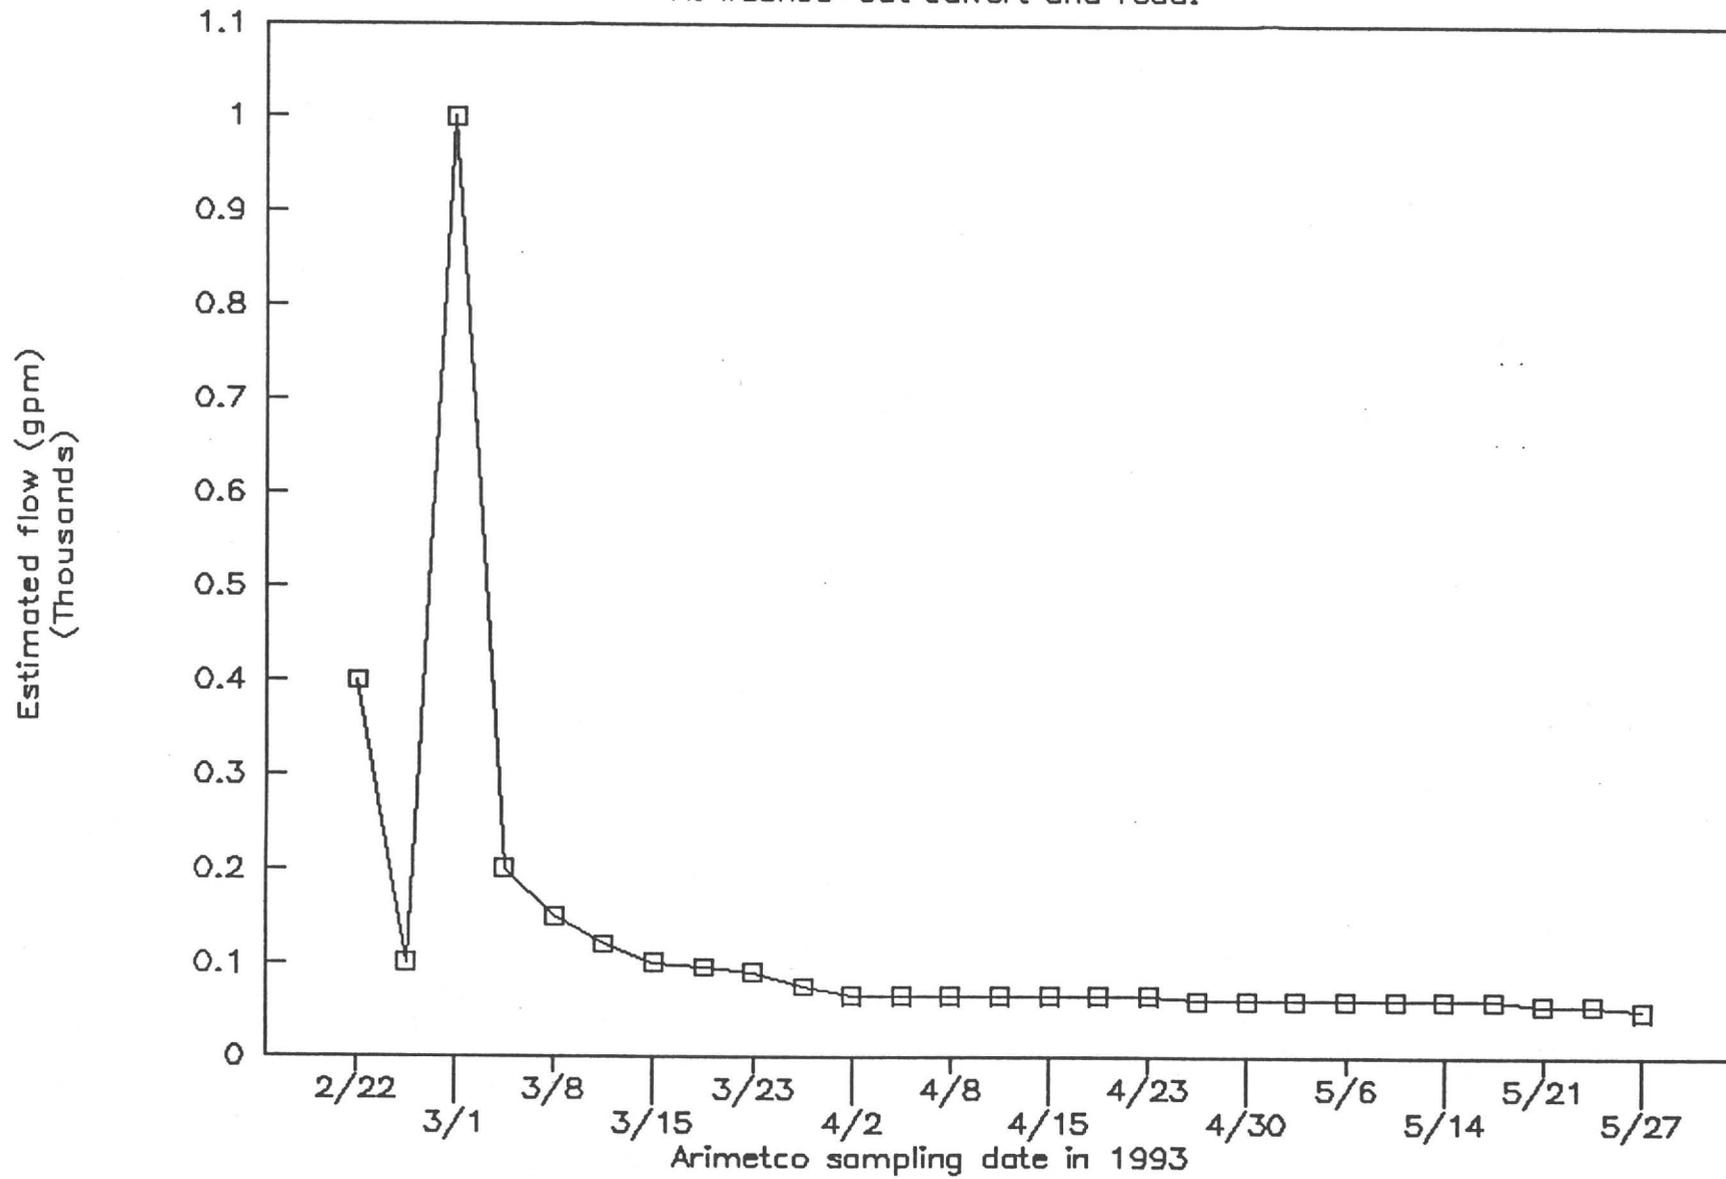
Figure 8. French Gulch Flow.

The Zonia Mine is in the drainage basin of French Gulch, a nine mile long arroyo that runs through the mine site (Figure 2). French Gulch's drainage area is almost 14 square miles. A stretch of French Gulch downstream from most of the mine's facilities has natural perennial flow fed by groundwater springs. The rest of French Gulch is normally dry adjacent to the mine property. The flow of French Gulch varies with rainfall; historical data indicates flows ranging from 22 to 34 gallons per minute (gpm) in the vicinity of the springs.¹ However, flow estimates submitted in response to EPA's November 13, 1992, Order show flows of as much as 100-200 gpm in French Gulch at about the same point used to collect the 1980 data. Flow peaks of as much as 1000 gpm were recorded this past winter (Figure 8).

At washed-out culvert and road.
