ARIZONA DEPARTMENT OF MINES AND MINERAL RESOURCES AZMILS DATA

PRIMARY NAME: ROSALIE

Property Case Name: BLOODY BASIN TRACT Case Number: PLC-006B

Type of Action: Site Investigation of Non Federal Lands for Exchange

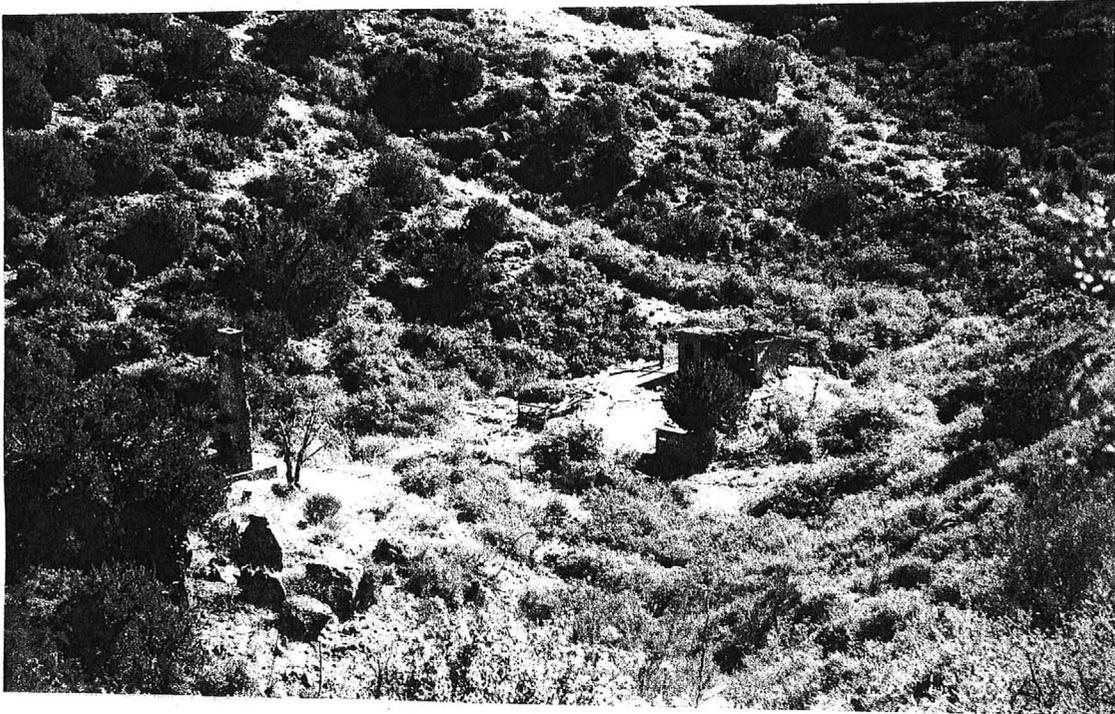
PHOTO 5: Overview of the two demolished structures on the tract. The structure on the left was burned, the one on the right appears to be collapsing due to weathering Photo by Oldfield

There are the remains of two structures on site. One appears to have been the mine office and residence. It is delapidated and collapsing due to weathering. The other was built by a squatter. The individual burned the structure down after being ordered to vacate.

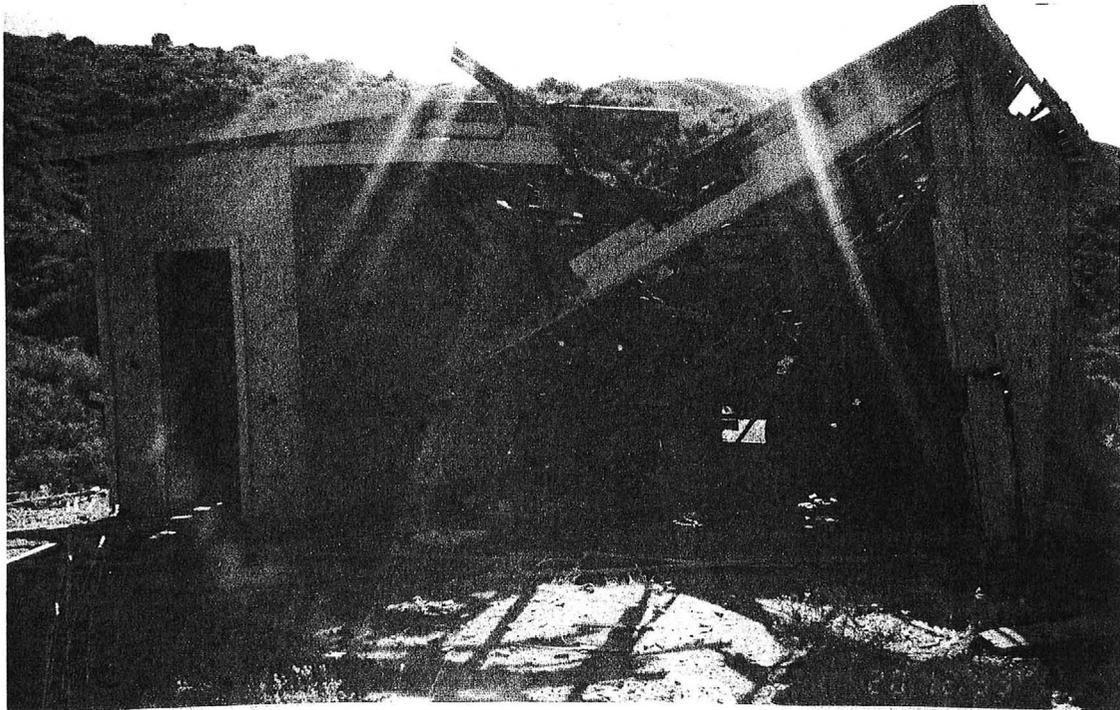
PHOTO 6: Close-up of collapsing wood structure No asbestos material noted. Photo by Oldfield

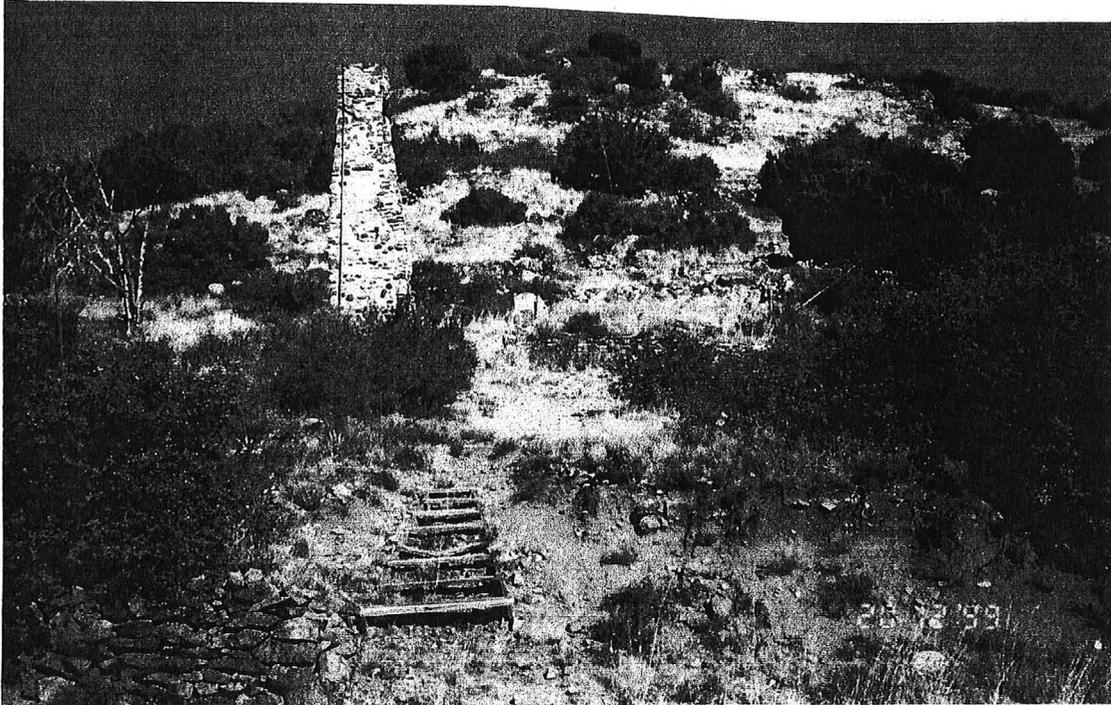
PHOTO 7: View north of the structure that was burned down. Note rock wall and wood stairs. Photo by Oldfield

Fire insurance maps were not consulted, but it is obvious that one structure had been used for mining purposes. The other structure was built and occupied by a squatter who had no interest in mining, and burned the structure down after being evicted. It is also unlikely that fire insurance maps would cover the subject, and unlikely that anyone could get fire insurance on a structure located on the subject due to remoteness and poor access.

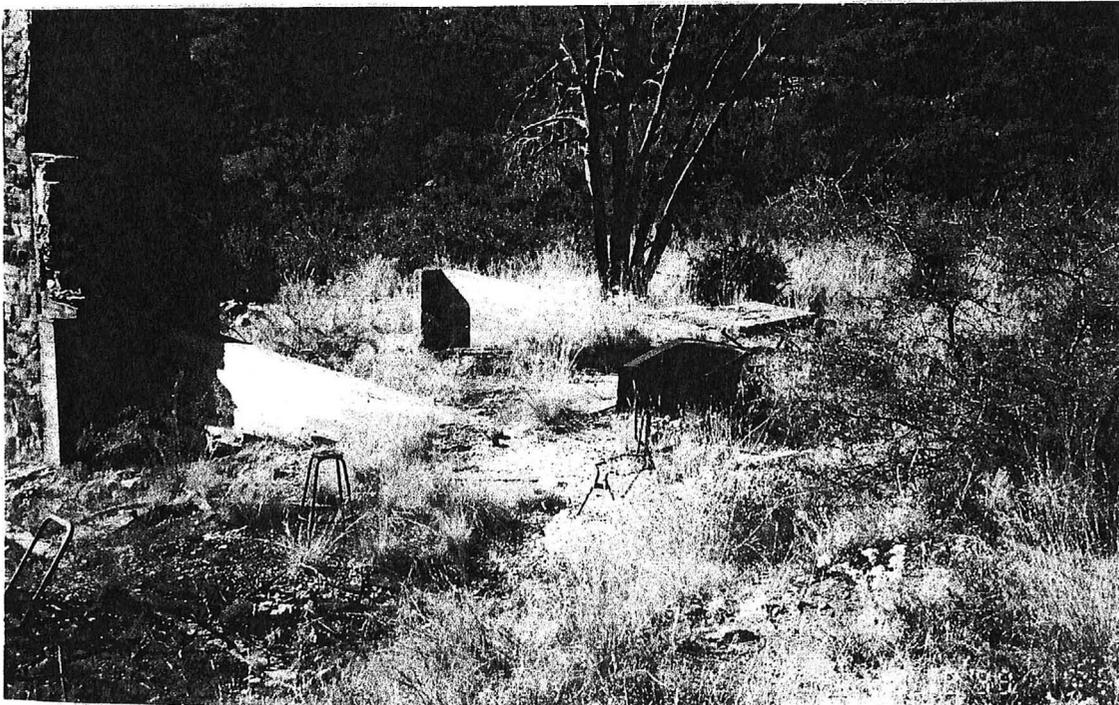
PHOTO 8: Another view of the burned structure, showing charred remains. Photo by Oldfield

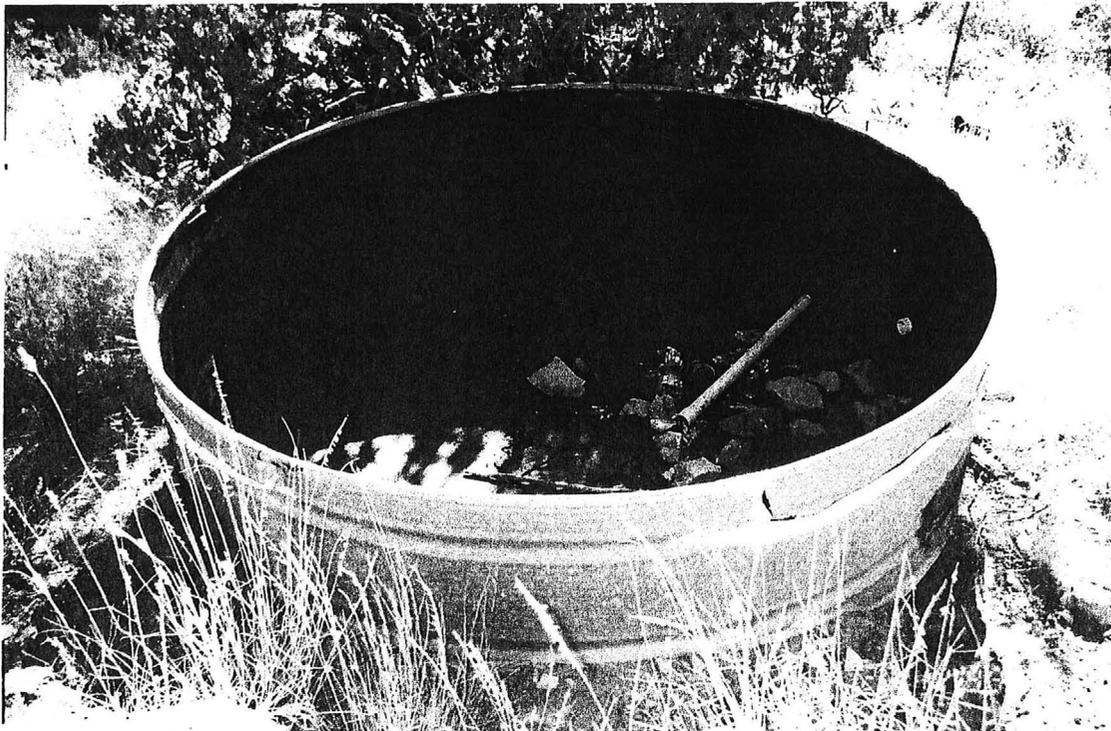
PHOTO 9: Asphalt-lined water tank used for (probably) potable water at burned out structure. Capacity approximately 2,600 gallons (10,2000 liters). Note pipe for gravity-feed. Photo by Oldfield.

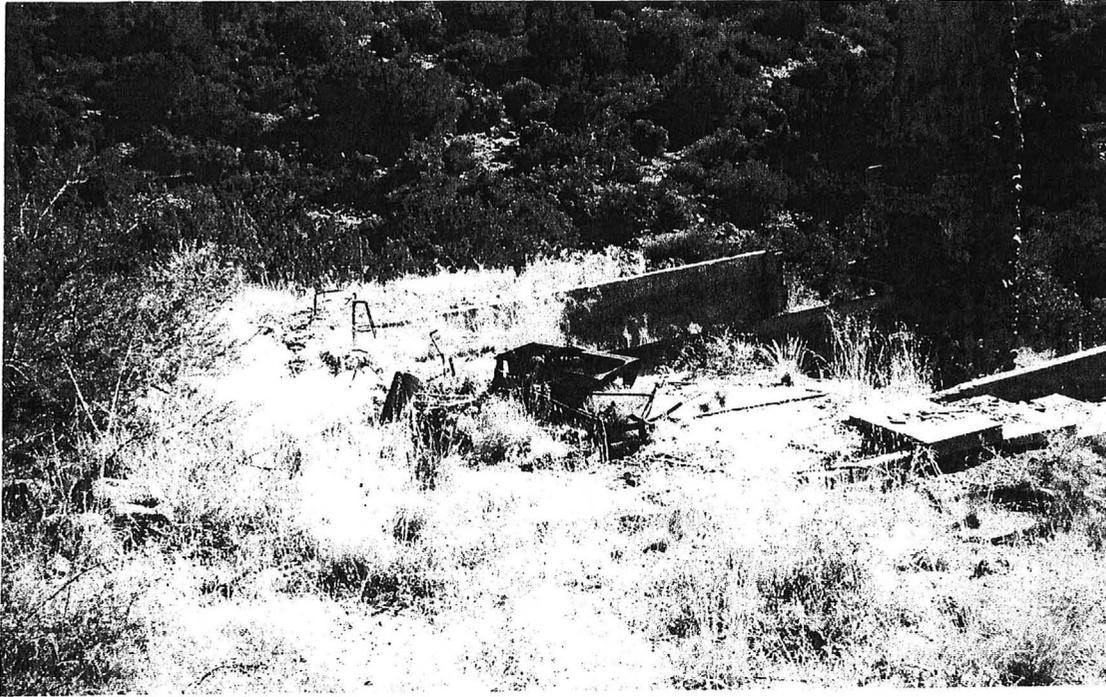
PHOTO 11: Another view of the remains of the burned down structure. Note resurging vegetation on site. Photo by Oldfield.

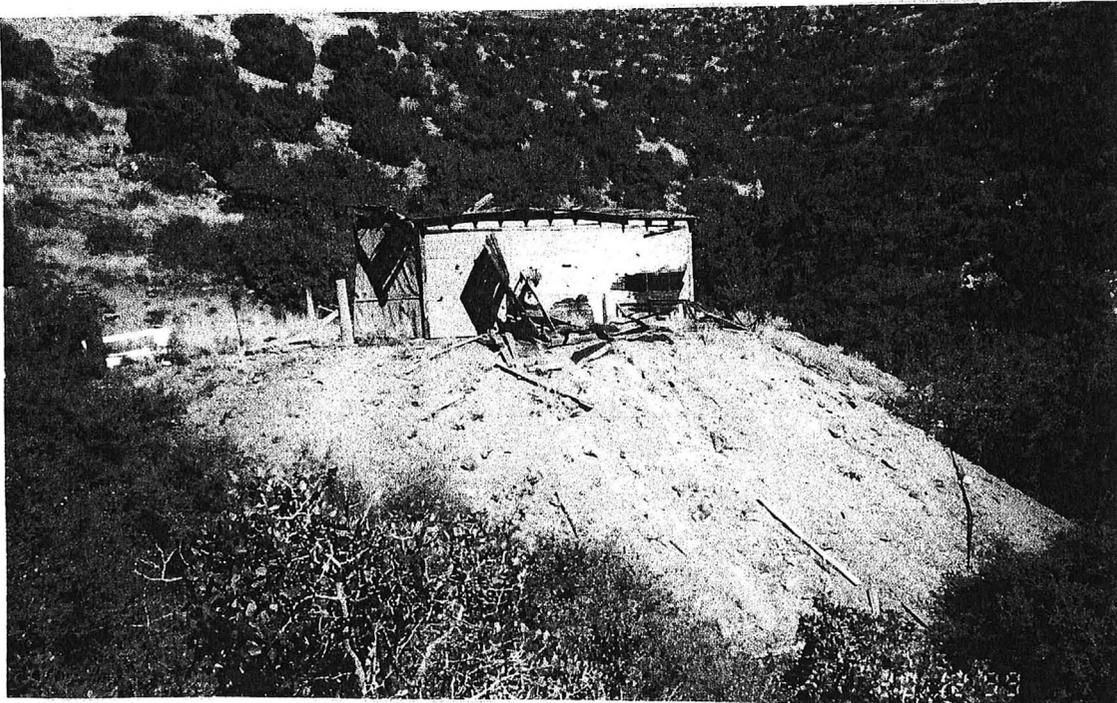
PHOTO 12: View of rock waste dump at collapsing building. That building was probably the mine headquarters office, and the material appears to be waste rock. Photo by Oldfield.

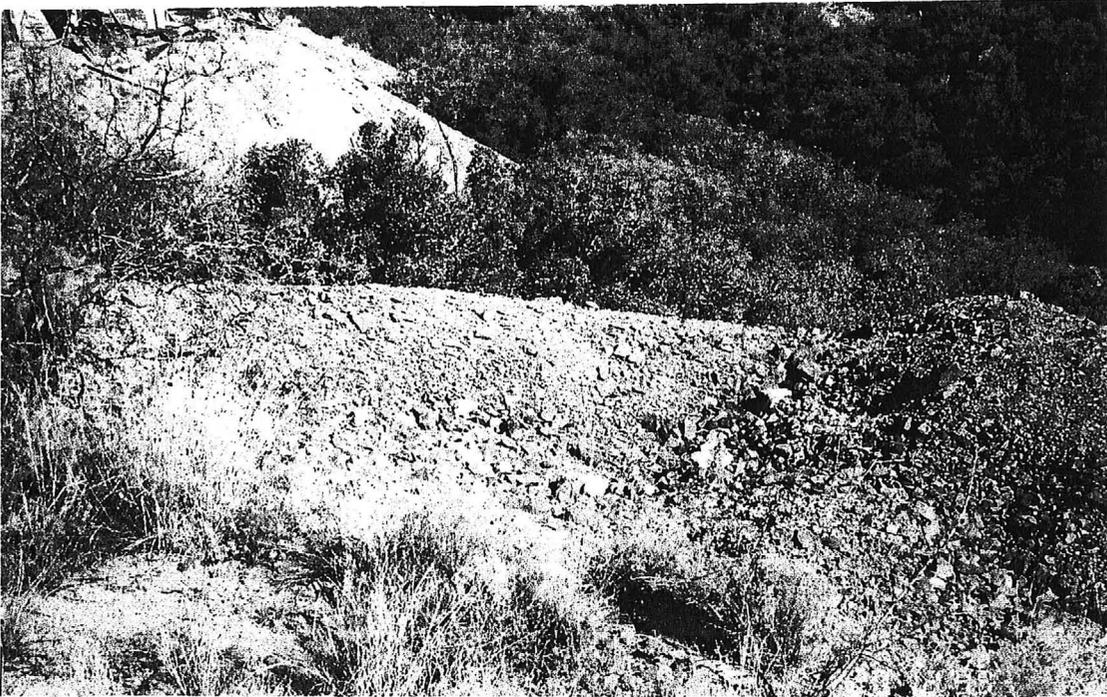
PHOTO 13: Rock waste dump just across drainage from one in Photo 12. Material here appears to have been crushed, suggesting the possible presence of some type of crushing mill. Photo by Oldfield.

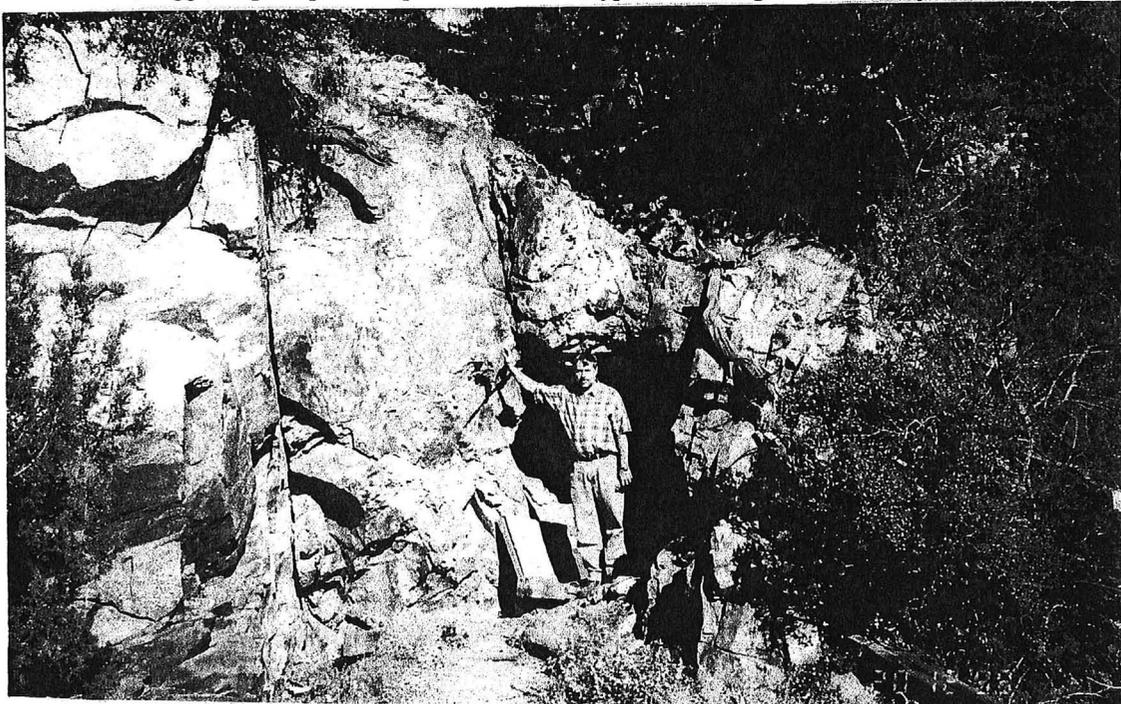
PHOTO 14: Geologist Mike Grivois standing at entrance to an adit on north side of former structures. Adit goes back approximately 20 feet (6 m), following an enriched fault. There is surface subsidence at the end of the adit. However, the existence of a second surface subsidence suggests a cross-cut or "room removal" in back of and to the south of the subsidence on the fault. The fault strikes approximately N 10° E, dipping steeply to the east. Photo by Oldfield.

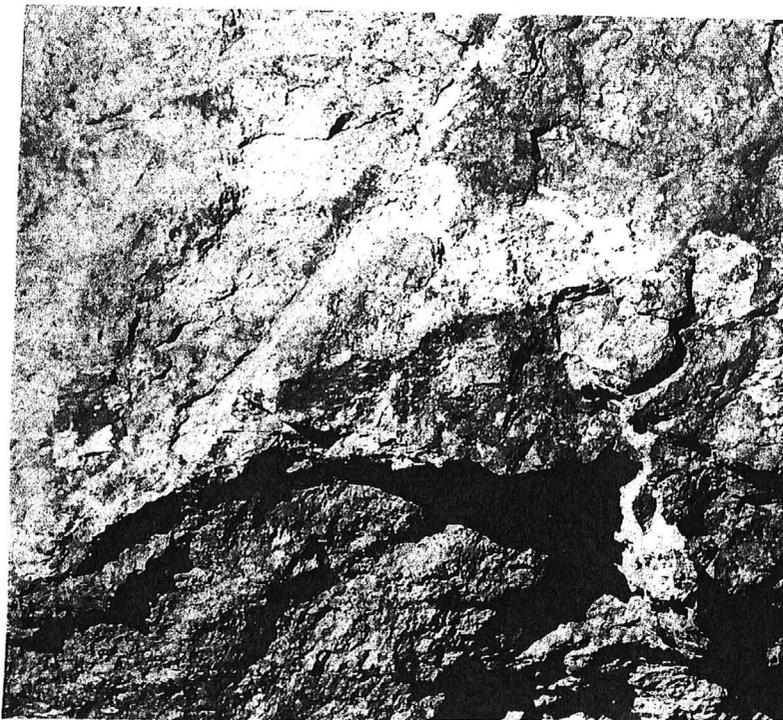
PHOTO 15: Close-up of oxide copper mineralization on fault scarp and adit entrance. Photo by Oldfield.

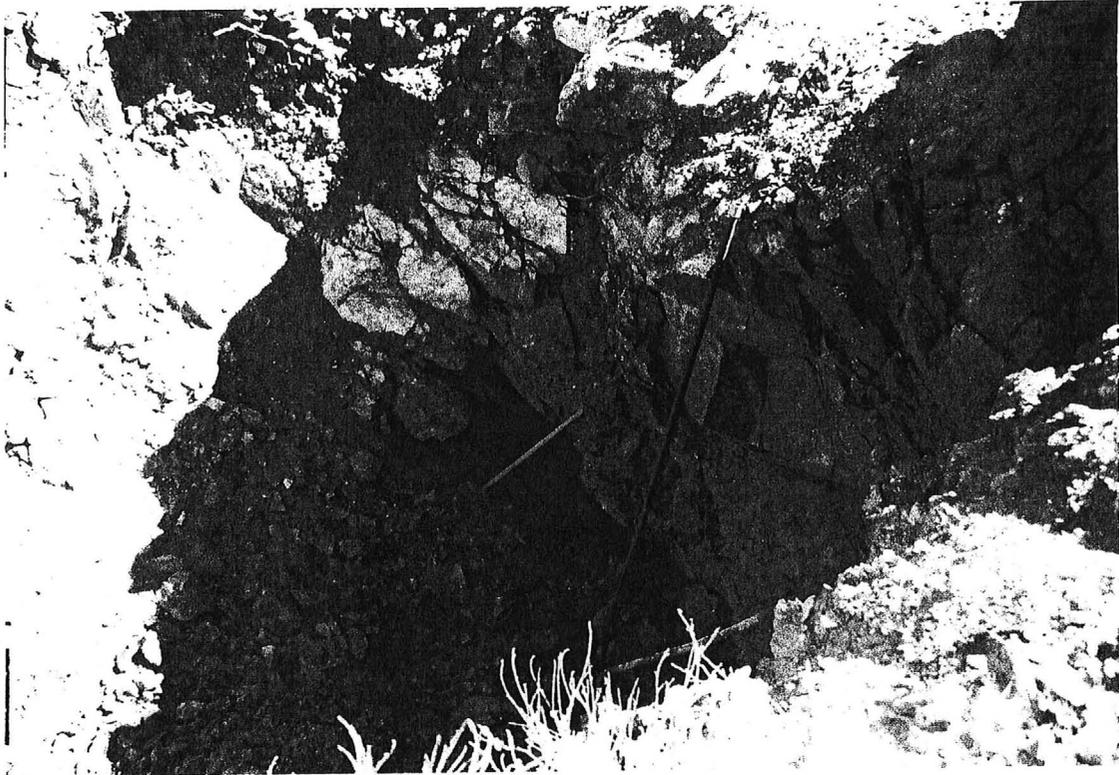
PHOTO 17: Surface subsidence (one of two) into mine (adit). Note fracture of rock that contributed to the subsidence. Also note steel and PVC pipe. Photo by Oldfield.

There are two subsidence cavities into the mine workings east of the "squatter" structure. Both were difficult to photograph due to finding a good vantage point. Both appear to be stable, but are hazards to humans and animals. They were likely formed when the mine workings came too close to the surface and the weathered rock forming the roof could not support the weight above it.

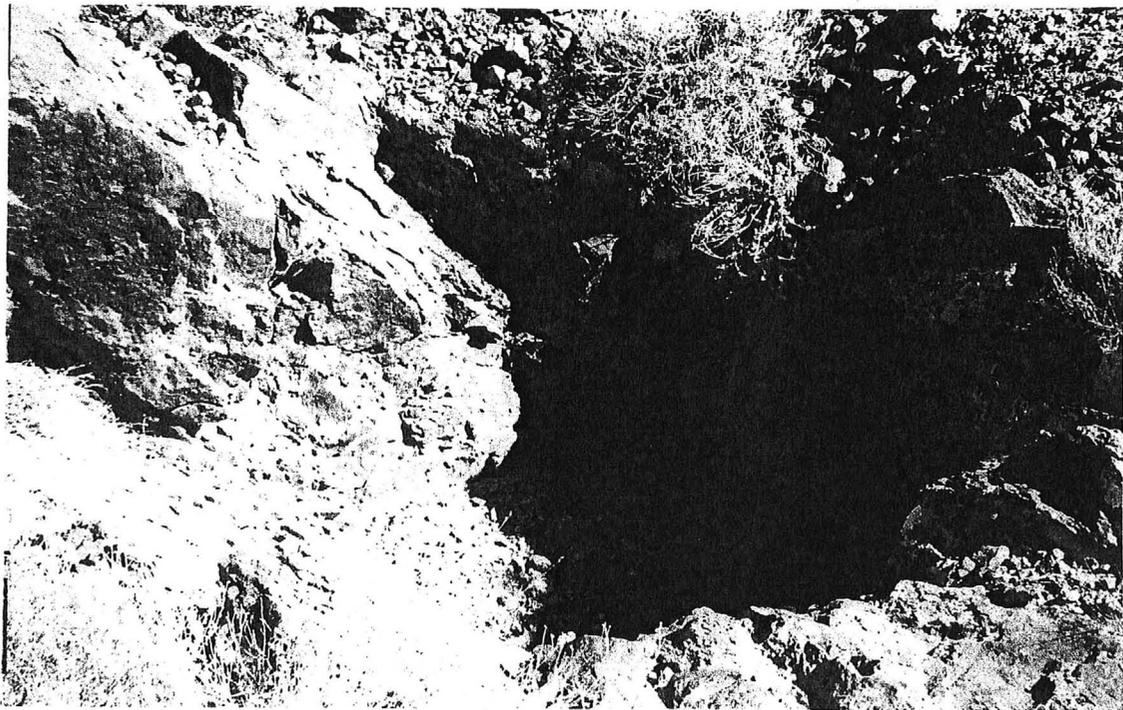
PHOTO 18: One of three prospects dug into top of fault (north of adit). Volume is less than 1 yd³ (0.9 m³). Photo by Oldfield.

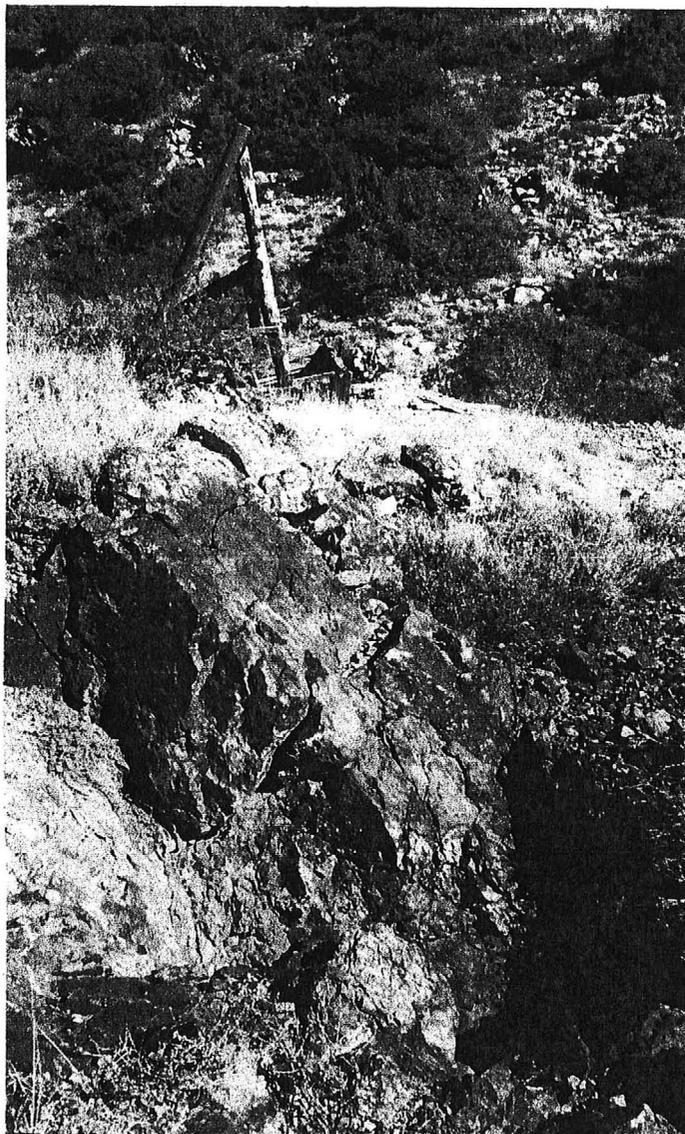
PHOTO 19: View from prospect in Photo 18 along strike of fault. Note wooden head frame (over small shaft) and prospect beyond it. Photo by Oldfield.

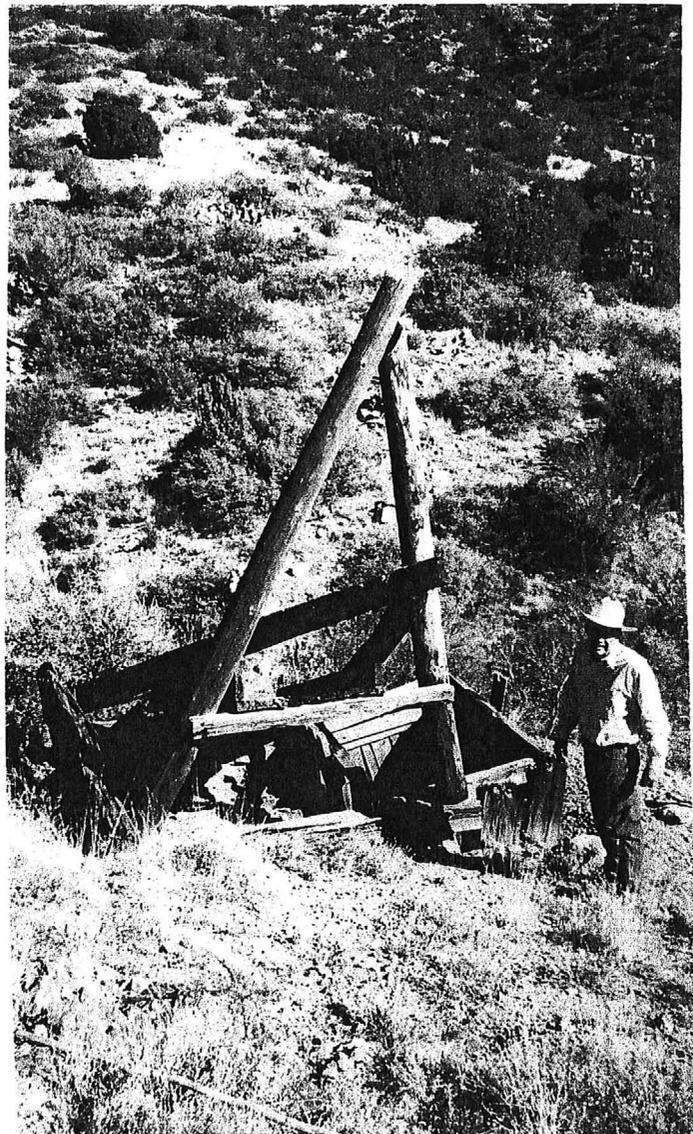
PHOTO 20: Steve Brophy standing by wooden head frame over shaft. Depth undetermined, but estimate to be less than 15 feet (5 m). Photo by Oldfield.

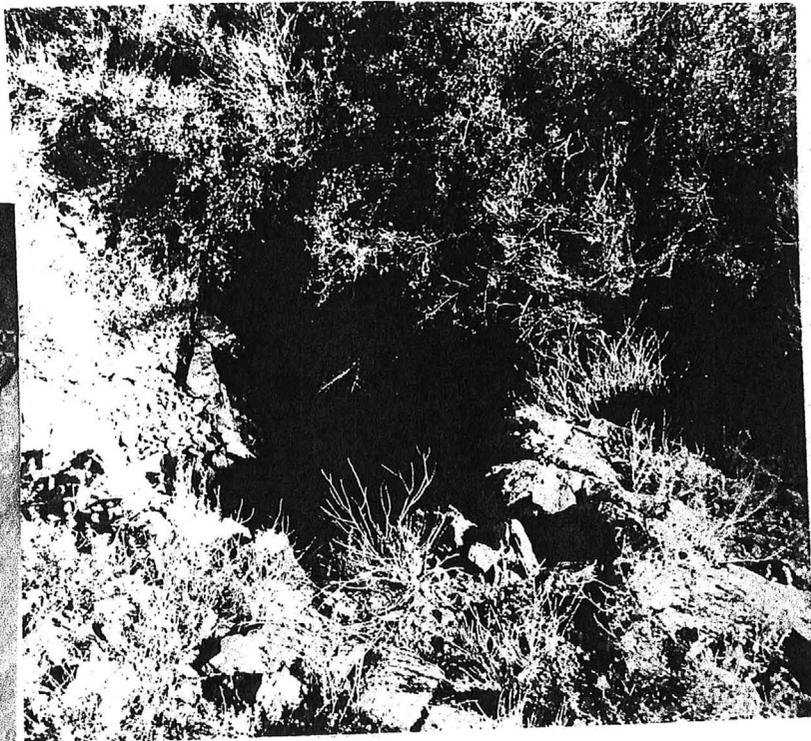
PHOTO 22: Another shallow prospect on the strike of the fault. Photo by Oldfield.

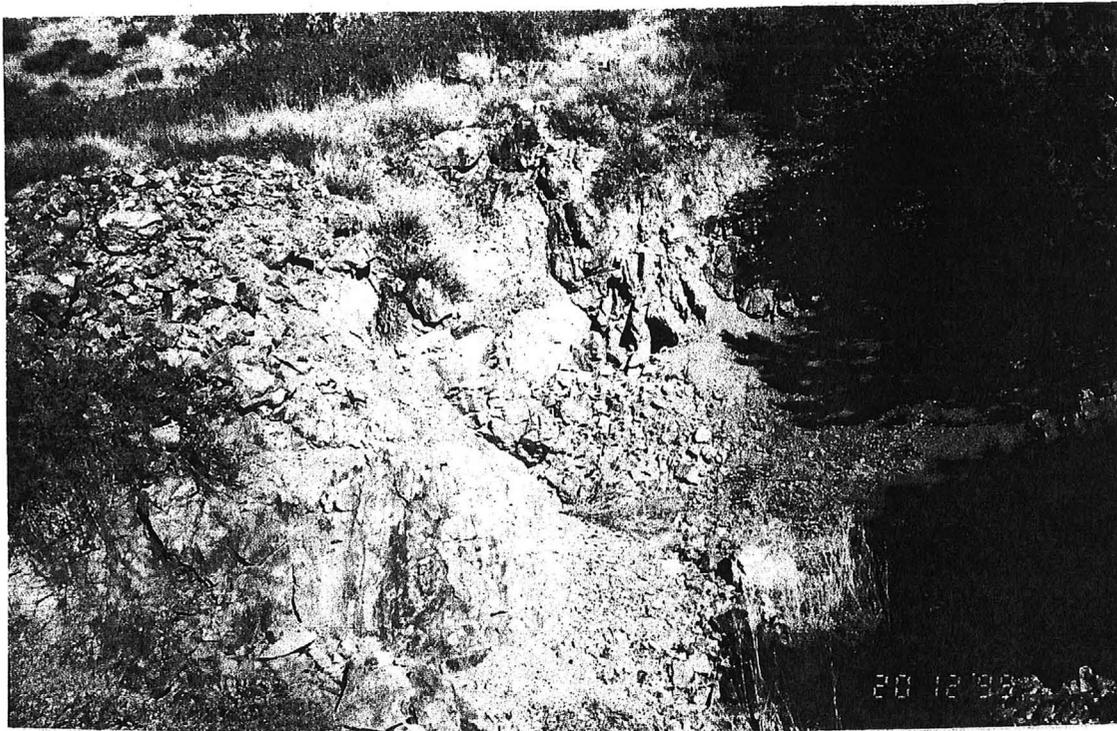
PHOTO 23: Large prospecting pit (Approximately 25 feet (7 m) in diameter and averaging 5 feet (1.5 m) deep located about 700 feet (213 m) northerly of the open adit near the structures. The site did not appear as a burial site, no evidence seen that waste may have been disposed at this site. Photo by Oldfield.

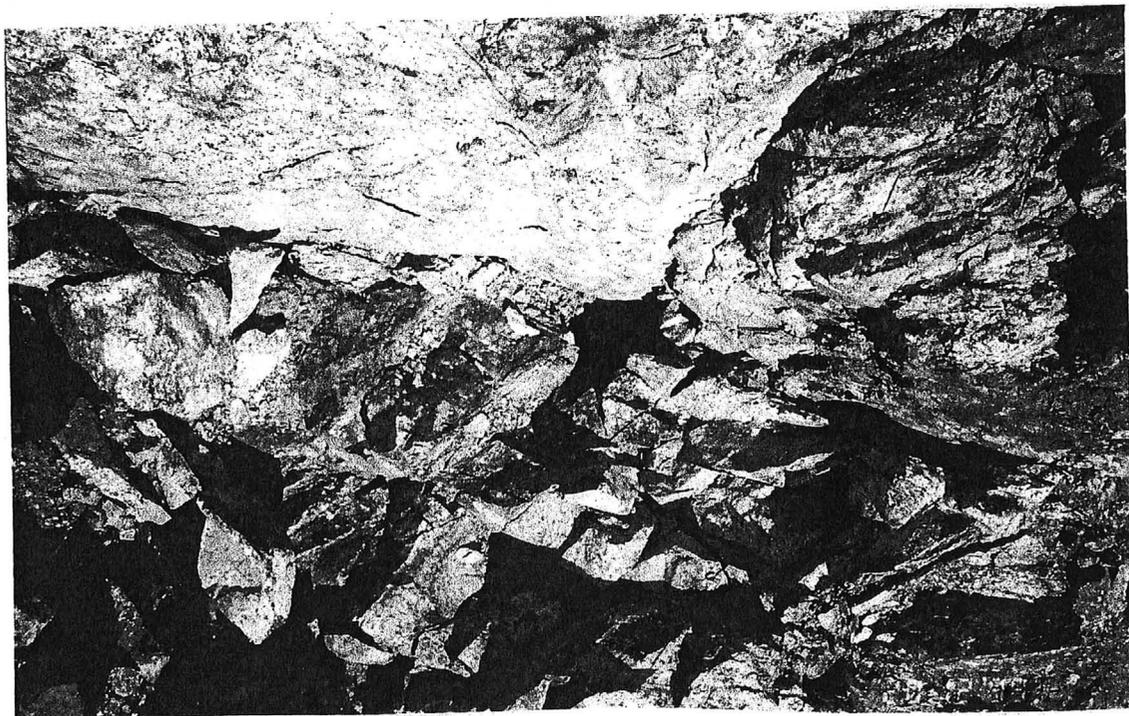
PHOTO 24: Close-up of wall rock of pit in photo 23. Note small copper oxide mineralization in wall and in waste rock (behind wall). Photo by Oldfield.

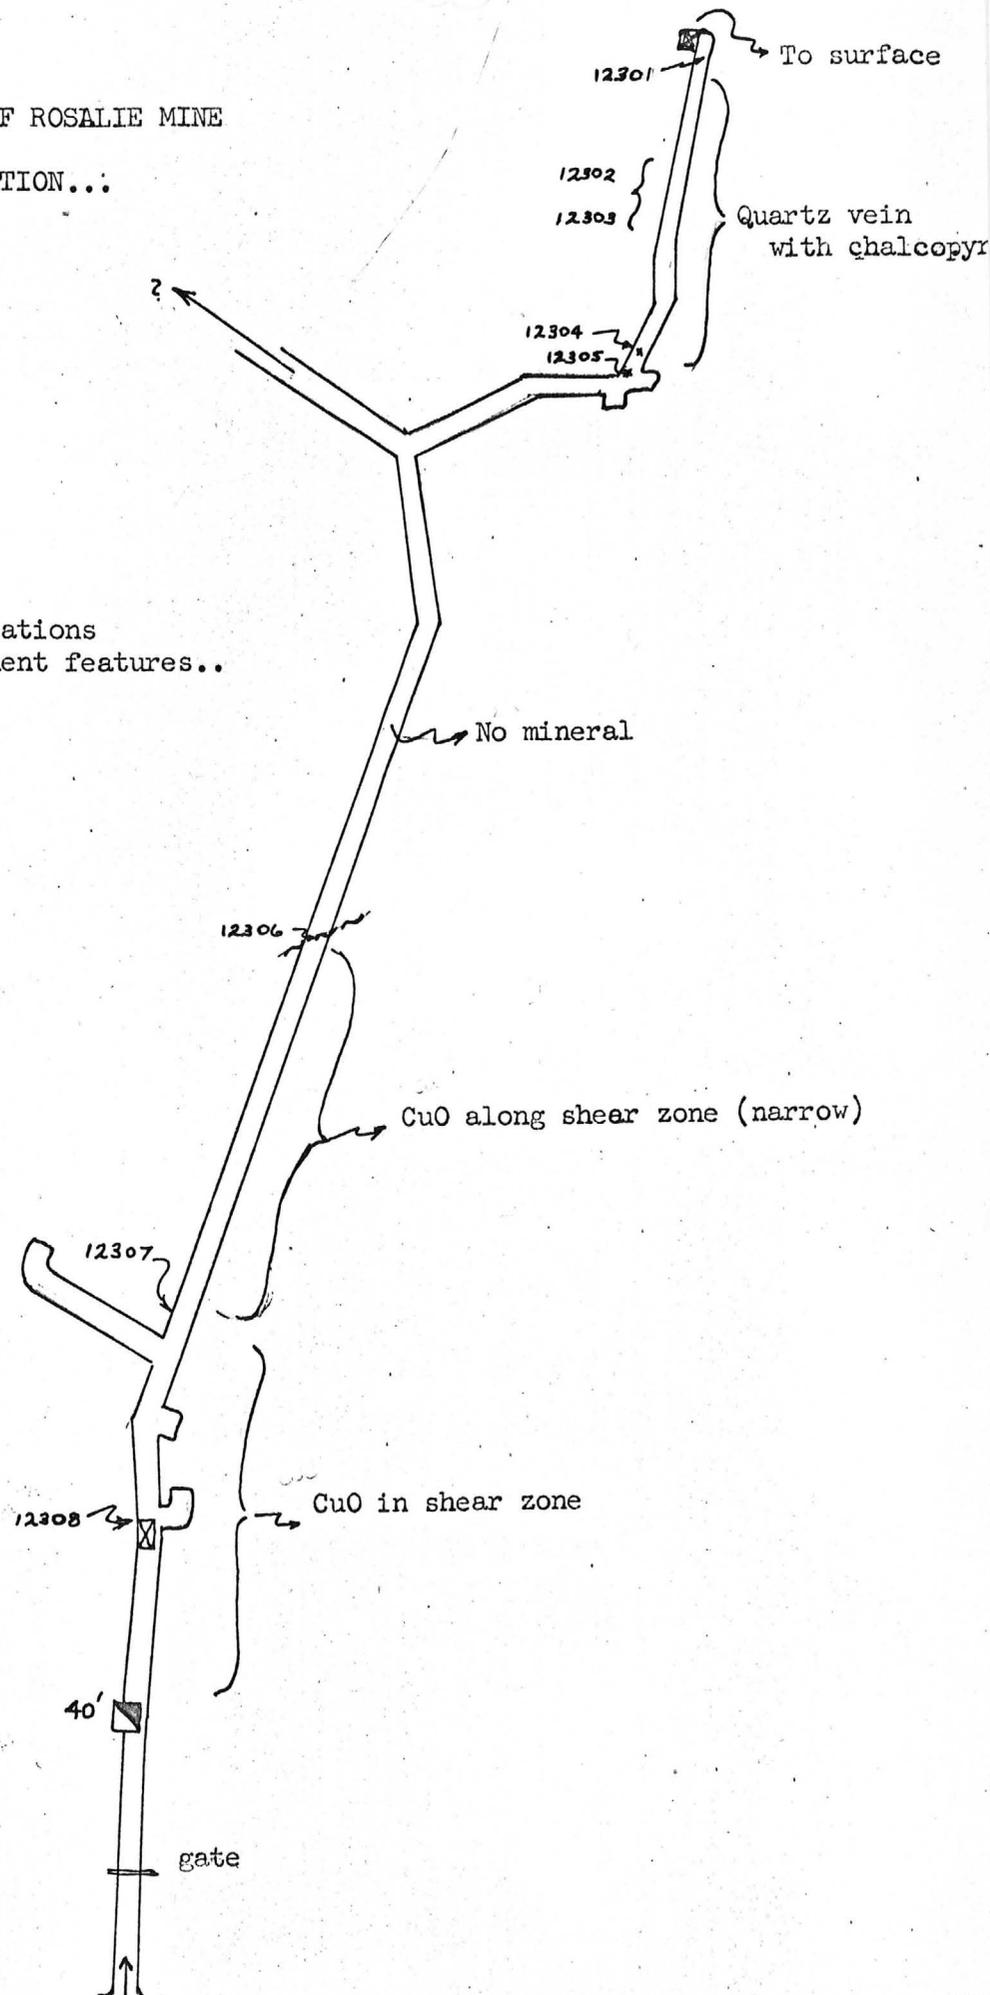
Scale 1" : 100'

The following samples were collected and assayed. The locations are noted on the accompanying plan of underground workings.

Showing sample locations
and pertinent features..

Despite the concentration of copper sulphides with the fissure veins and shear zones, it is quite apparent from the underground examination that these are quite local shoots. It is doubtful any substantial tonnage could be developed. Nothing should be done with this property.
