REPORT ON A VISIT TO ZANNARAPOLIS NO. 19 CLAIM IN YAVAPAI COUNTY ARIZONA

This No. 19 Claim includes the Crushing Plant, the Open Pit Mine to the rear of the Plant, and the Worker's Camp Site one mile to the north of the plant. This Claim was visited by my son James Taseos, and Socrates G. Taseos, writer of this report, on November 6, 1993.

CONDITION OF ZANNARAPOLIS NO. 19 CLAIM - NOVEMBER 6, 1993

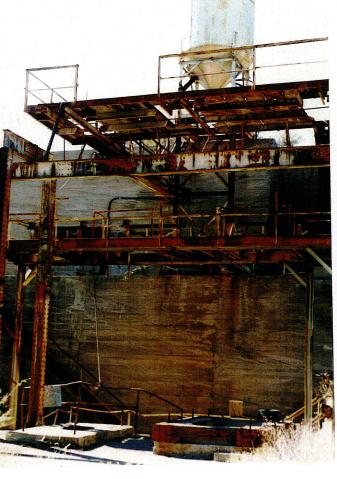
The Steel Frame Work of the Crushing Plant is void of all equipment listed on Page 1: items No. 1 to No. 12 inclusively and item No. 15. The only items remaining are item No. 13 (-20 Mesh Elevator) and item No. 14 (40 Ton, -20 Mesh Storage Bin). See attached Photoes No. 1 - No. 5.

Apparently, the above missing items were either sold and or vandalized.

It wasn't possible to take one Photo of the Crushing Plant's Full Elevation with my camera. Therefore, the above three Photos were taken. One has to visualize the Photos superimposed on top of each other to see the true length of the Crushing Plant's Steel Frame.

Only the -20 Mesh Ore Elevator was left as shown to the right in Photo No. 3. All of the other Equipment that previously filled the Streel Frame was either sold and or vandalized.

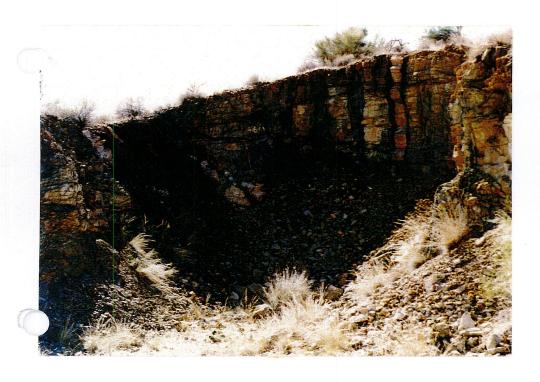
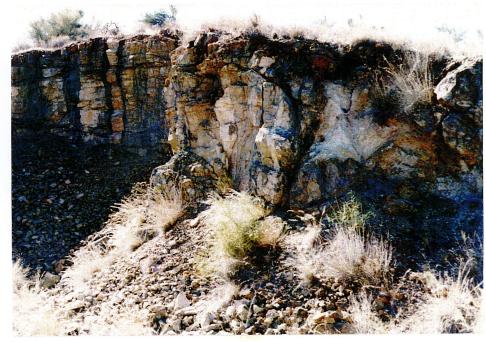
There is no equipment at the Open Mine Pit to the rear of the Crushing Plant. See attached Photoes No. 6 - No. 7.

Photos No. 6 and No. 7 show the Open Pit Mine directly behind the Crushing Plant. It is approximately 60 feet long, 30 feet wide, with a 30 foot face. A few small samples of rock taken from this Pit showed some Scheelite was present when viewed under violet light. That is, the characteristic Blue Light radiated from the rocks.

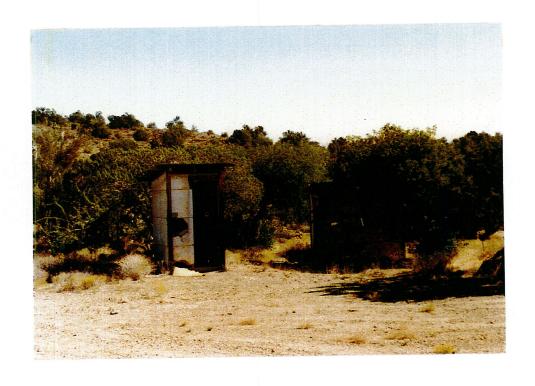
PHOTO NO. 8

Photo No. 8 shows the remains of two small buildings at the Worker's Camp Site.

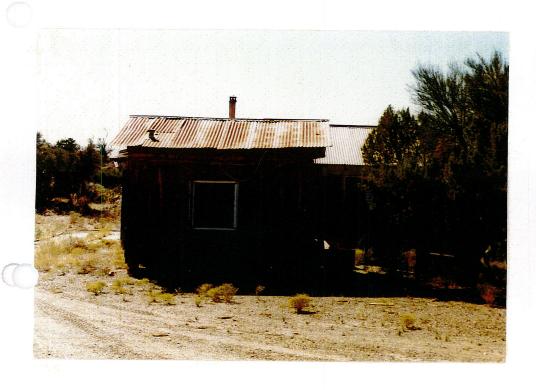
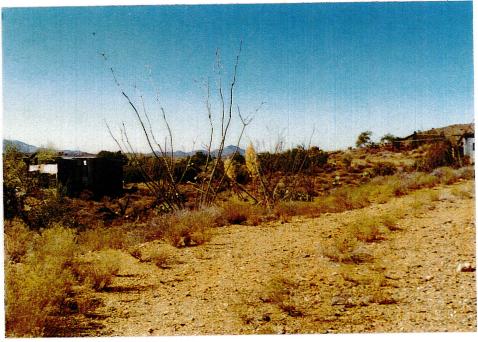
PHOTO NO. 12

Photo No. 12 and No. 13 show the shell remains of buildings at the Worker's Camp Site.

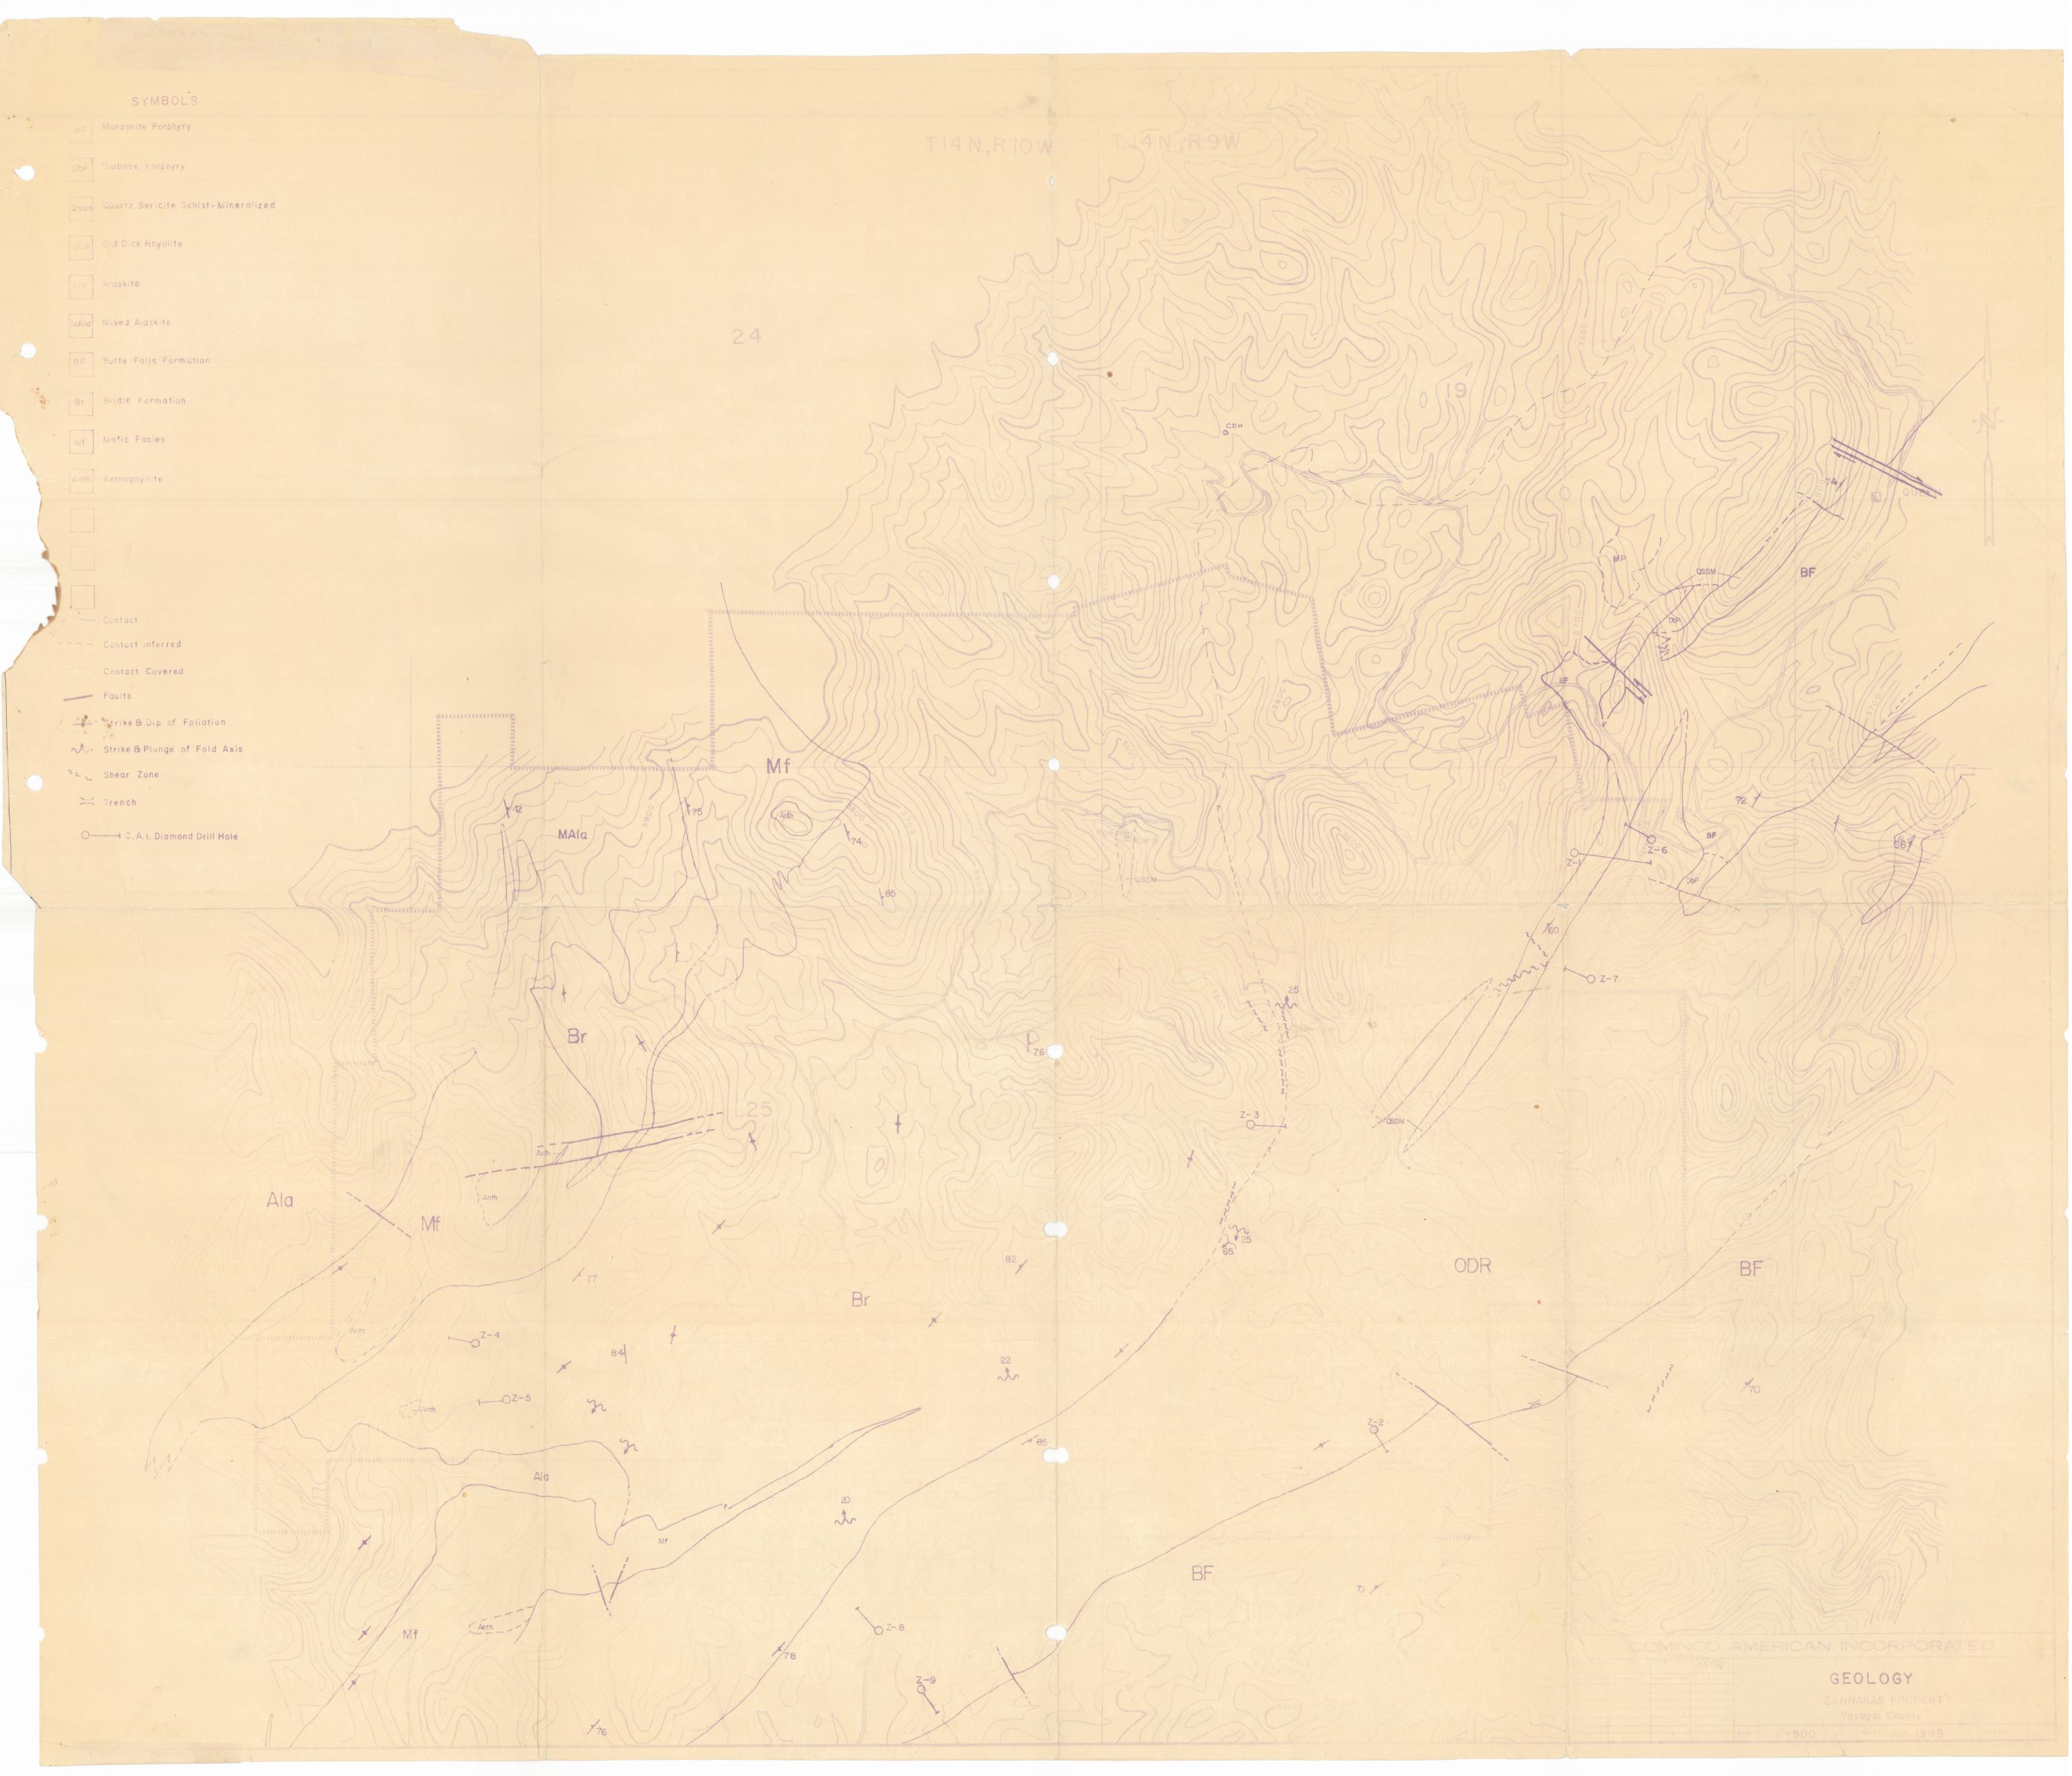
ZANNARAS PROPERTY YAVAPAI COUNTY, ARIZONA SCALE 1"=500'
COUNT INT 20' J.J. JUNE, 1965 Alp Alaskite Porphyry and related rocks T.14 N., R.10 W T. 4N, R.9W. Bridle Formation Undifferentiated - Mostly Mica Schists Dick Rhyoute Formulan 24 Diabase und/or Basic Volcanics Moderate to Strong Mineralization Strong Mineralization
