NOTES ON RECENT EVENTS AT PRODUCERS MINERALS CORPORATION PEACOCK MINE, GRAHAM COUNTY, ARIZONA

PRODUCERS MINERALS CORP
PEACOCK MINE

Safford, Arizona

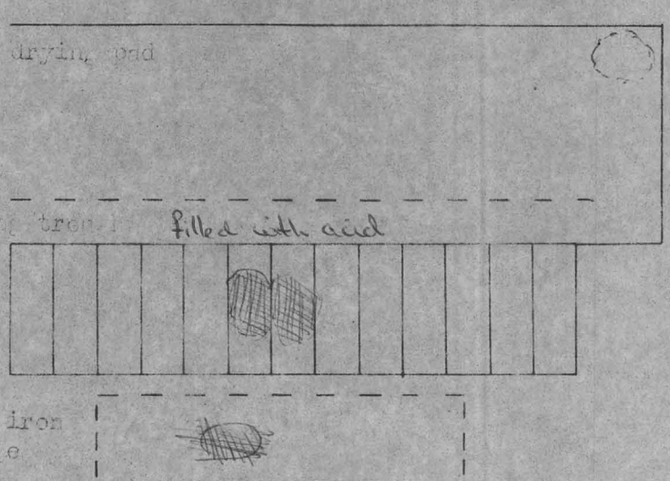
1) Is the circulation pump running? Yes
2) Is acid being distributed on main leach dump? Yes
   If so, which side? center
3) Is acid being pumped onto run-of-the-mine rock and fine leach dump? Yes
4) Where are the acid trucks dumping? Yes
5) Is acid circulating through exchange cells?
6) Is there cement copper on drying pad? No
   In collection trough below cells? Yes
7) Is there scrap iron in the cells? Yes
8) Has any scrap iron been added to cells since previous inspection? No
9) Is there any new scrap iron on the ground? No
10) List date, time and license number of acid trucks seen on or near the property.
    3-20-73, 9:15, J 11-336 (Tex), ← tractor trailer, Chemical Producers.
11) Describe any changes in routine or unusual activity on the property.
    As noted in yesterdays report, acid is still leaking from broken transfer pipe.

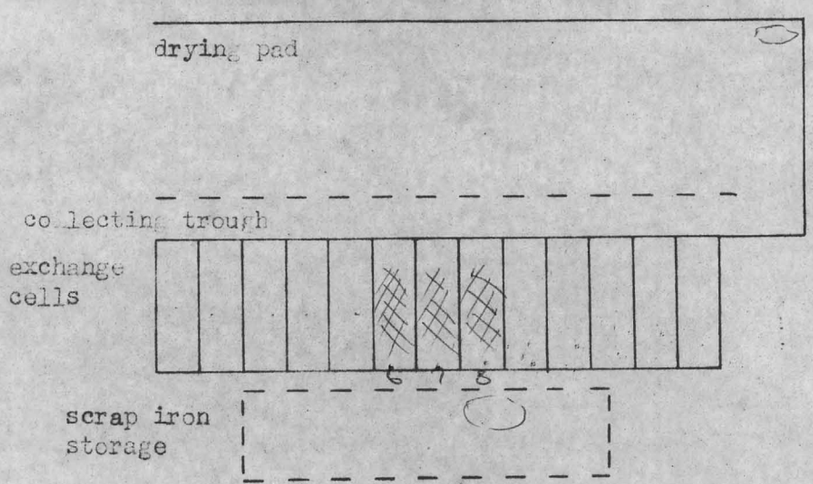
11) Describe any changes in routine or unusual activity on the property. Exchange cells 6, 7, and 8 were washed with water to remove copper cement, the copper cement and water were in the collection trough. A front loader was used to move the dry copper cement from the drying pad into the truck described above.

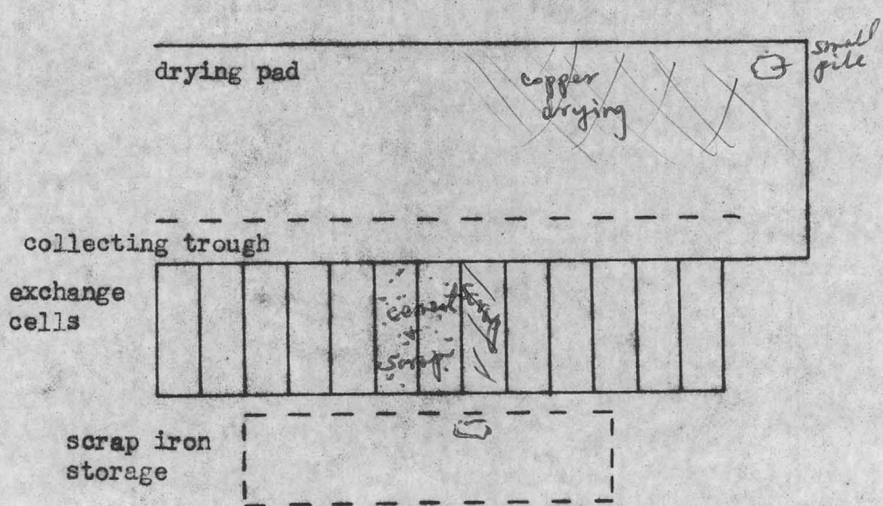
11) Describe any changes in routine or unusual activity on the property.
John Boss & Ron Gietz were trying to operate high pressure water pump to wash out cells 6 & 7.

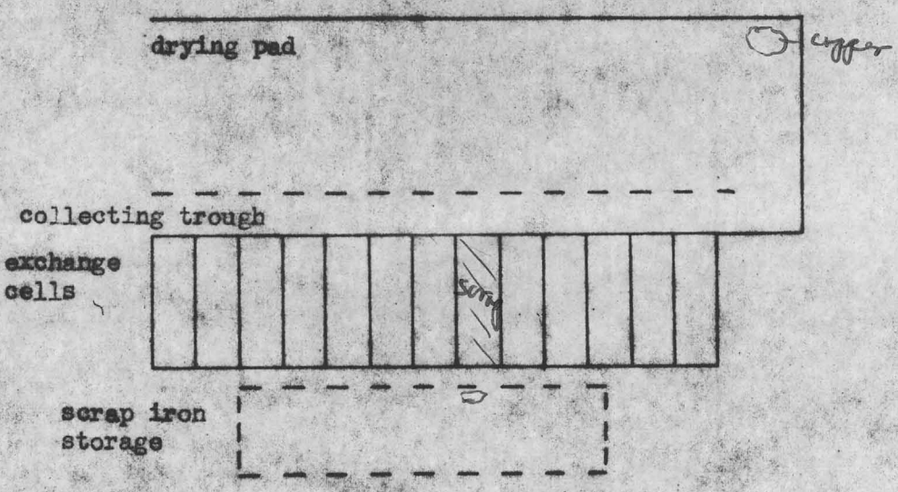
11) Describe any changes in routine or unusual activity on the property.
    All copper has been removed from drying pad except small pile in corner. Small pile now consists of remnants of two loads removed from drying pad. A load must have gone out late Tues or Wed.

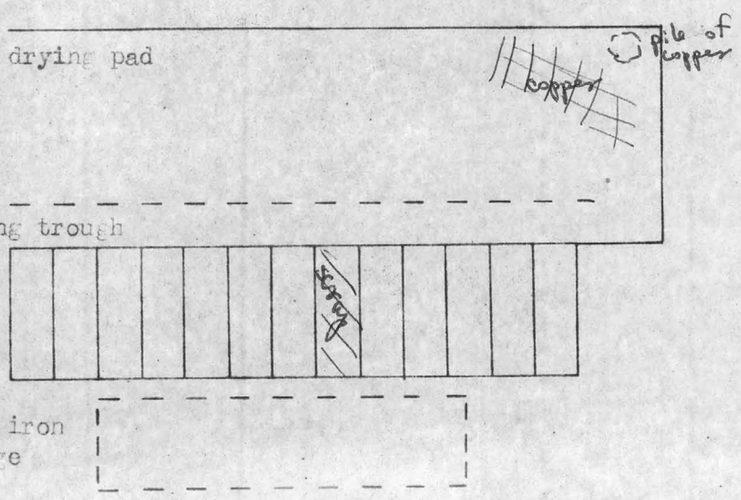
1) Normally two diesel motors operate the main circulation pumps, a Detroit and a Cummins. Today the Cummins diesel is missing from its mounting and could not be located on the property.

2) The compressor used to unload the acid trucks has been moved onto the drying pad. Employees are using a jack hammer, picks, and shovels to remove a layer of compacted cement copper adhering ~~the~~ the surface of the concrete. This layer varies from ½" to 3" thick and is thickest at the north end of the collecting sump.

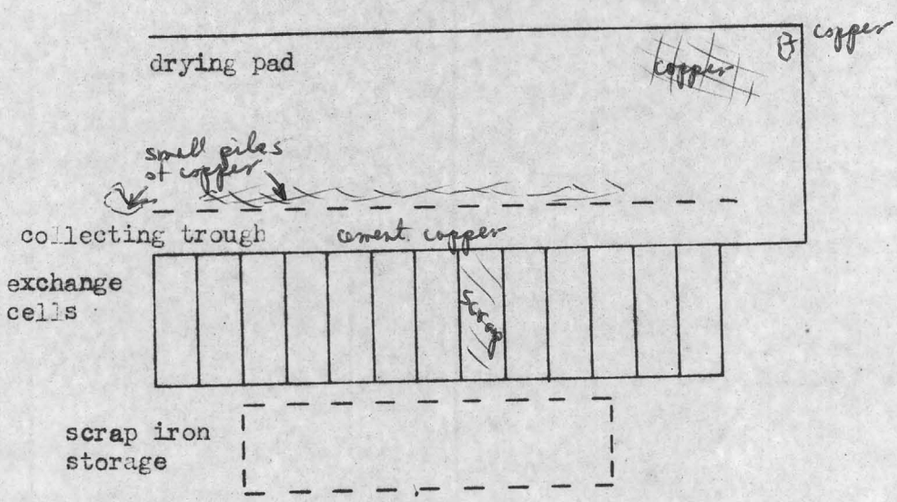
11) Describe any changes in routine or unusual
    activity on the property.
    Small compressor used to unload acid trucks into storage tanks.
    Large compressor being used to help scale off drying pad.

#4 cell washed out this morning and possibly others.

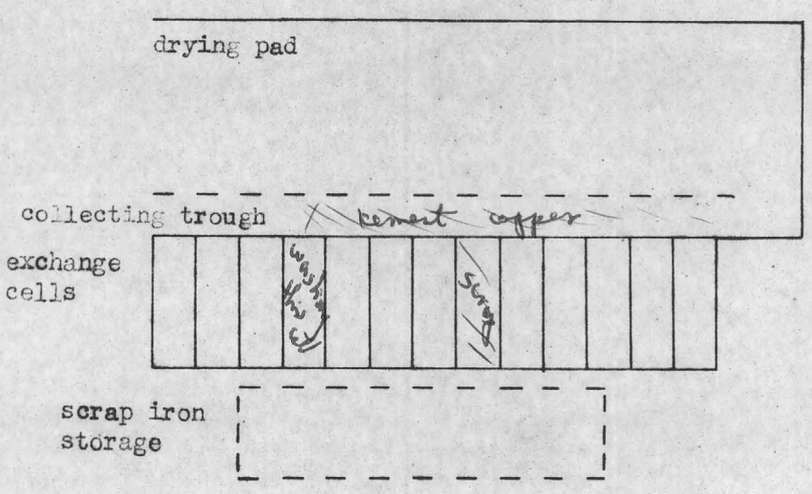
11) Describe any changes in routine or unusual activity on the property.
large compressor for unloading acid trucks replaced in original location at top of run-of-mine and fine-leach heap

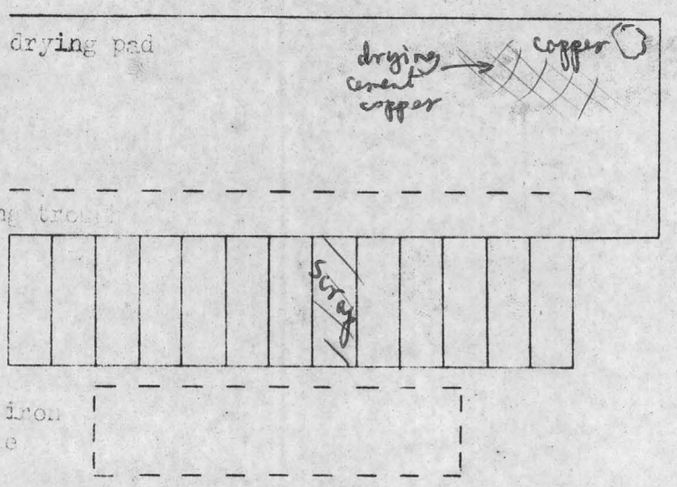
11) Describe any changes in routine or unusual activity on the property.
washing out cell #4
Dave Williams said a load of copper was shipped yesterday, Sunday April 8. He also confirmed that PMC had been working unusually hard the last 2 or 3 weeks to produce copper.

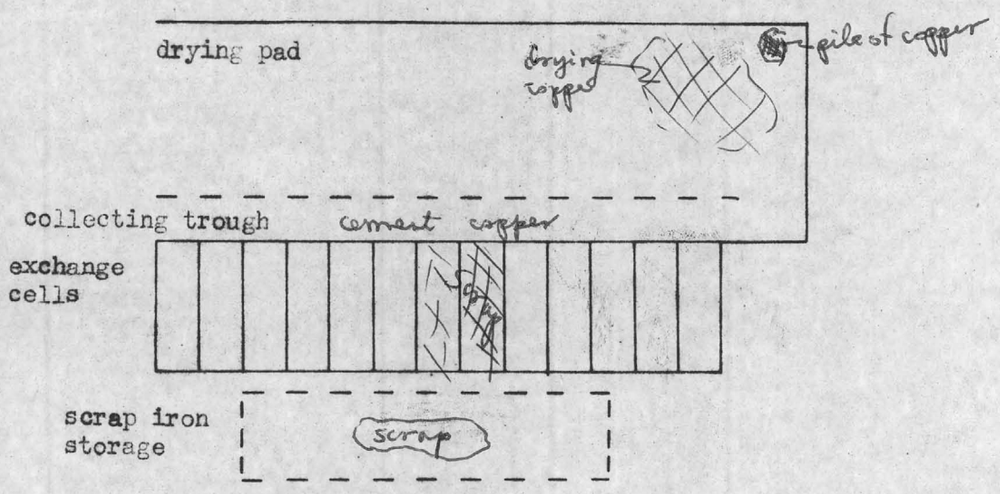
11) Describe any changes in routine or unusual activity on the property.
Load of scrap iron received Tuesday afternoon.
Crew is washing out all cells not currently in use.

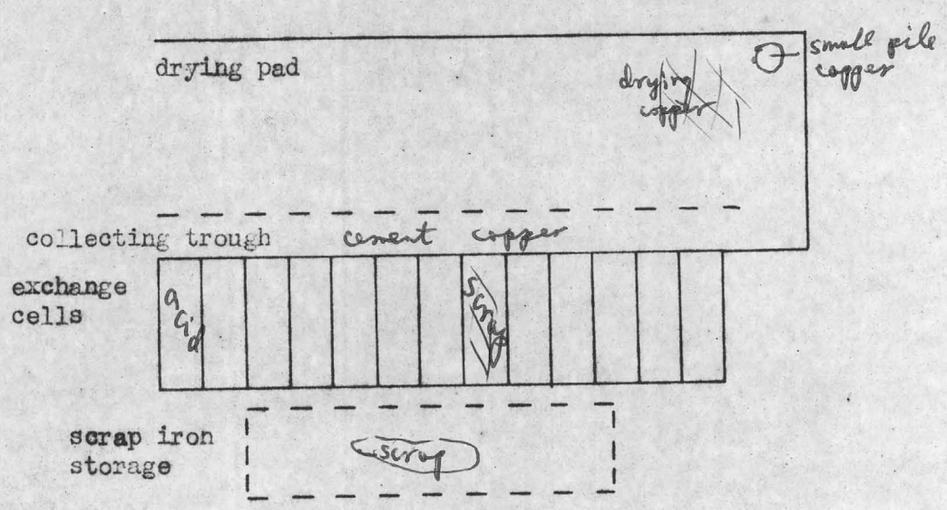
11) Describe any changes in routine or unusual
    activity on the property.
Only 1 cell on the north end contains any acid. All other cells are empty of acid and being washed out

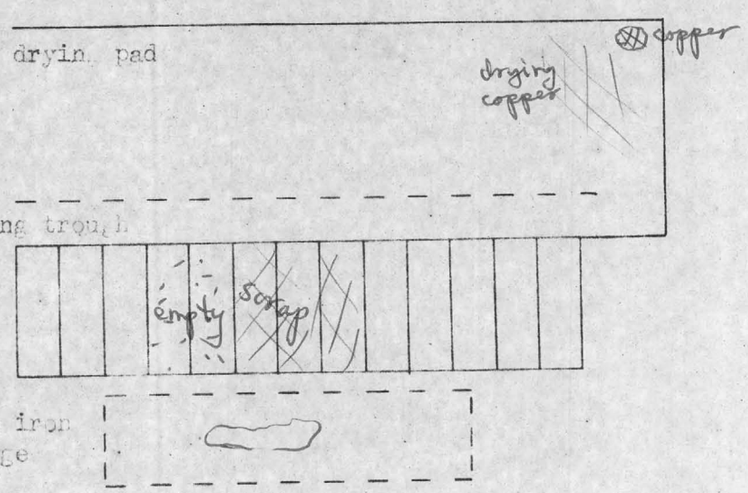
1) Is the circulation pump running? no - impeller shaft on pump is broken
2) Is acid being distributed on main leach dump? no
   If so, which side?
3) Is acid being pumped onto run-of-the-mine rock and fine leach dump? no
4) Where are the acid trucks dumping? same place
5) Is acid circulating through exchange cells? yes - reduced flow
6) Is there cement copper on drying pad? yes
   In collection trough below cells? no
7) Is there scrap iron in the cells? yes 7 & 8
8) Has any scrap iron been added to cells since previous inspection? no
9) Is there any new scrap iron on the ground? y
10) List date, time and license number of acid trucks seen on or near the property.

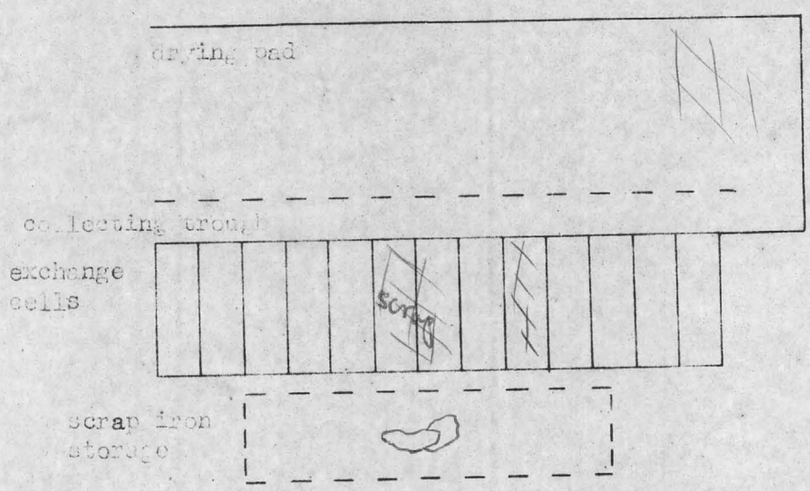
They were cleaning cell # 8, all scrap iron had been moved to # 9.

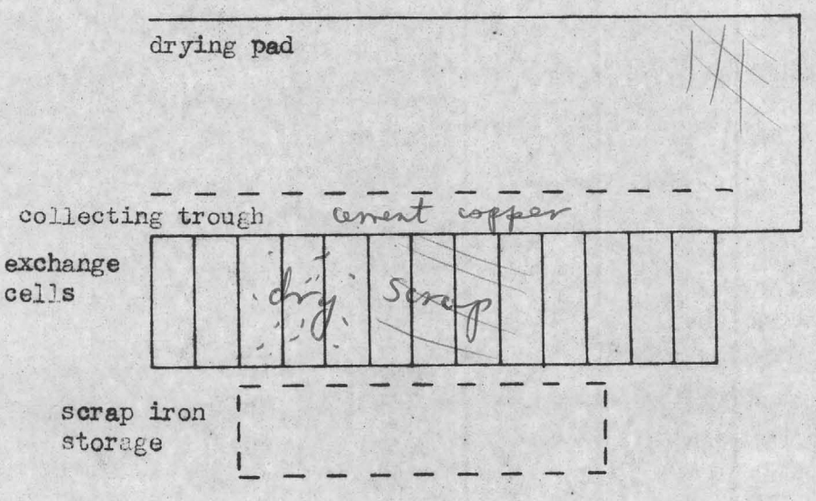
11) Describe any changes in routine or unusual activity on the property.
cells 3-4-5 are dry
John and mechanic were working on cat pump on pond below main circulation pump.

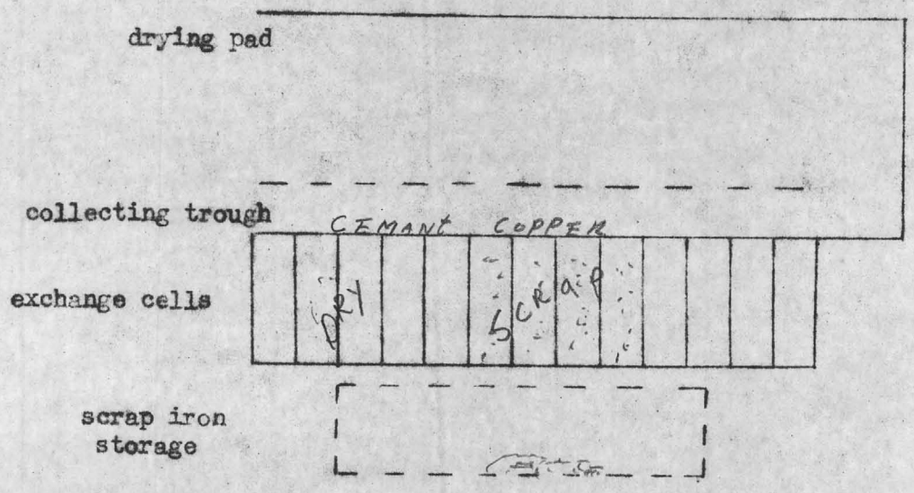
Acid RUNNING ON ALL PADS BUT VERY LOW.
CELLS CLEAN & COPPER STILL IN SUMP.

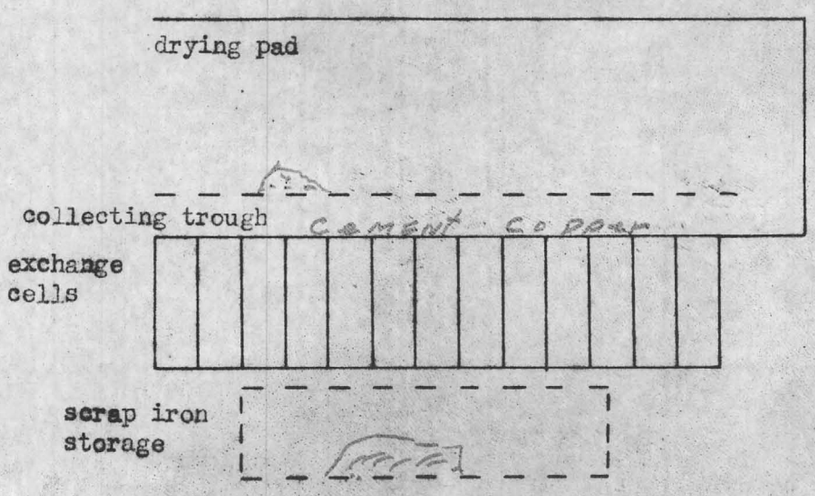
Two pads running on the East side. And they are still cleaning copper. They also got a new load of scrap.

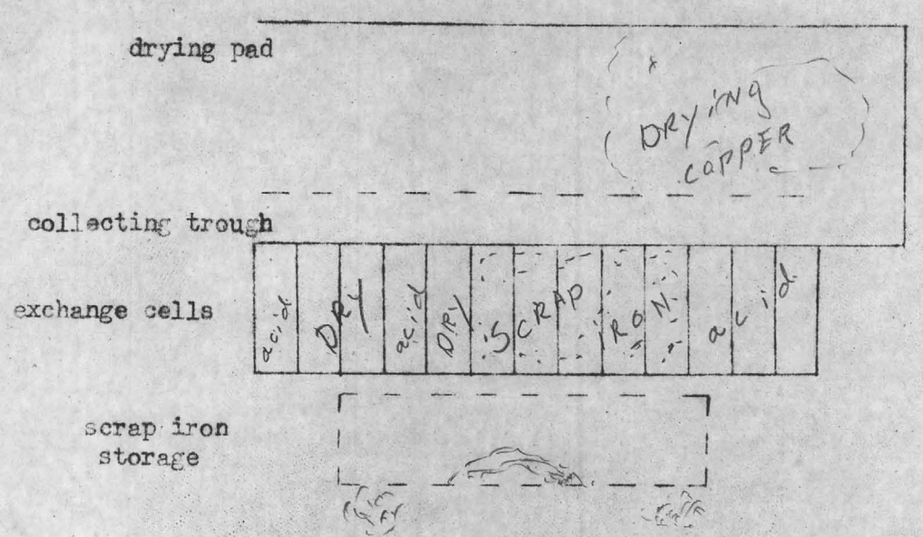
On the diagram indicate the location of scrap iron and cement copper.

1) Is the circulation pump running? no - there is only 1 diesel motor
2) Is acid being distributed on main leach dump? no and the pump is B/O
3) Is acid being pumped onto run-of-the-mine rock and fine leach heap? no
4) Where are the acid trucks dumping? same place as last observed 5/14/73
5) Is acid circulating through exchange cells? yes
6) Is there cement copper on drying pad? yes - estimated 40 tons
   In collection trough below cells? no
7) Is there scrap iron in the cells? yes
8) Has any scrap iron been added to cells since previous inspection? —
9) Is there any new scrap iron on the ground? —
10) List date, time, and license number of acid trucks on or near the property.
    11:30 AM tractor R-3583
    " R-3584
11) Describe any changes in routine or unusual activity on the property.
    office trailer #3 has been removed from property

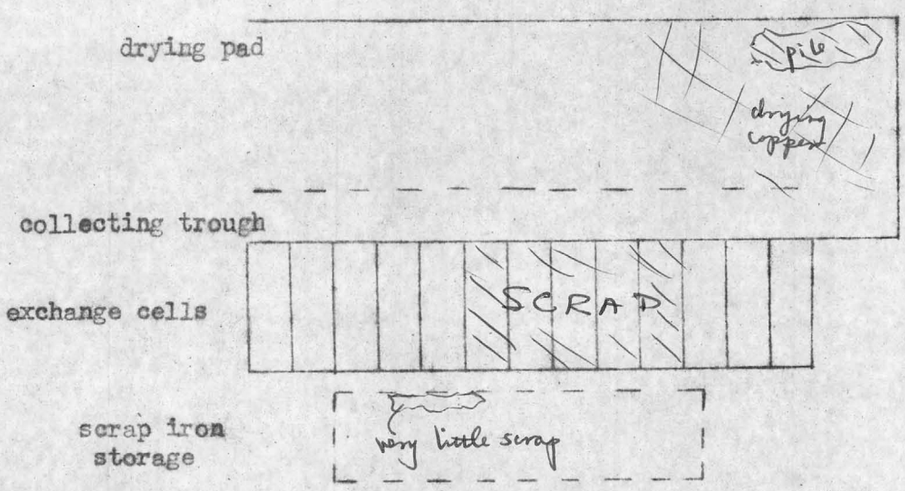
On the diagram indicate the location of scrap iron and cement copper.

1) Is the circulation pump running? no
2) Is acid being distributed over cells each day? no
3) Is acid being pumped onto run-of-mine rock and fine leach heap? no
4) Where are the acid trucks dumping? same place
5) Is acid circulating through exchange cells? a little
6) Is there cement copper on drying pad? yes
   In collection trough below cells? no
7) Is there scrap iron in the cells? yes
8) Has any scrap iron been added to cells since previous inspection? no
9) Is there any new scrap iron on the property? no
10) List date, time, and license number of acid trucks on or near the property.
    tractor R-3584 3 PM
    " R-3583 4:30 PM (sampled for acid)
11) Describe any changes in routine or unusual activity on the property.

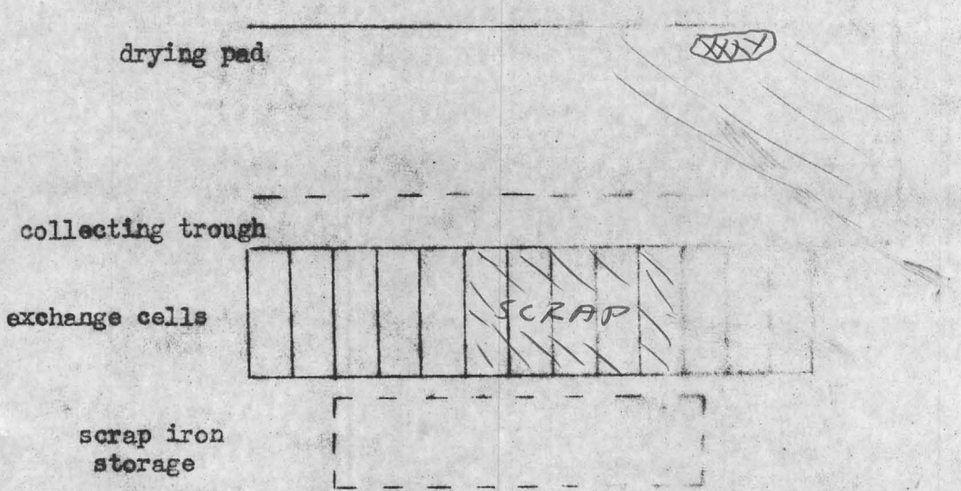
On the diagram indicate the location of scrap iron and cement copper.

1) Is the circulation pump running? no
2) Is acid being distributed on [illegible] leach dump? no
3) Is acid being pumped onto run-of-the-mine rock and fine leach heap? no
4) Where are the acid trucks dumping? some place
5) Is acid circulating through exchange cells? a little
6) Is there cement copper on drying pad? yes
   In collection trough below cells? no
7) Is there scrap iron in the cells? yes
8) Has any scrap iron been added to cells since previous inspection? no
9) Is there any new scrap iron on the property? no
10) List date, time, and license number of acid trucks on or near the property.
9:30 AM tractor R-3583
R-3584
11) Describe any changes in routine or unusual activity on the property.

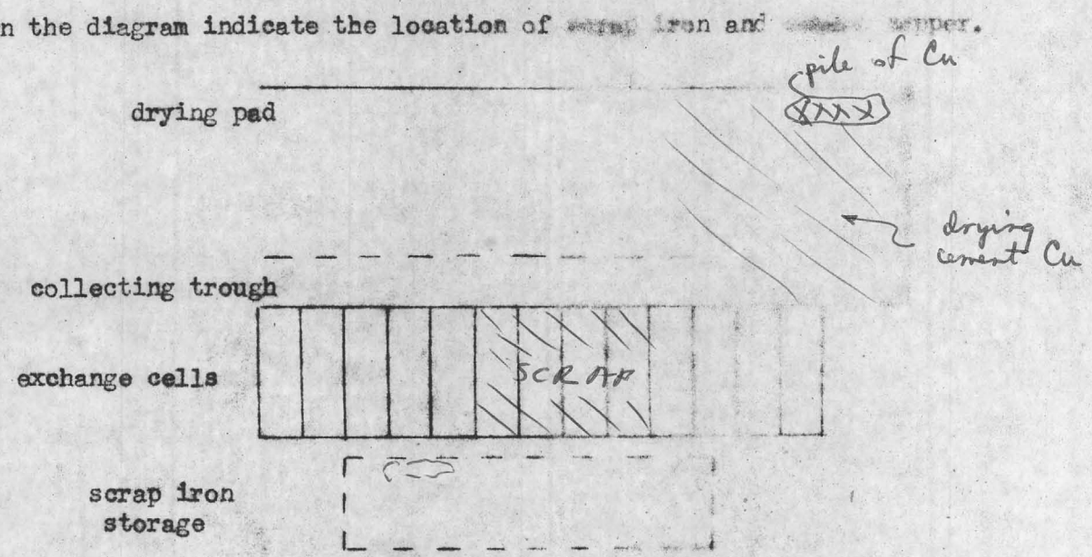
On the diagram indicate the location of scrap iron and cement copper.

1) Is the circulation pump running? NO
2) Is acid being distributed on main leach dump? NO
3) Is acid being pumped onto run-of-the-mine rock and fine leach heap? NO NO
4) Where are the acid trucks dumping? SAME PLACE
5) Is acid circulating through exchange cells?
6) Is there cement copper on drying pad? YES
   In collection trough below cells?
7) Is there scrap iron in the cells? YES
8) Has any scrap iron been added to cells since previous inspection? NO
9) Is there any new scrap iron on the ground? NO
10) List date, time, and license number of acid trucks on or near the property.

11) Describe any changes in routine or unusual activity on the property.

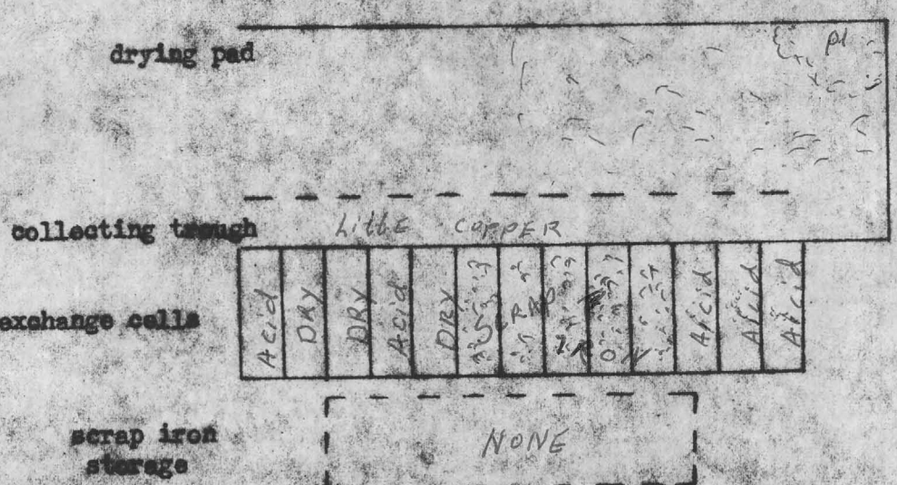
On the diagram indicate the location of scrap iron and cement copper.
