ARABIAN MINE SURVEY AND RECONNAISSANCE

ENGINEERS INTERNATIONAL, INC. PROJECT NO. AZ1075

SEPTEMBER, 1991

ARIZONA DEPARTMENT OF TRANSPORTATION
HIGHWAYS DIVISION
PHOENIX, ARIZONA

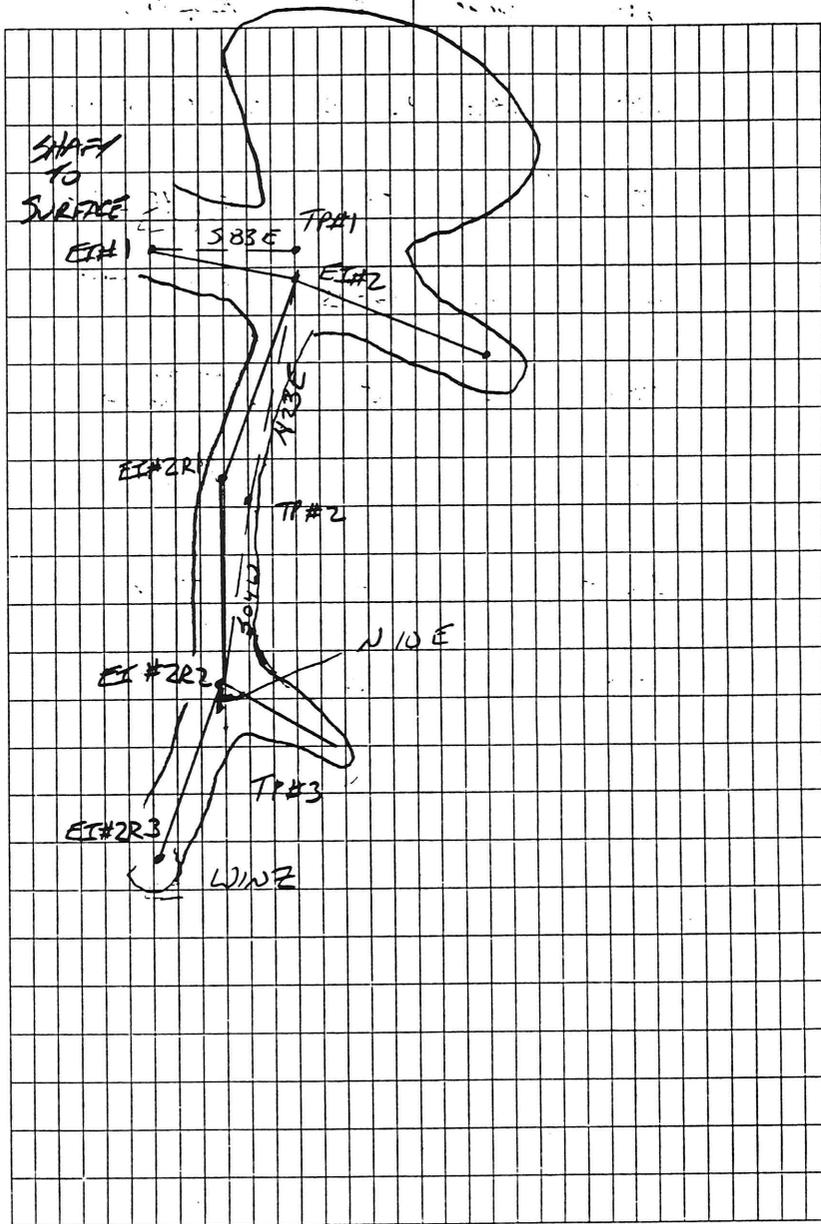
AZ	DIST	∠	DESCRIPTION
			CORNER OF DOG HOLE
160°-4'	29.0	+22°-15'	55' x 5.4' AXIS N44W
173-54'	32.6	+31°-15'	HEIGHT SHOT.
208-30'	13.3'	-0°-45"	HOPPER CHUTE
220-21'	15.4	∅	BULKHEAD INT W/ ROCK
281°	4.0'	∅	"223"
358°-25'	4.5'	37°-10'	EI#2
TP#2 BS: EI#2			BEARING N-23° E
129-53-00	22.3	-12°-30'	B.S. EI#2 BEARING N23 E
	17.6		EI#2 - EI#2A1
93-46-47	6.3	12°-30'	EI# 2R1
290-53-00	21.4	-3°-30'	EI#2R2 BEARING S. 04-W

PAGES	AZ	DIST	Δ	DESCRIPTION
TP#3	BS	EI#2R2		BEARING N-10°-E
	133°-02'	2.9	-5°-0'	EI#2R2
	225°-41'-15"	13.9	+3°-30'	DOG LEA LEFT X-SECT 4XL
	339-10'	32.4'	-2°	EI#2R3 OVER WJ27
SET UP ON EI#2				
	BS	EI#2A		BEARING S-57°-E
	0-00-00	24.1	0°	EI#2A

PAGE 6			
LINE / OFFSET			
EI#	HORIZ	LEFT	RIGHT
EI#2	0		
	5	-	- LIP OF SHAF
	6	2.7	2.5
	10	2.9	1.5
	15	3.1	1.8
EI#2R1	18	2.7	2.8
EI#2R1	0		
	6	1.9	3.8
	12	1.5	4.6
	18	2.5	2.5
	24	3.1	3.4
EI#2R2	27	4.1	5.0
