**ARIZONA DEPARTMENT OF
ENVIROMANTAL QUALITY**

I am pleased to submit on behalf of Morgan Mining Company the Aquifer Protection Permit Application for the *Golden Eagle Mine, Mohave County*. The Aquifer Permit Application, ADEQ Water Unit Form APP 1, is included in the application document. Supplementary information for the Application can be found in Attachments 1 - 12. Drawings and supporting documentation in the form of third party consultant reports are included as Exhibits A and B.

**Tailings Impoundment,
Spill Containment and Leak Detection
Monitoring Program
Closure**

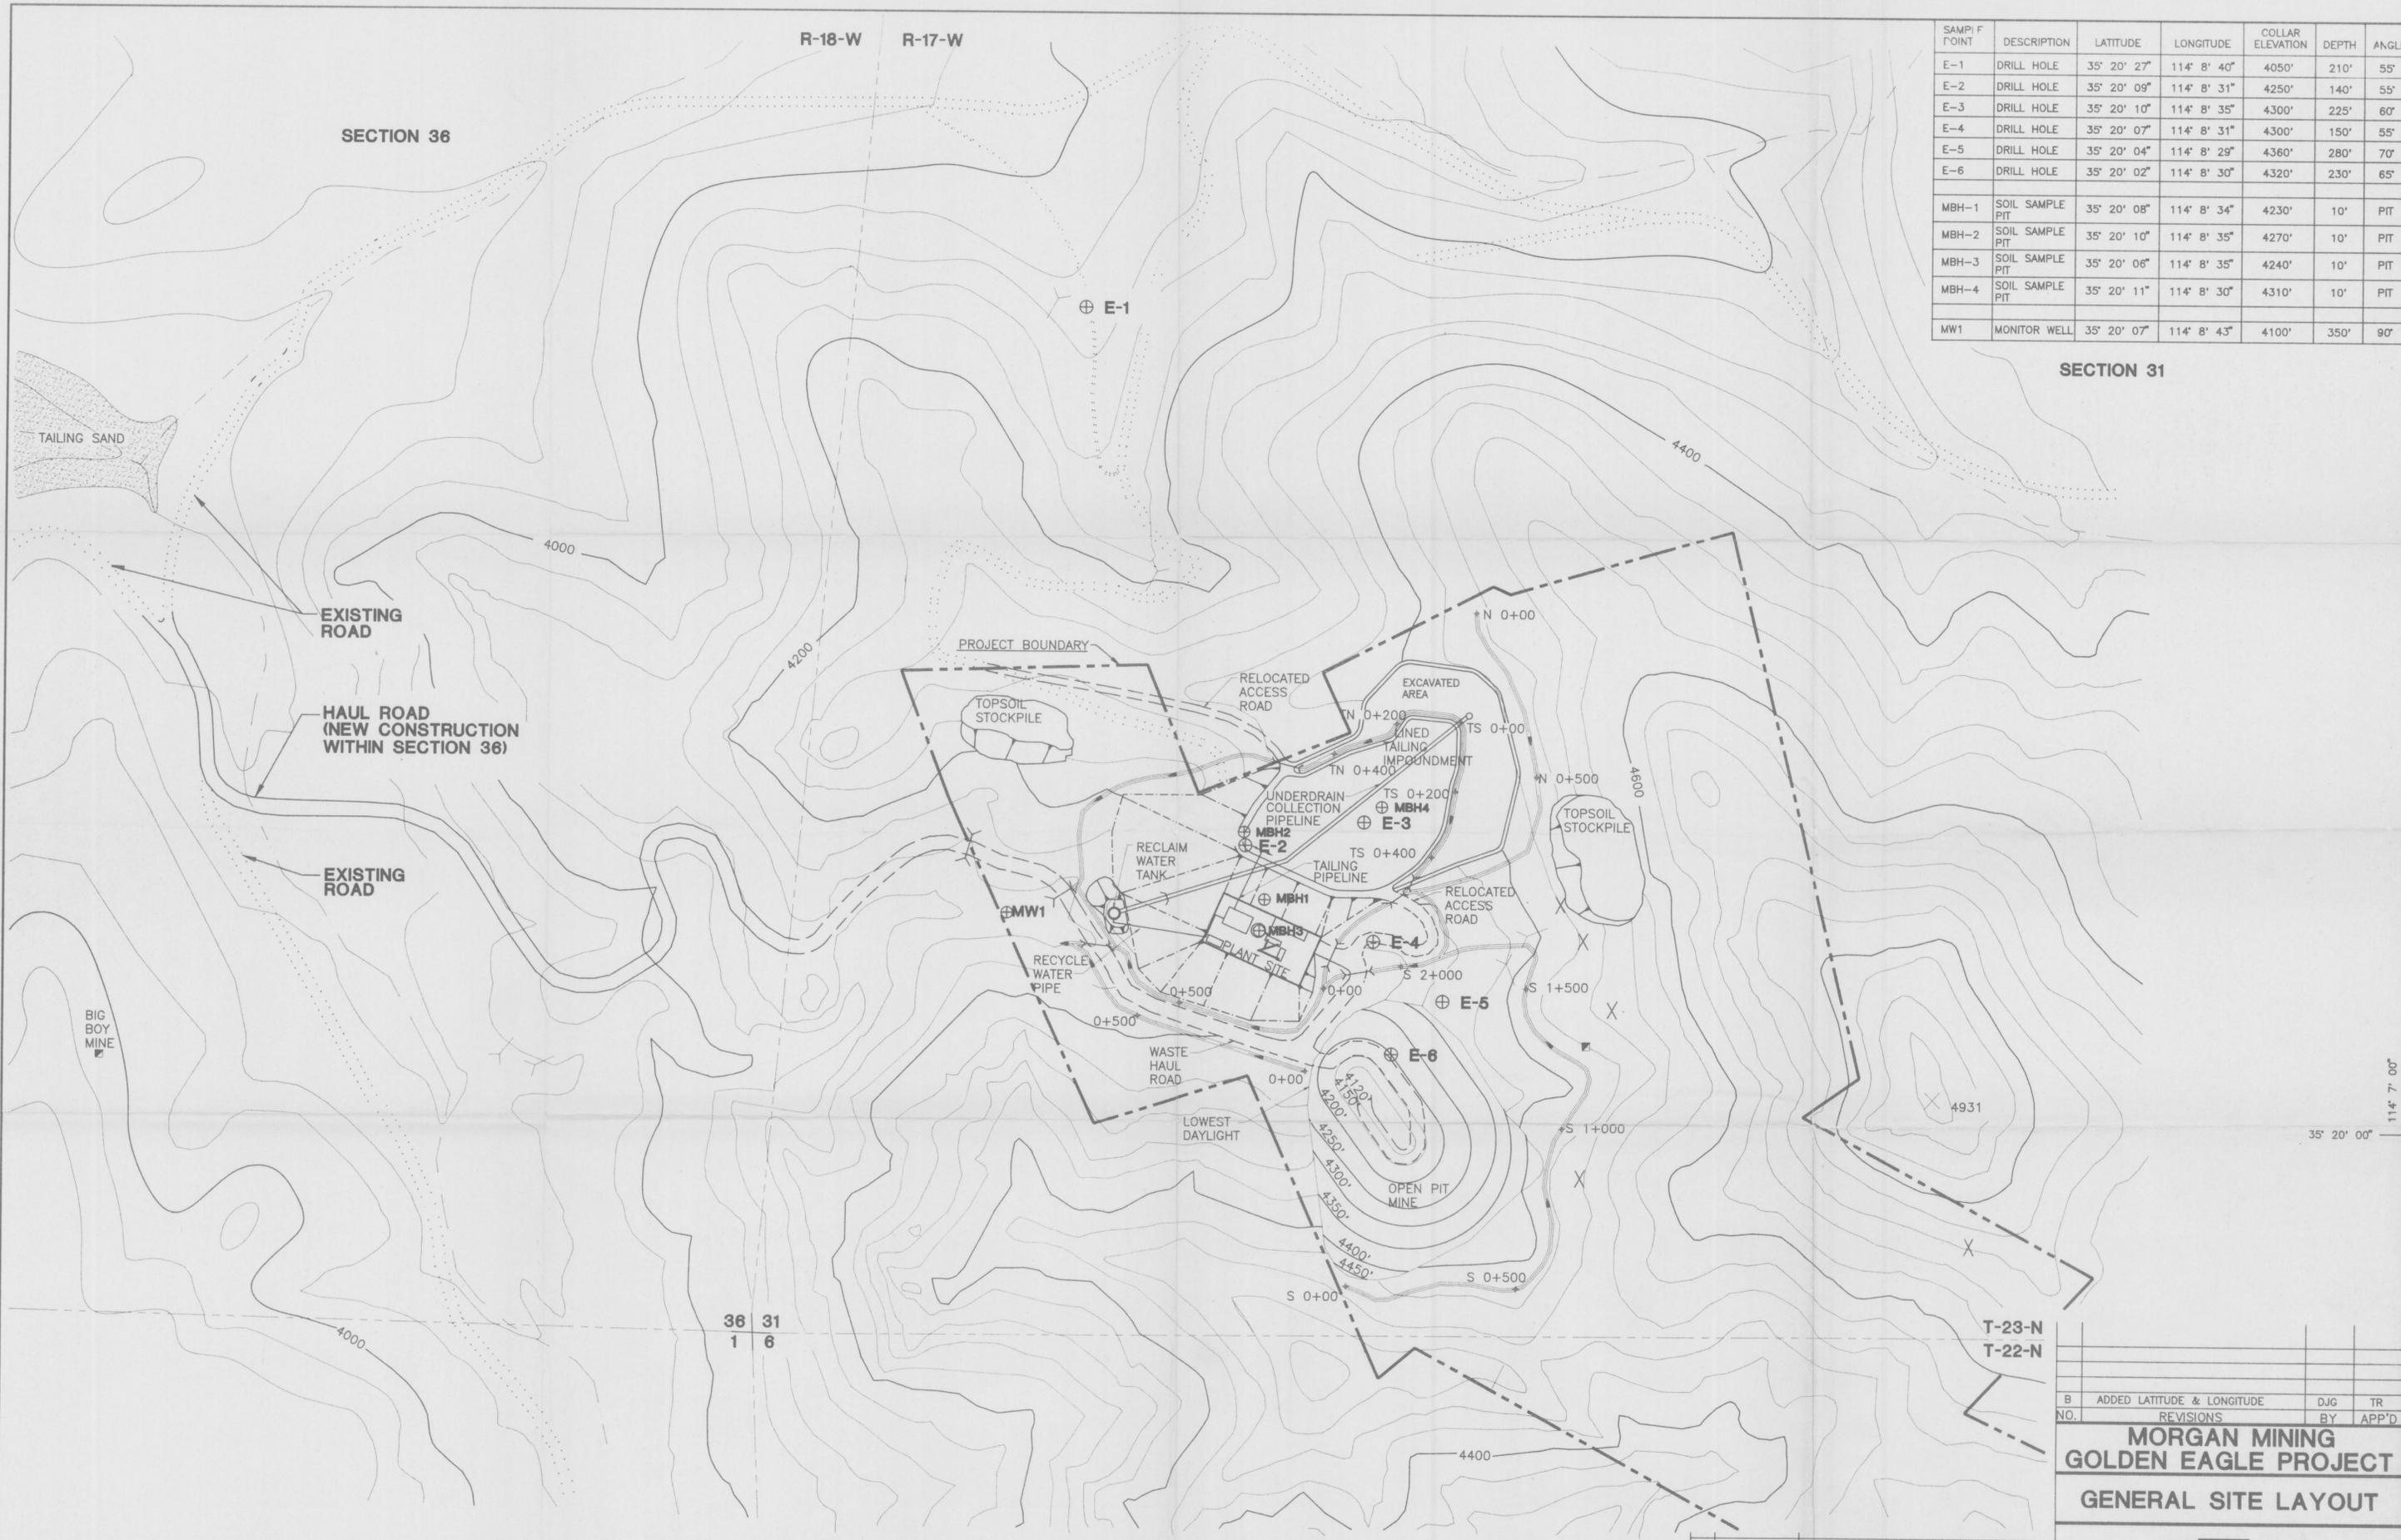
SAMPLE POINT	DESCRIPTION	LATITUDE	LONGITUDE	COLLAR ELEVATION	DEPTH	ANGLE
E-1	DRILL HOLE	35° 20' 27"	114° 8' 40"	4050'	210'	55°
E-2	DRILL HOLE	35° 20' 09"	114° 8' 31"	4250'	140'	55°
E-3	DRILL HOLE	35° 20' 10"	114° 8' 35"	4300'	225'	60°
E-4	DRILL HOLE	35° 20' 07"	114° 8' 31"	4300'	150'	55°
E-5	DRILL HOLE	35° 20' 04"	114° 8' 29"	4360'	280'	70°
E-6	DRILL HOLE	35° 20' 02"	114° 8' 30"	4320'	230'	65°
MBH-1	SOIL SAMPLE PIT	35° 20' 08"	114° 8' 34"	4230'	10'	PIT
MBH-2	SOIL SAMPLE PIT	35° 20' 10"	114° 8' 35"	4270'	10'	PIT
MBH-3	SOIL SAMPLE PIT	35° 20' 06"	114° 8' 35"	4240'	10'	PIT
MBH-4	SOIL SAMPLE PIT	35° 20' 11"	114° 8' 30"	4310'	10'	PIT
MW1	MONITOR WELL	35° 20' 07"	114° 8' 43"	4100'	350'	90°

⊕ LOCATIONS OF BACKHOE AND DRILL SAMPLES

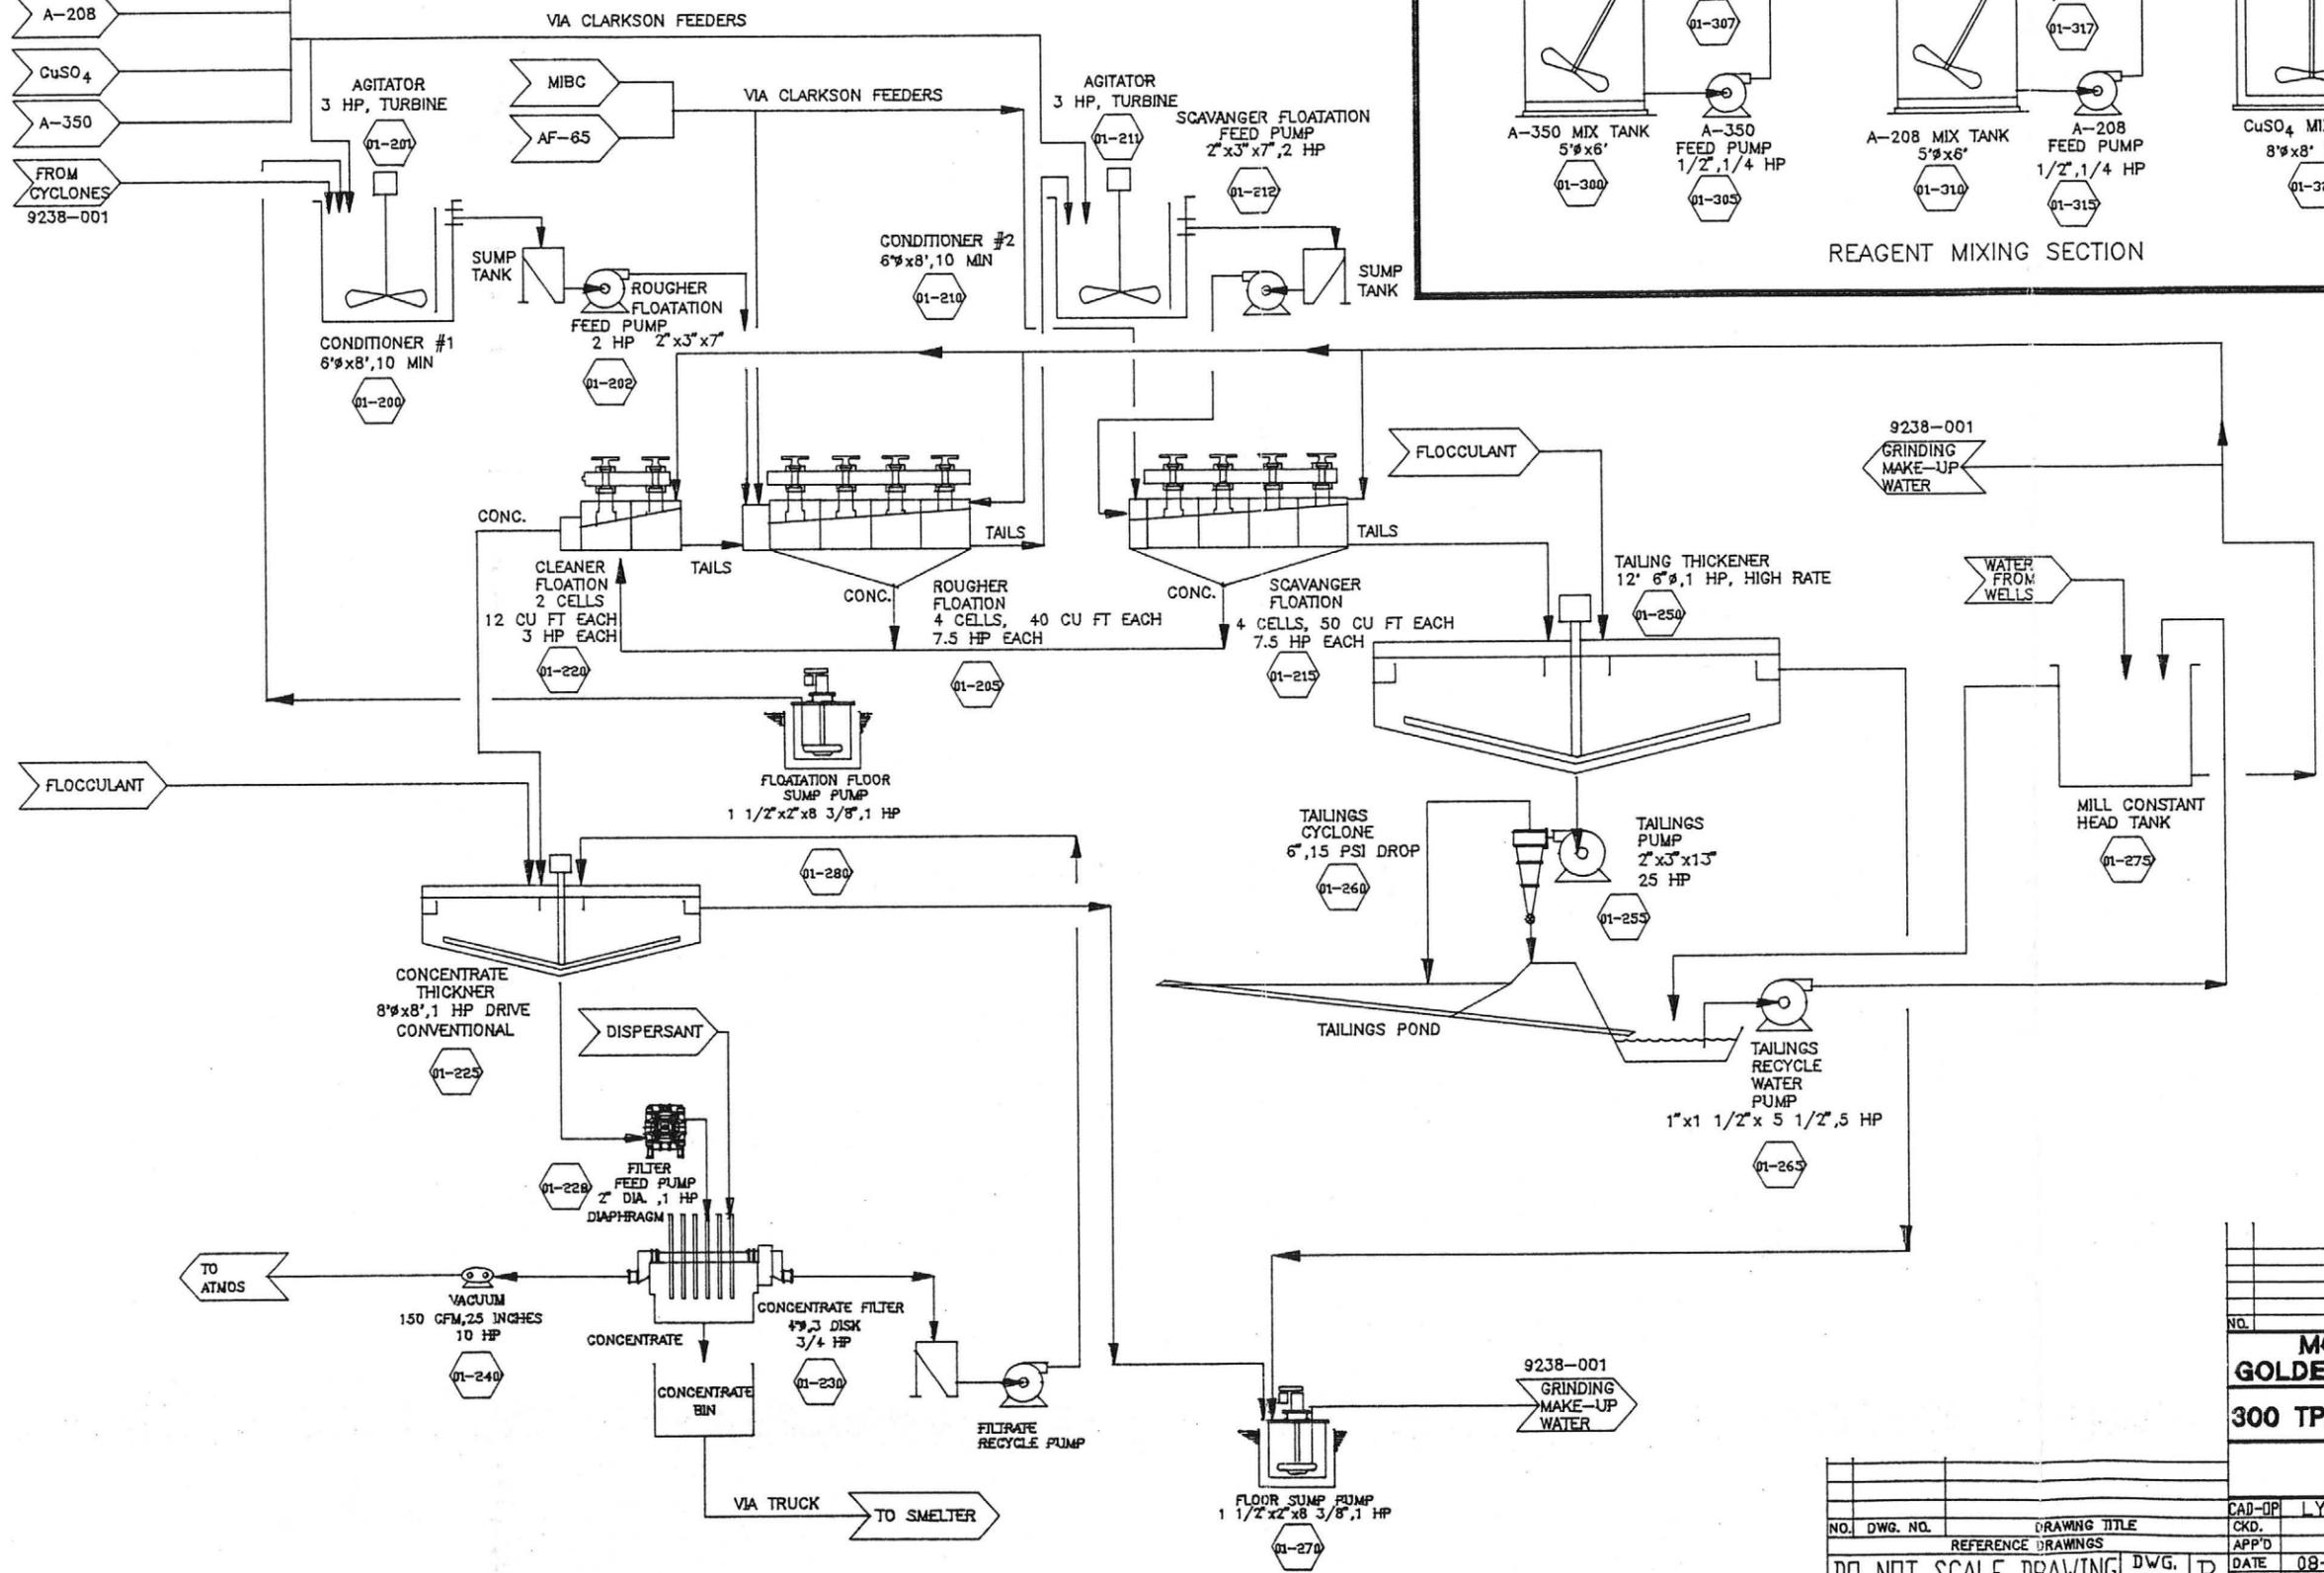
NO.	REVISIONS	BY	APP'D
MORGAN MINING GOLDEN EAGLE PROJECT			
300 TPD MILL FLOW SHEET			
LYNTEK INC.			
CAD-OP	LYNTEK	930527.1030	
CKD.	-		
APP'D	-	DRAWING NO.	REV.
DATE	08-12-92	DWG. SIZE	B
SCALE	NONE	9238-002	-

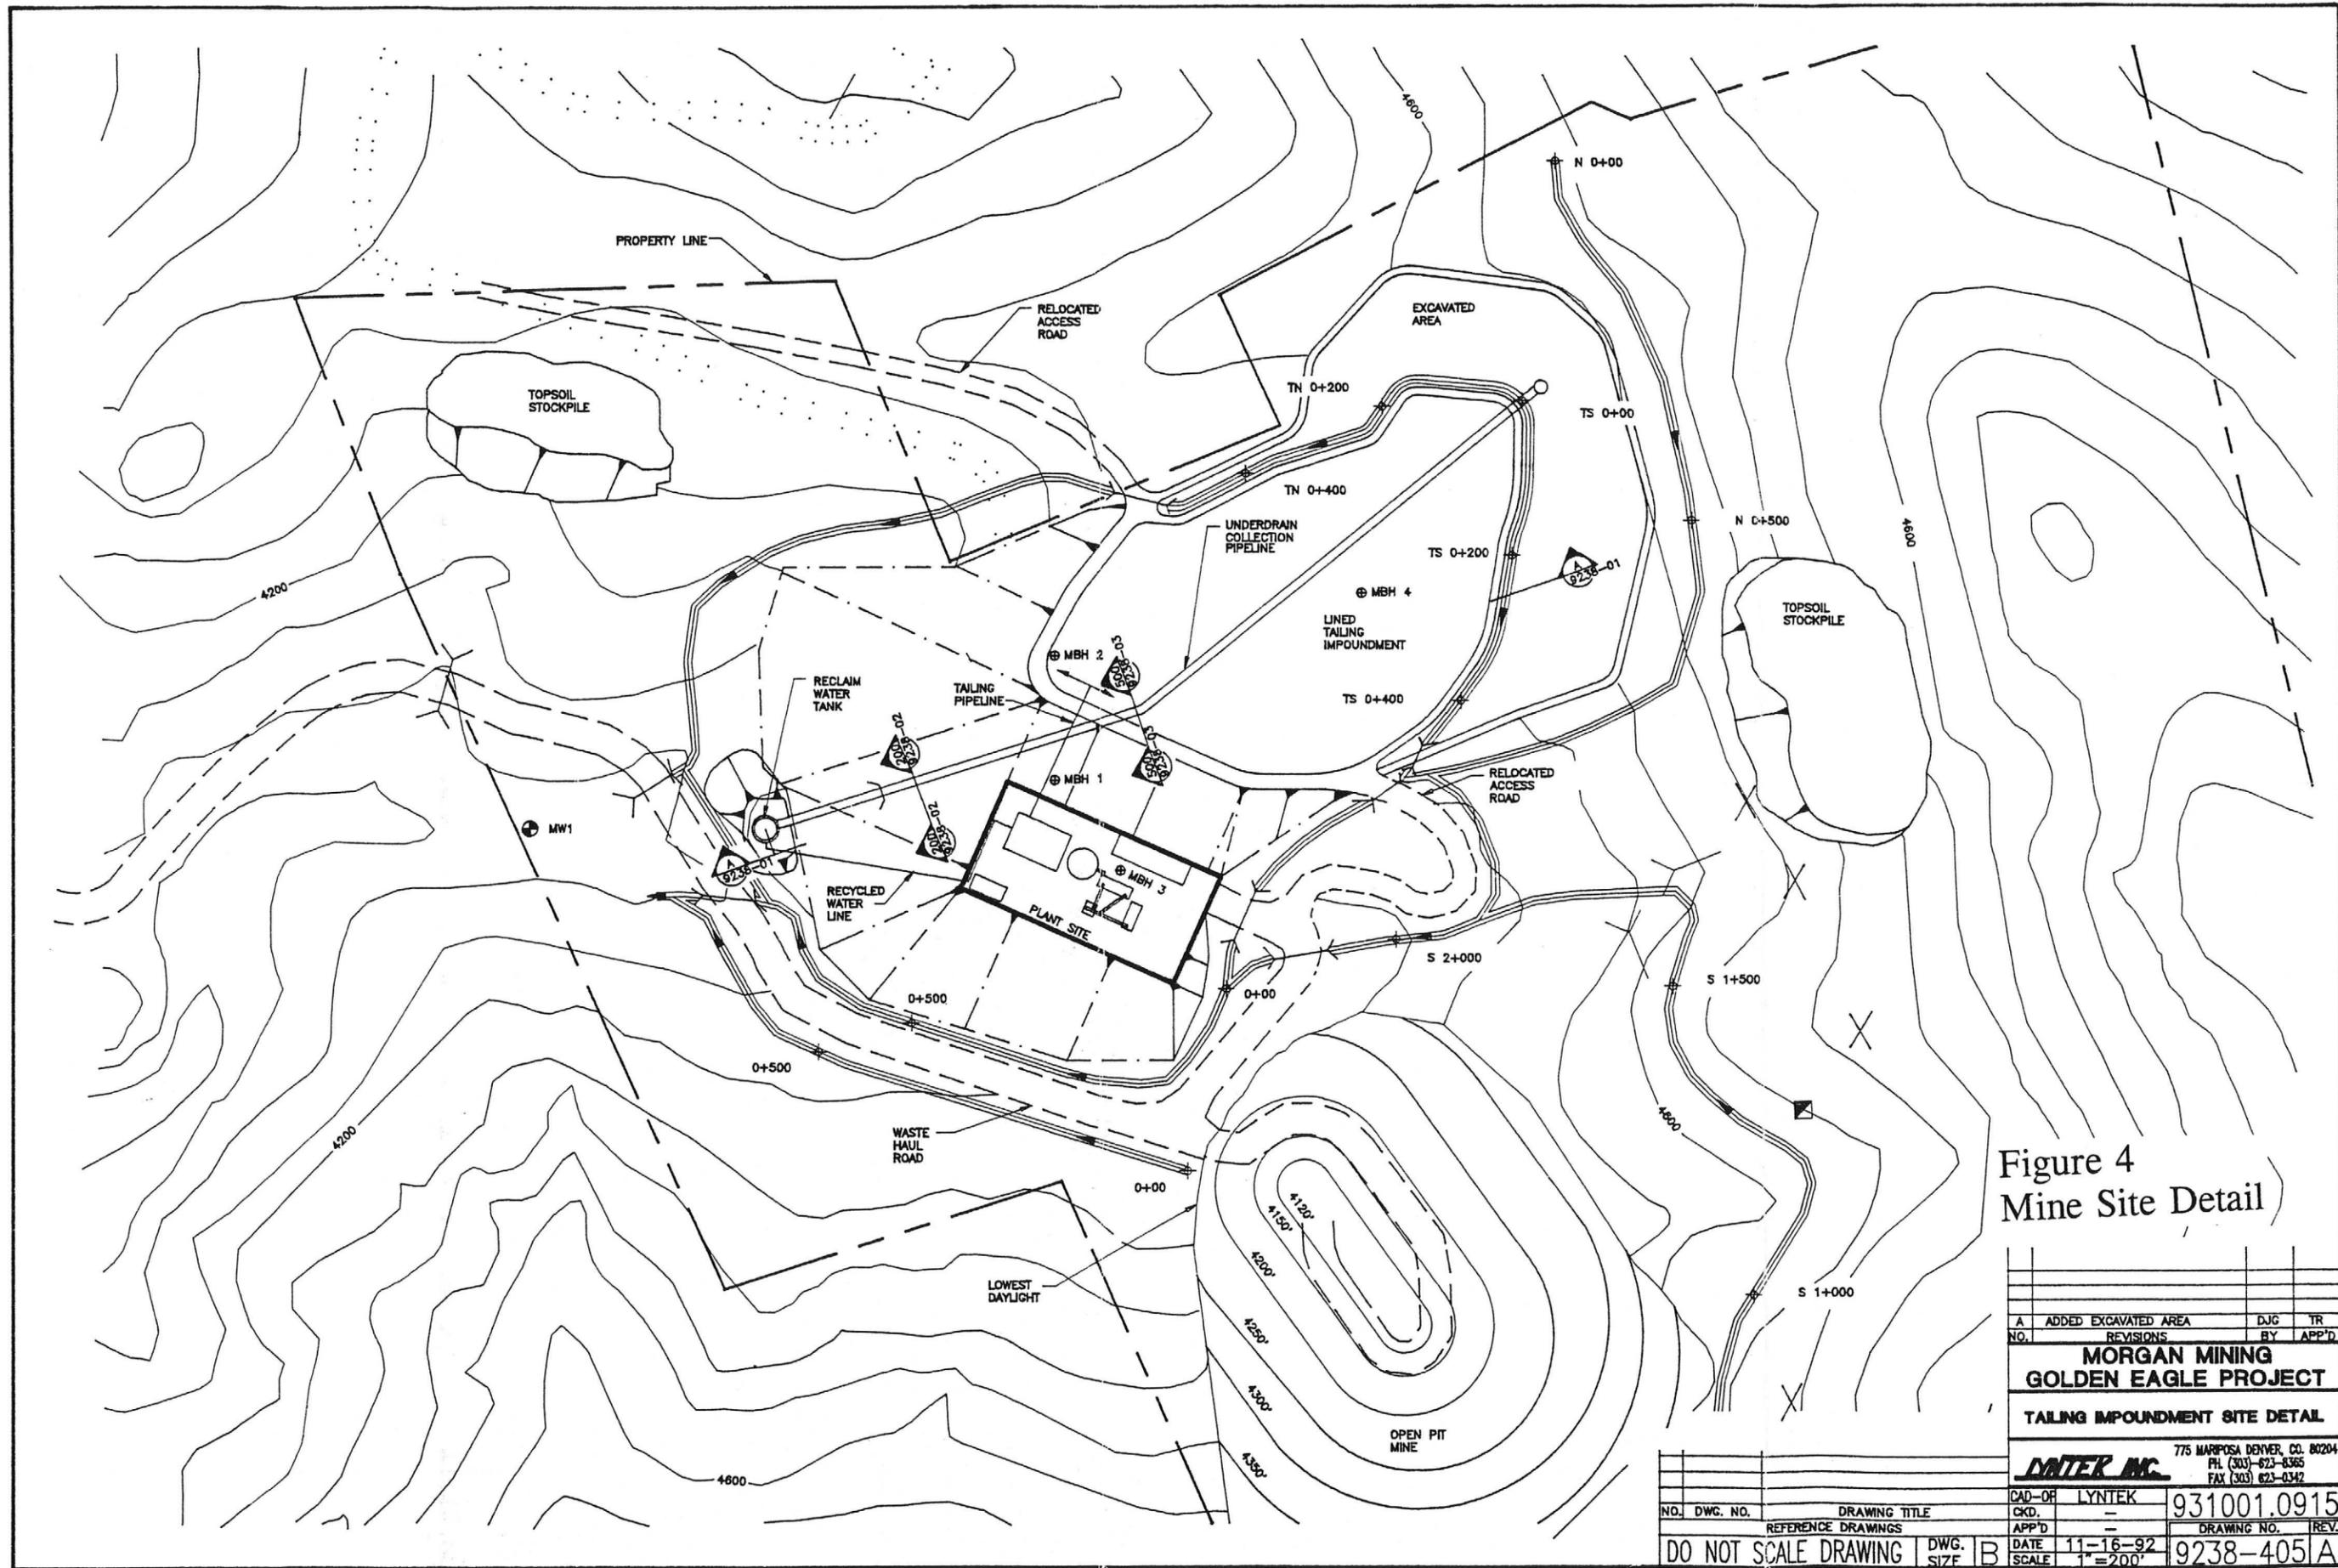
Figure 4
Mine Site Detail

NO.	DESCRIPTION	BY	APP'D
A	ADDED EXCAVATED AREA	DJC	TR
MORGAN MINING			
GOLDEN EAGLE PROJECT			
TAILING IMPOUNDMENT SITE DETAIL

The water reclaim system will collect water in the tailings impoundment area for reuse in the processing plant. This system will consist of an internal drainage pipe, a reclaim water tank and a reclaim return pipeline. Details 4 and 5 on Figure 11 (Details Tailings Impoundment), as well as Figures 4 and 8 shows details of the layout and construction of the water reclaim system. All water flowing with the exception of the return pipeline is gravity driven. The pipe in the internal drainage system will collect water and direct flow into the reclaim pipe. The reclaim pipe will extend through the tailings dam , and direct water flow into the reclaim tank. Reclaimed water is then piped back to the process plant via the return pipeline.

The water will be reclaimed through an underdrain that will be placed in the bottom of the valley within the tailings disposal area as shown on Figure 4 and Figure 8, Detail 8. The reclaim water collection line will be perforated and wrapped with non-woven geotextile of high hydraulic conductivity and covered in gravel. Water that pools against the perimeter farthest from the dam crest as well as water that seeps out of the emplaced tailings, will be allowed to flow into the line through the geotextile and gravel blanket to be collected in the recirculation tank located below the dam.

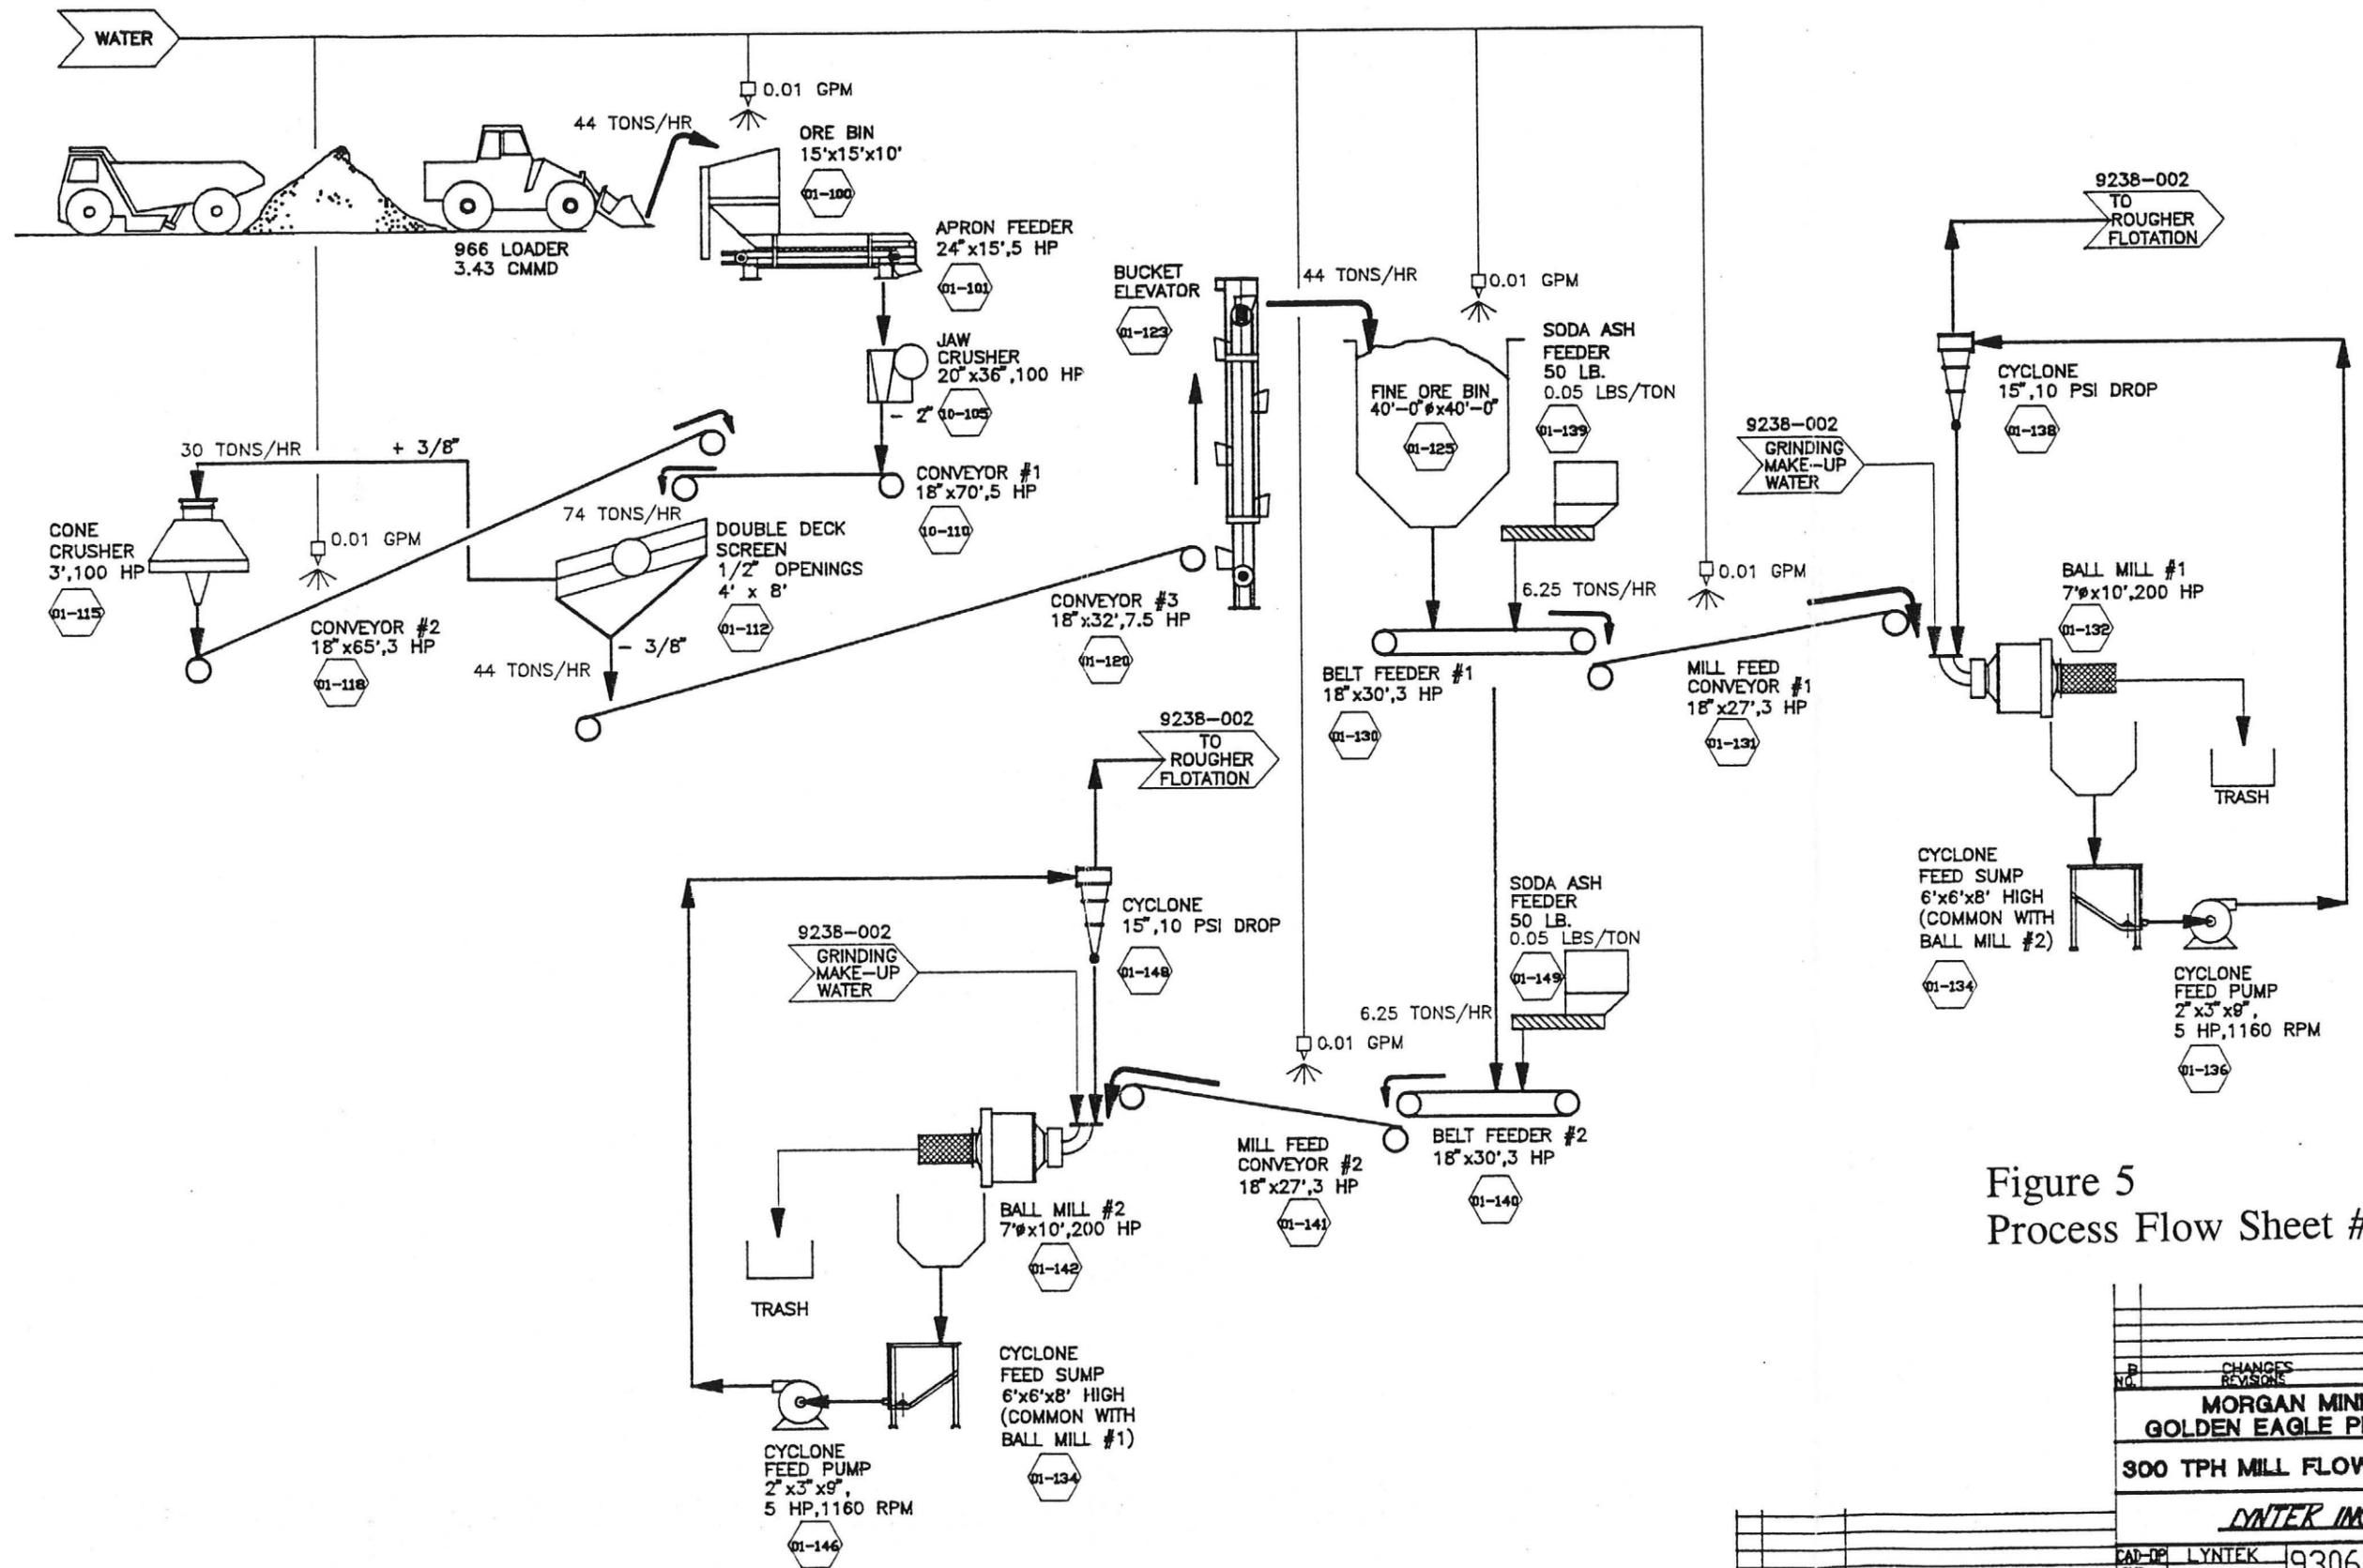
Figure 5
Process Flow Sheet #1

CHANGES	NO.	BY	DATE	APPROVED
MORGAN MINING GOLDEN EAGLE PROJECT 300 TPH MILL FLOW SHEET				
DINTER INC.

Design work addressing flow parameters, material balances and engineering studies on the grinding and processing plant have been undertaken on behalf of MMC by Lyntek, Inc. of Denver, Colorado. The results of this design and engineering work are shown in the process flow diagrams in Appendix B (Figures 5, 6 and 7).

The milling circuit consists of two parallel ball mills closed with cyclones producing 300 tons per day of 80% minus 200 mesh (74 microns) flotation feed. Each mill will be rated at about 6.25 tons per hour based on 24 hour per day operation. Recycled water from the tailings impoundment will be utilized to dilute the slurry to approximately 30% solids for feed to flotation. Figure 5, Process Flow Sheet #1, details the grinding section of the processing plant.

Morgan Mining Company (MMC) proposes to mine and recover gold from an orebody in the Kingman District of Mohave County Arizona. MMC plans to mine the orebody by open pit mining methods consisting of drilling, blasting, loading and hauling. The ore will be hauled by off road trucks to the proposed processing facility to be crushed. Crushed ore will then be ground in the ball mill system and finally reduced to a concentrate in the flotation circuit. The concentrate will then be trucked off site to be further processed (See Figures 5 and 6, Process Flow Diagrams, Appendix B)

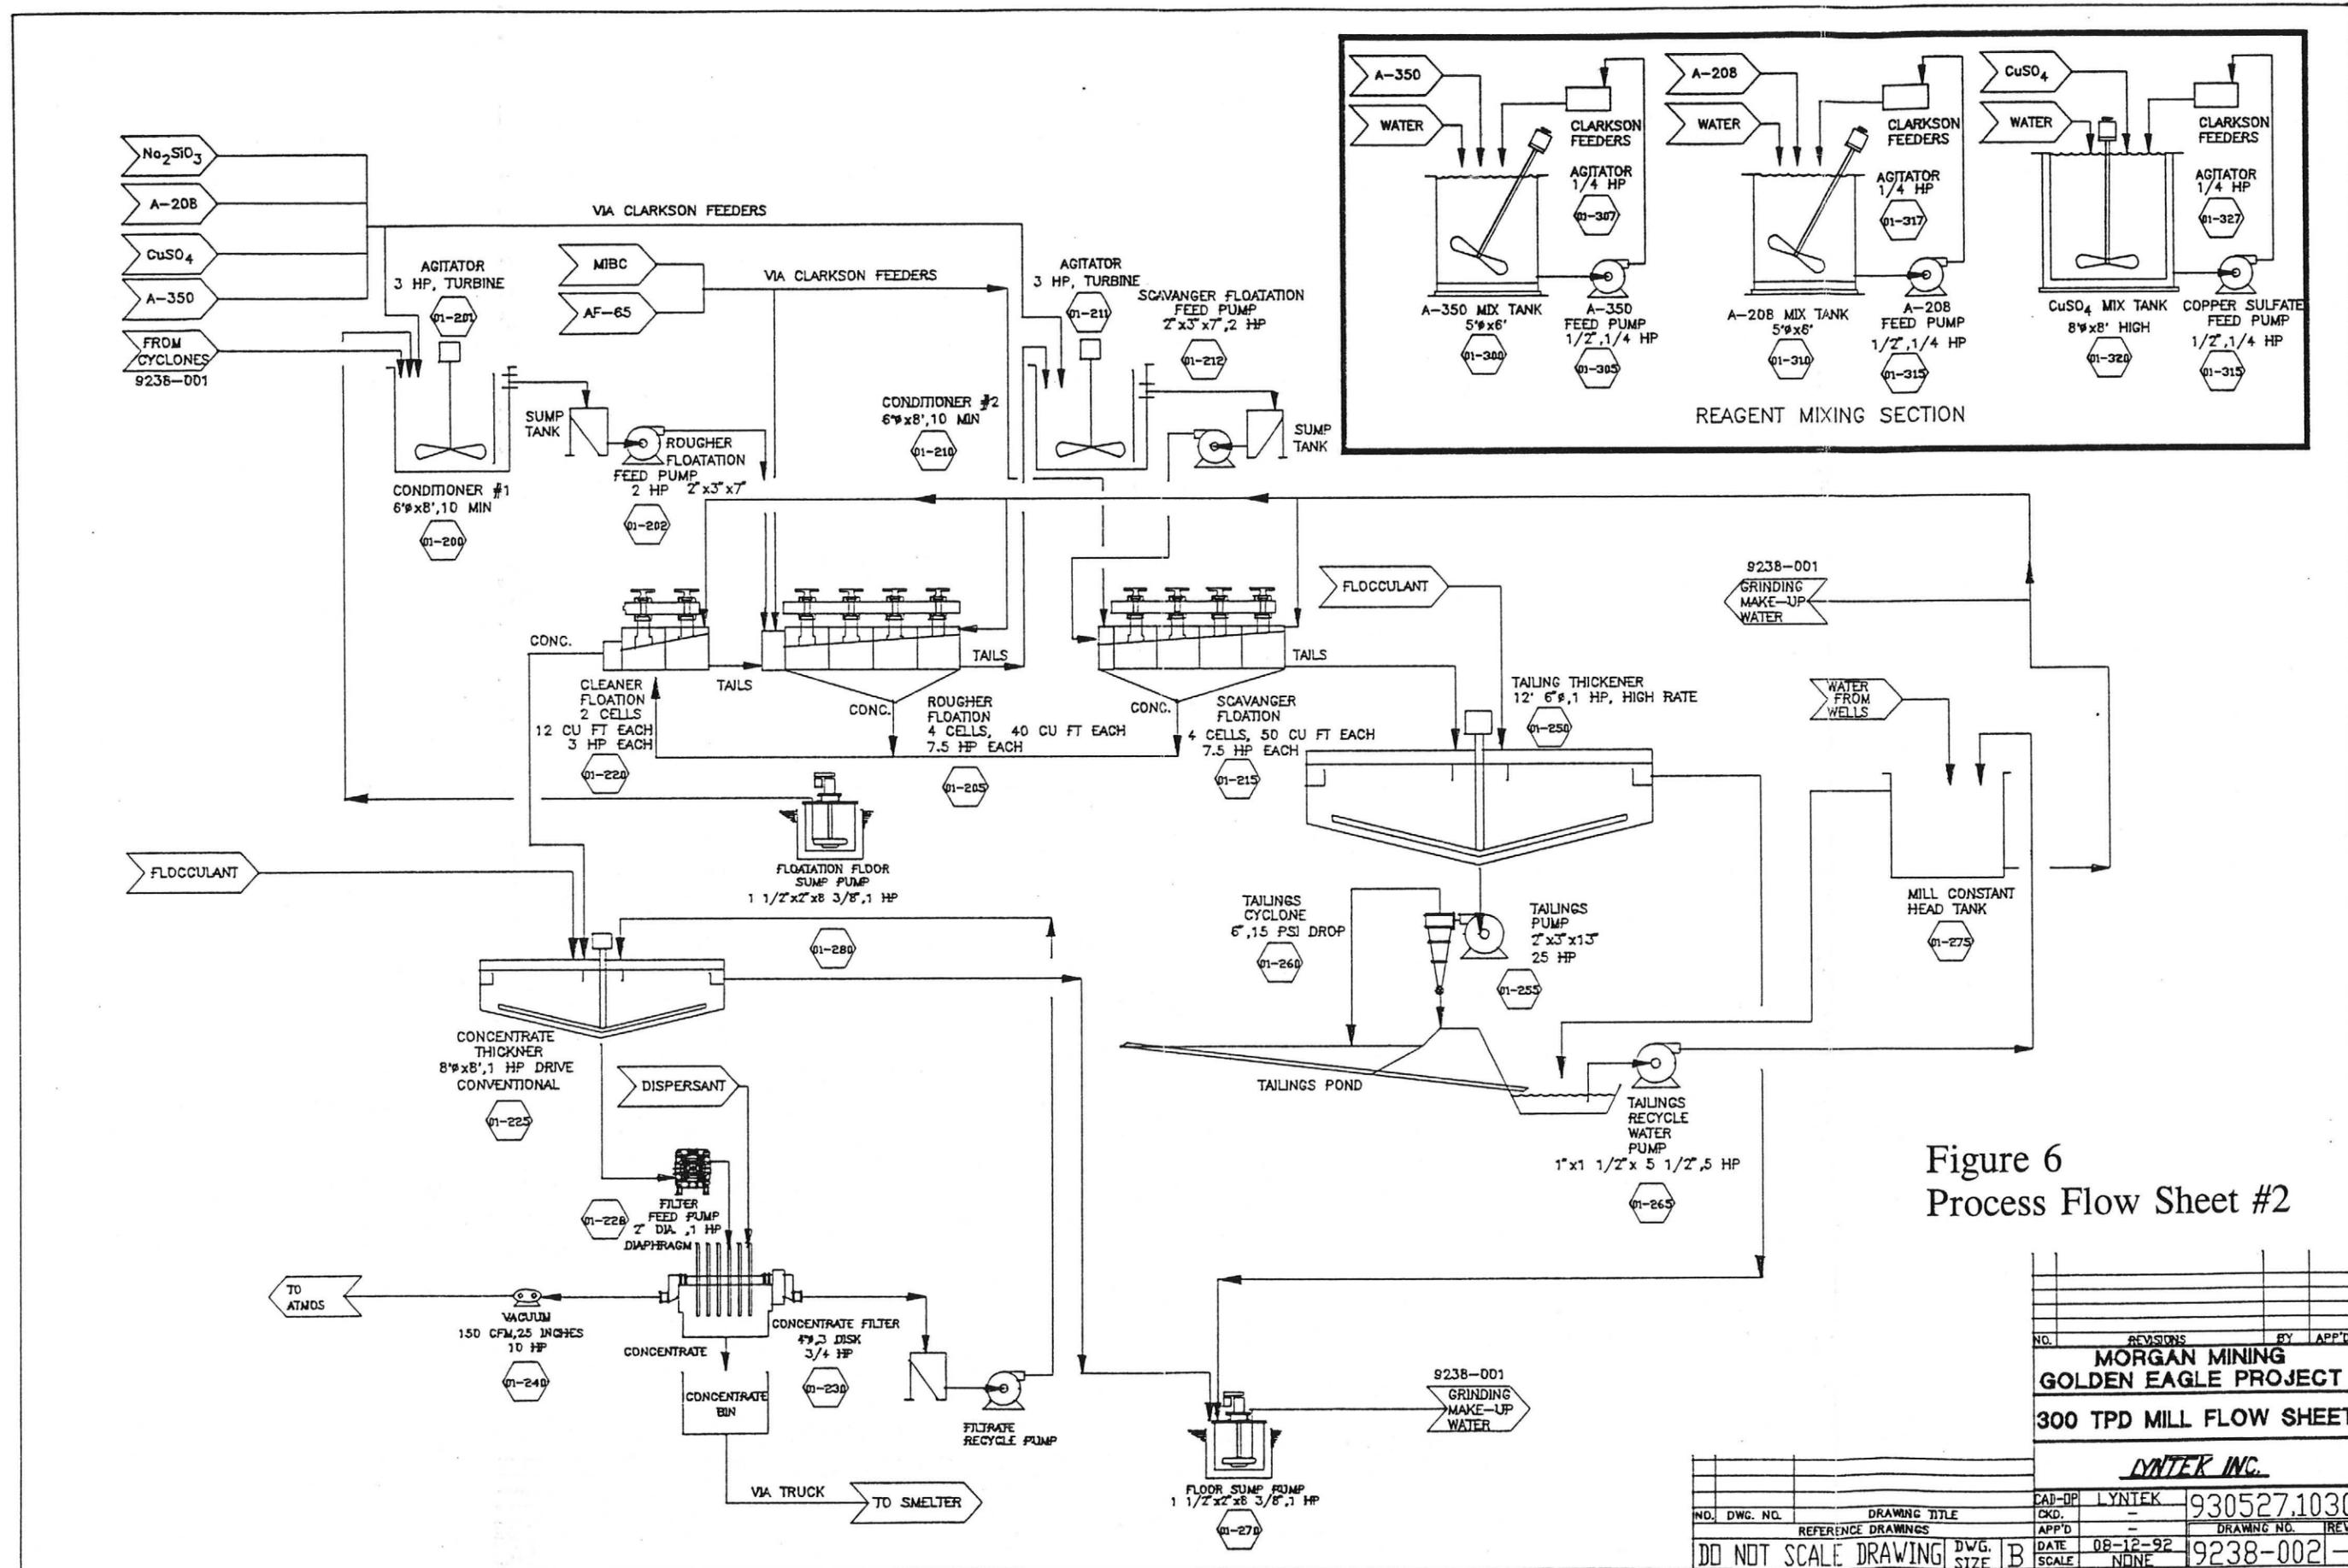
Figure 6
Process Flow Sheet #2

REVISIONS			
NO.	DESCRIPTION	BY	APP'D
MORGAN MINING GOLDEN EAGLE PROJECT 300 TPD MILL FLOW SHEET			
LYNTEK INC.			
CAD-DP	LYNTEK	930527.1030	
CKD.			
APP'D		DRAWING NO.	REV.
DATE	08-12-92		
SCALE	NONE	9238-002

Flotation will be accomplished in standard cell to cell machines producing a rougher concentrate from the bulk feed. The rougher tailing will be subjected to scavenger flotation to remove residual values prior to transport to the tailings impoundment area. Water in excess of that needed to transport the tailings will be removed by a thickener prior to the tailings being pumped via pipeline to the impoundment area. The tailing pipeline will be enclosed in a secondary containment pipe to control potential leaks or spills. Figure 6, Process Flow Sheet #2, details the flotation and tailings section of the processing plant.

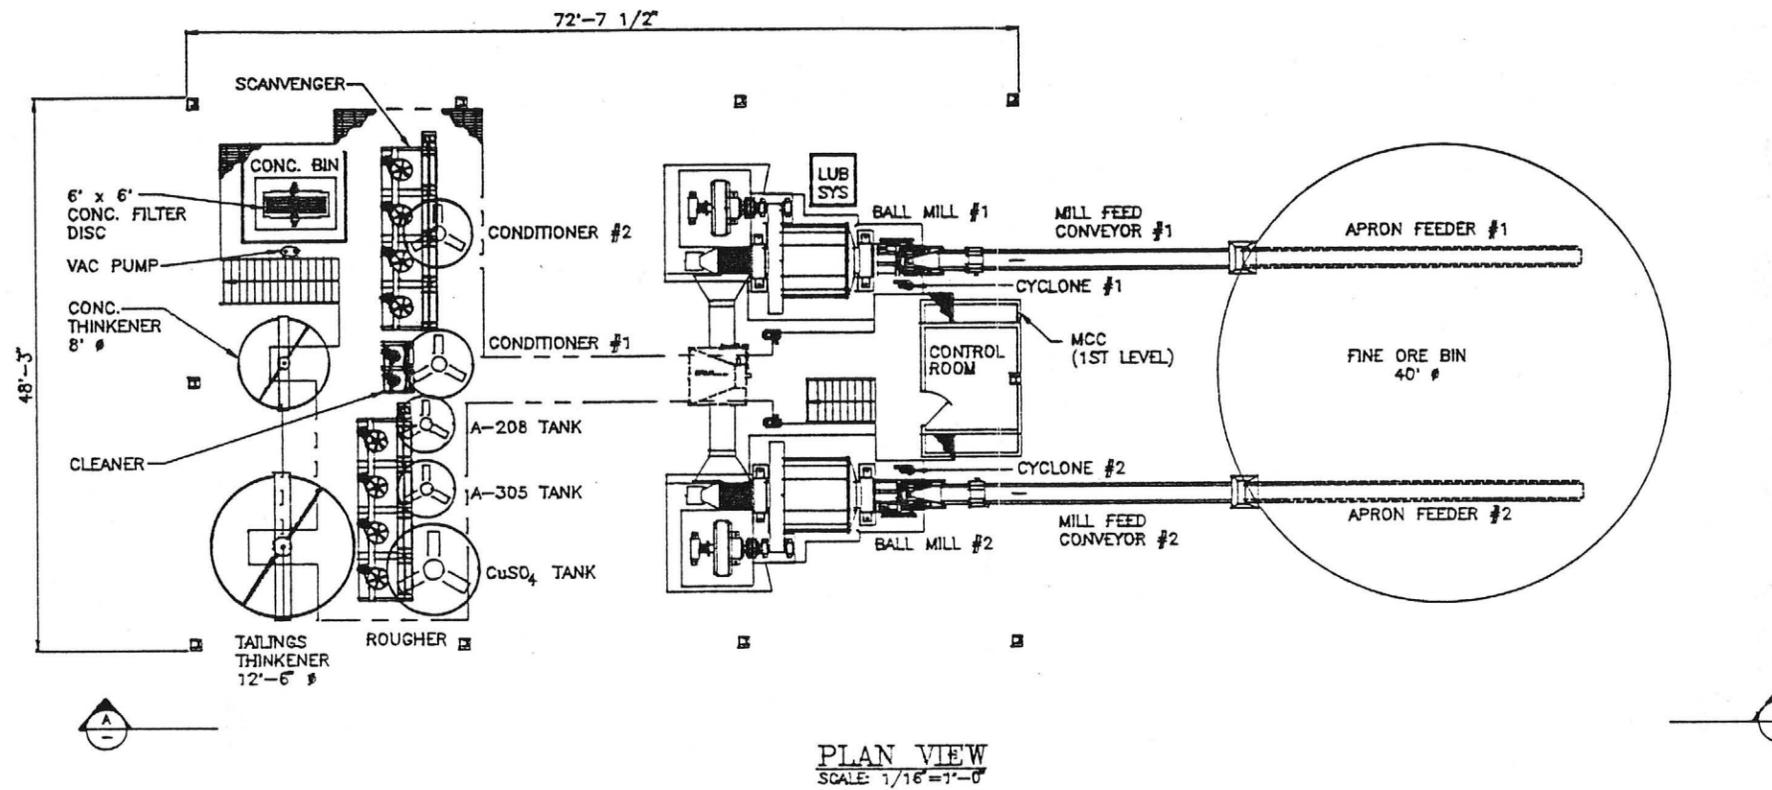
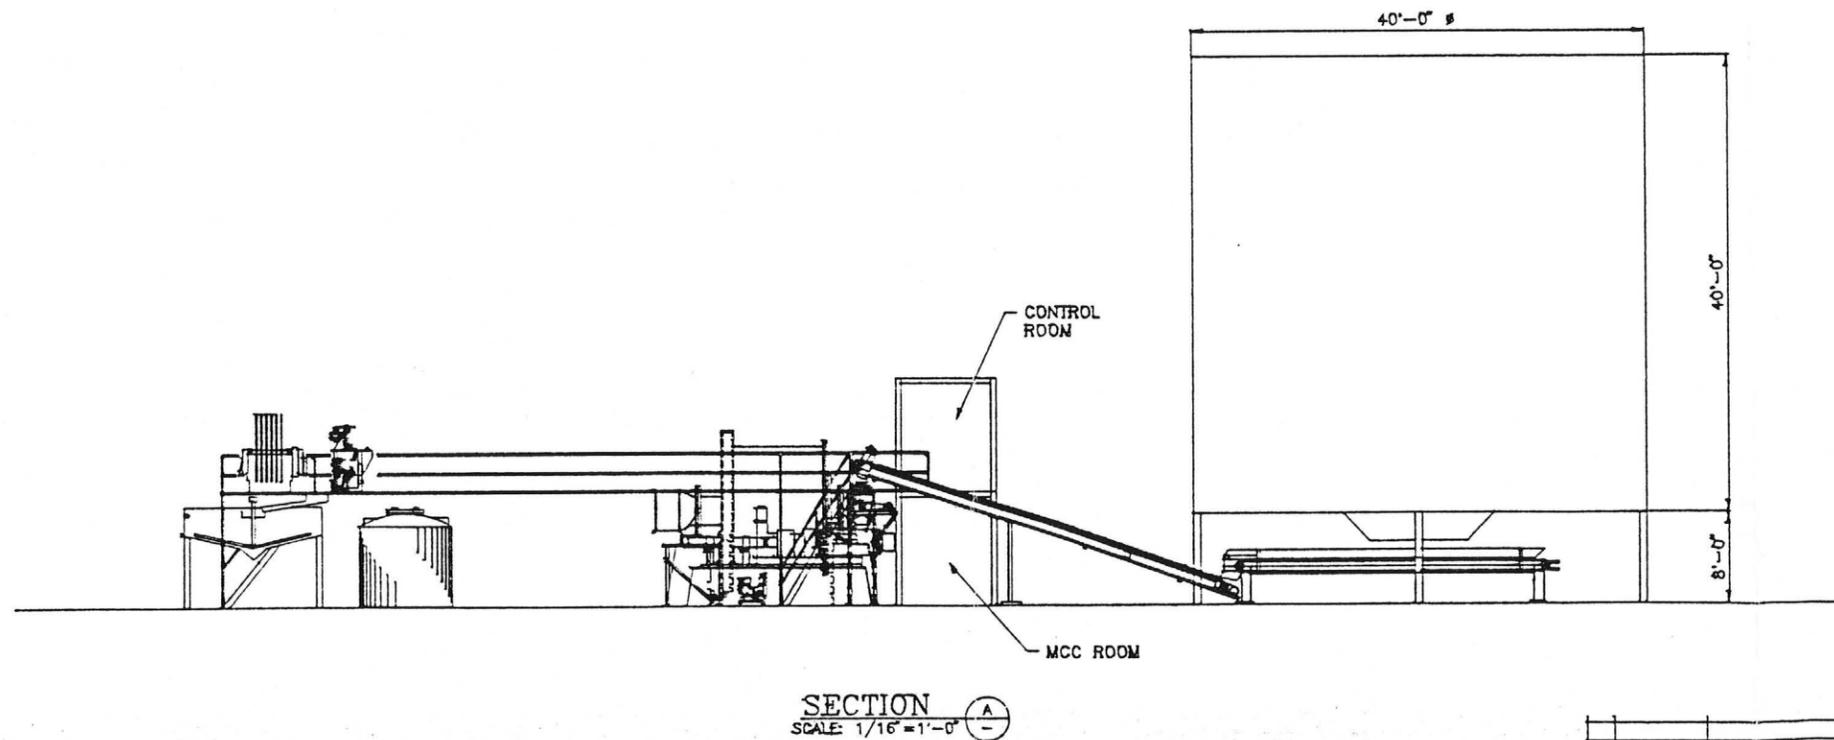
Figure 7
General Arrangement

NO.	REVISIONS	BY	APP'D.
MORGAN MINING GOLDEN EAGLE PROJECT			
MILL BUILDING G.A.			
LYNTEK INC.			
CAD-DR	LYNTEK	930527.1100	
CKD.	-	DRAWING NO.	
APP'D	-	DATE	REV.
DO NOT SCALE DRAWING		DWG. SIZE B	DATE 11-24-92
		SCALE 1/16" = 1'-0"	9238-003-

Figure 3 is a site plan showing the general layout of the proposed project. Figures 5 and 6 are flow charts of the above processes. Figure 7 is a general arrangement of the processing facilities. MMC intends to utilize a contract mining company for the mining portion of that operation. MMC will operate the process plant.
