**ARIZONA DEPARTMENT OF
ENVIROMANTAL QUALITY**

I am pleased to submit on behalf of Morgan Mining Company the Aquifer Protection Permit Application for the *Golden Eagle Mine, Mohave County*. The Aquifer Permit Application, ADEQ Water Unit Form APP 1, is included in the application document. Supplementary information for the Application can be found in Attachments 1 - 12. Drawings and supporting documentation in the form of third party consultant reports are included as Exhibits A and B.

**Tailings Impoundment,
Spill Containment and Leak Detection
Monitoring Program
Closure**

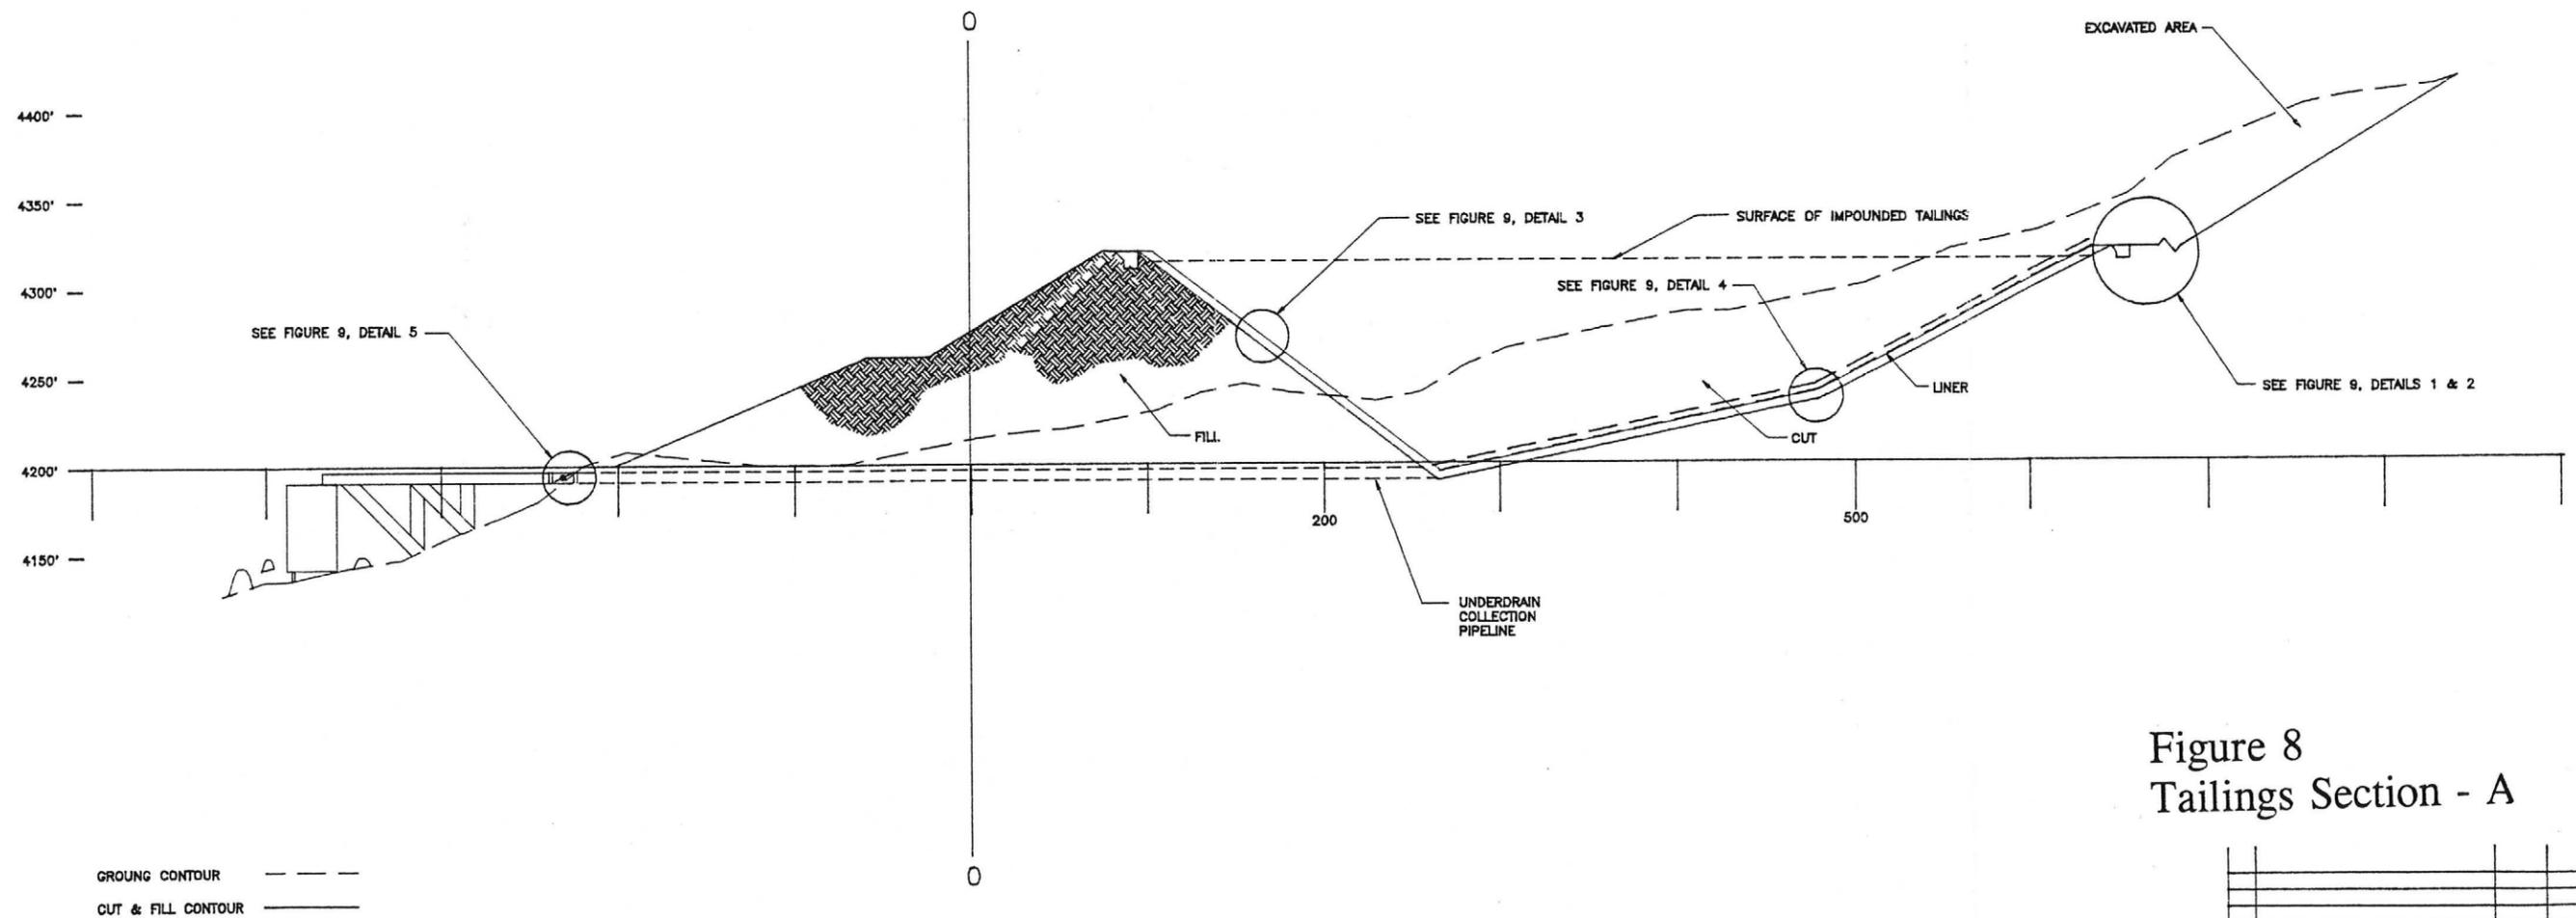
**Figure 8
Tailings Section - A**

GROUND CONTOUR - - - -
CUT & FILL CONTOUR - - - -

Perforated pipe will be placed on top of the HDPE liner to deliver water draining through the impounded tailings to a recycle water collection tank at the toe of the main dam (Figure 8, Tailings Section - A). The reclaimed water will then be pumped from the recycle water collection tank back to the processing facility in a lined corridor or within a secondary containment pipe.

The tailings impoundment site will be stabilized and allowed sufficient time to dry to permit safe access by heavy equipment. The surface will then be capped with available coversoil (Figure 8, Tailing Section - A). Coversoil will be placed on the face of the tailings dam as availability permits. Vegetation will be transplanted from the nearest site to those areas receiving coversoil.

The water will be reclaimed through an underdrain that will be placed in the bottom of the valley within the tailings disposal area as shown on Figure 4 and Figure 8, Detail 8. The reclaim water collection line will be perforated and wrapped with non-woven geotextile of high hydraulic conductivity and covered in gravel. Water that pools against the perimeter farthest from the dam crest as well as water that seeps out of the emplaced tailings, will be allowed to flow into the line through the geotextile and gravel blanket to be collected in the recirculation tank located below the dam.
