ARIZONA DEPARTMENT OF MINES AND MINERAL RESOURCES AZMILS DATA

PRIMARY NAME: MOONLIGHT MINE

ALTERNATE NAMES:  
GEORGIA BELLE

SANTA CRUZ COUNTY MILS NUMBER: 134

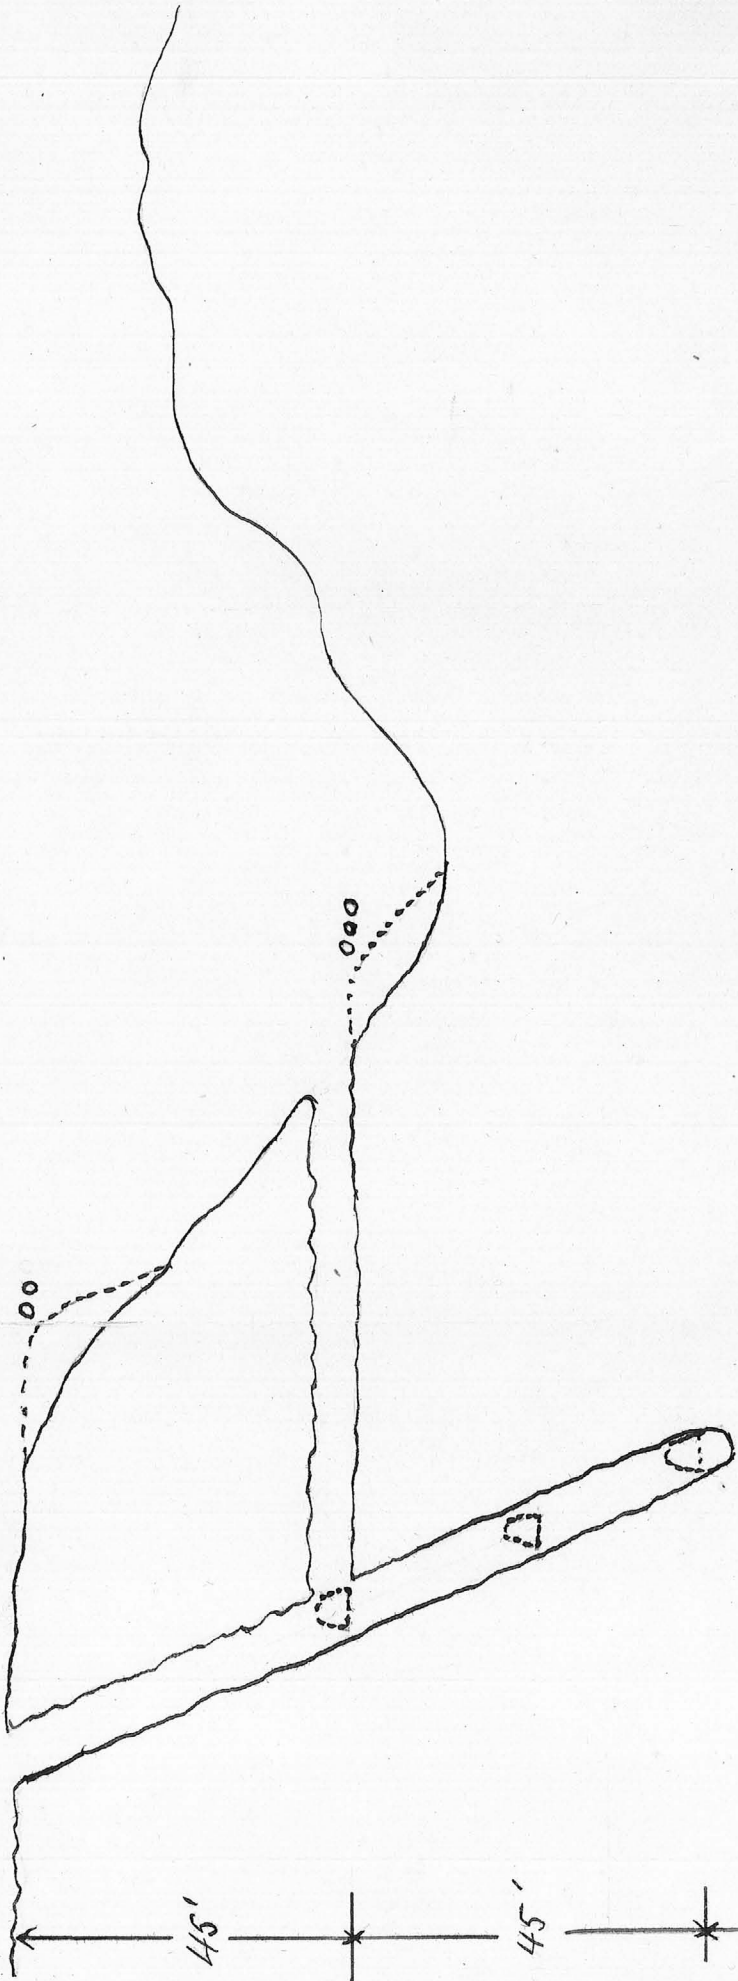
Moonlight Claim.

Section Looking N.W.

22. Mine Workings: Amt. & Condition Approximately 200 ft. of development work has been done,  
nearly all on the lode. Attached sketches show the distribution of this work and  
the location of proposed further development. All workings are open for inspection  
and sampling.

22. Mine Workings: Amt. & Condition Approximately 200 ft. of development work has been done, nearly all on the lode. Attached sketches show the distribution of this work and the location of proposed further development. All workings are open for inspection and sampling.
