ARIZONA DEPARTMENT OF MINES AND MINERAL RESOURCES AZMILS DATA

PRIMARY NAME: PROSPERITY GROUP

BIBLIOGRAPHY:
ADMMR PROSPERITY GROUP MINE FILE

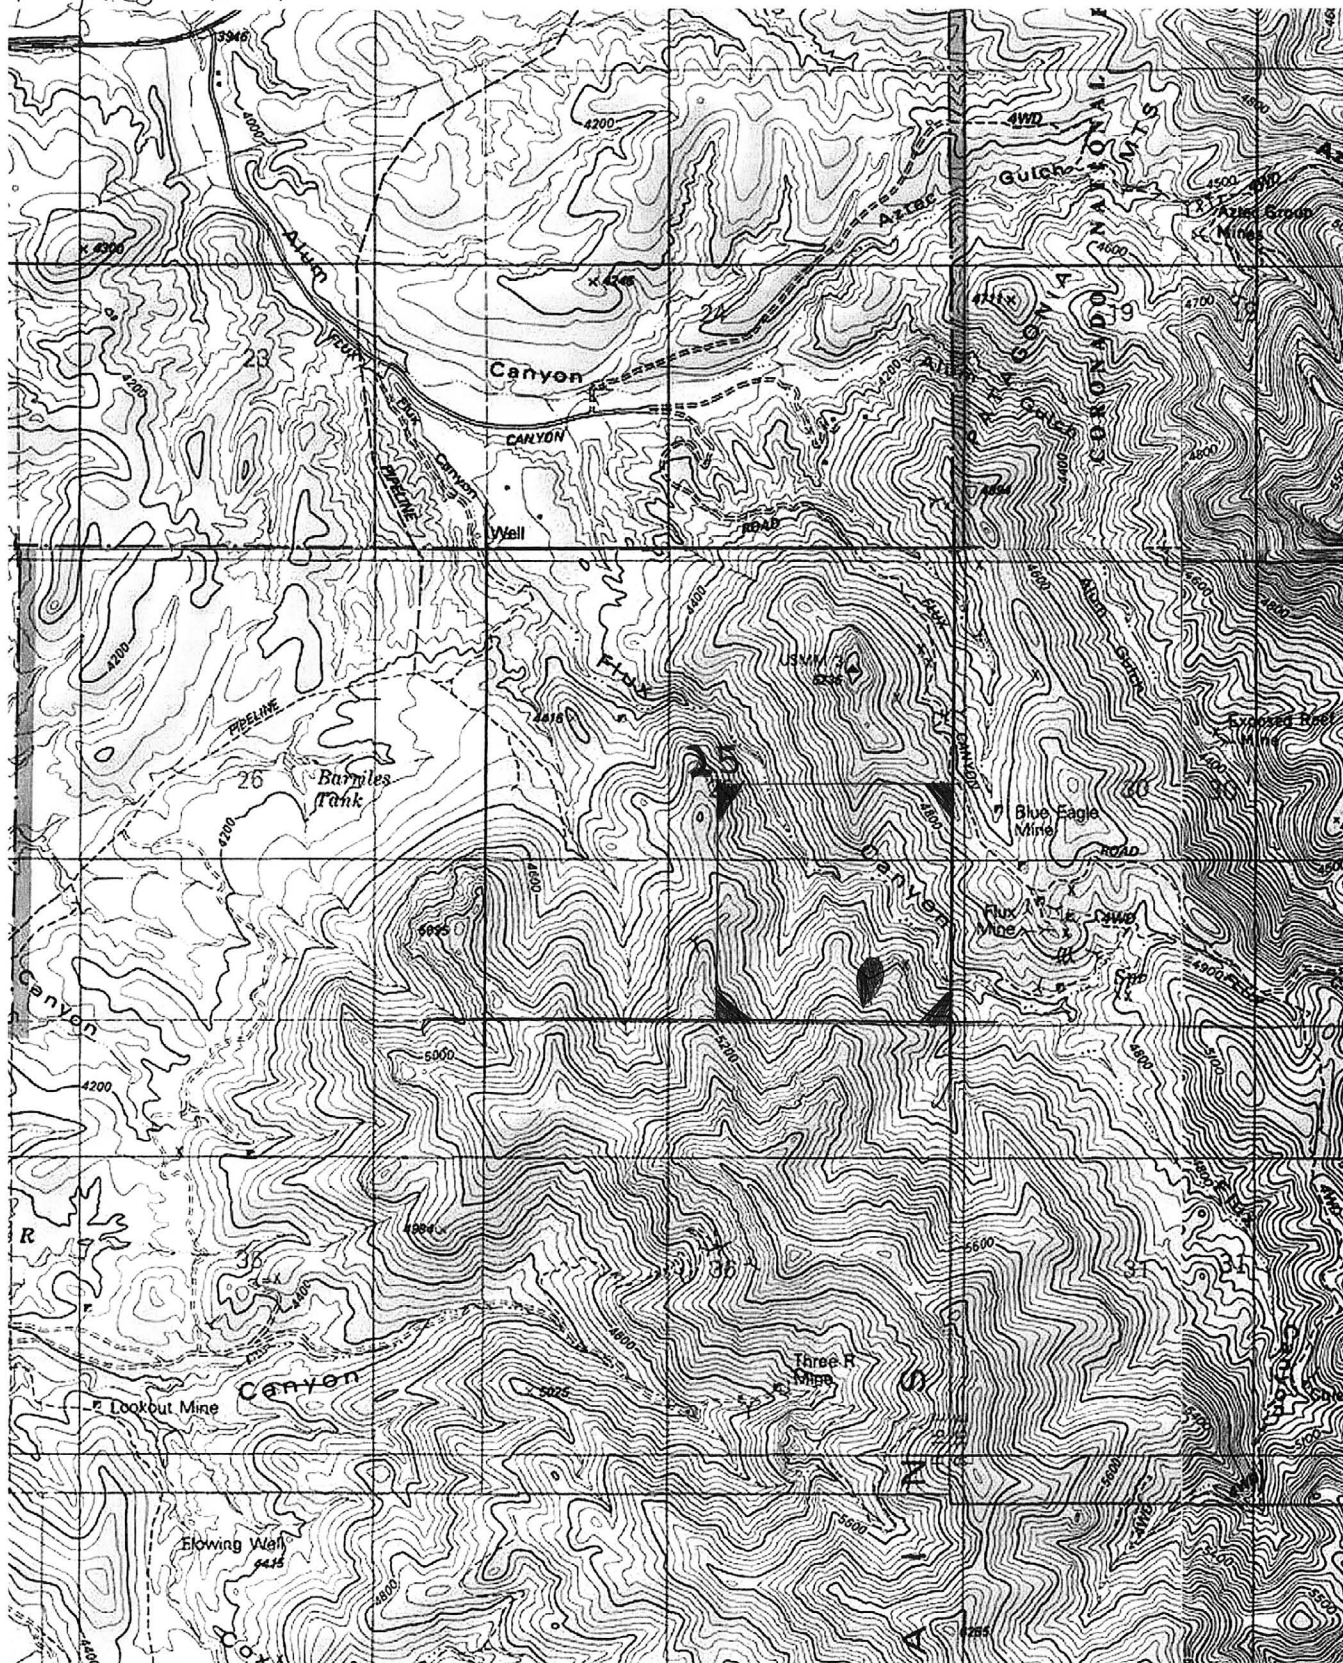
N 31 29' 10" W 110 45' 41"
Prosperity Group

Having been on the property I made a couple of sketches which were intended to clarify the underground workings and through accident this one did not get replaced in the docket.

22. Mine Workings: Amt. & Condition *Tunnel 350ft to vein and
700' drift on vein. Winze 100' from portal
110' deep with station on 100' level. 75' Xcut
toward vein which is dipping to north about 75°*
