PLAN BY PIMA CO. ENGR. OFFICE

SOIL & ROCK CLASSIFICATION SKI RUN ROAD R-AD-18(1)	
FOR PIMA CO. HIGHWAY DEPT.	
Scale	Date APRIL 1967

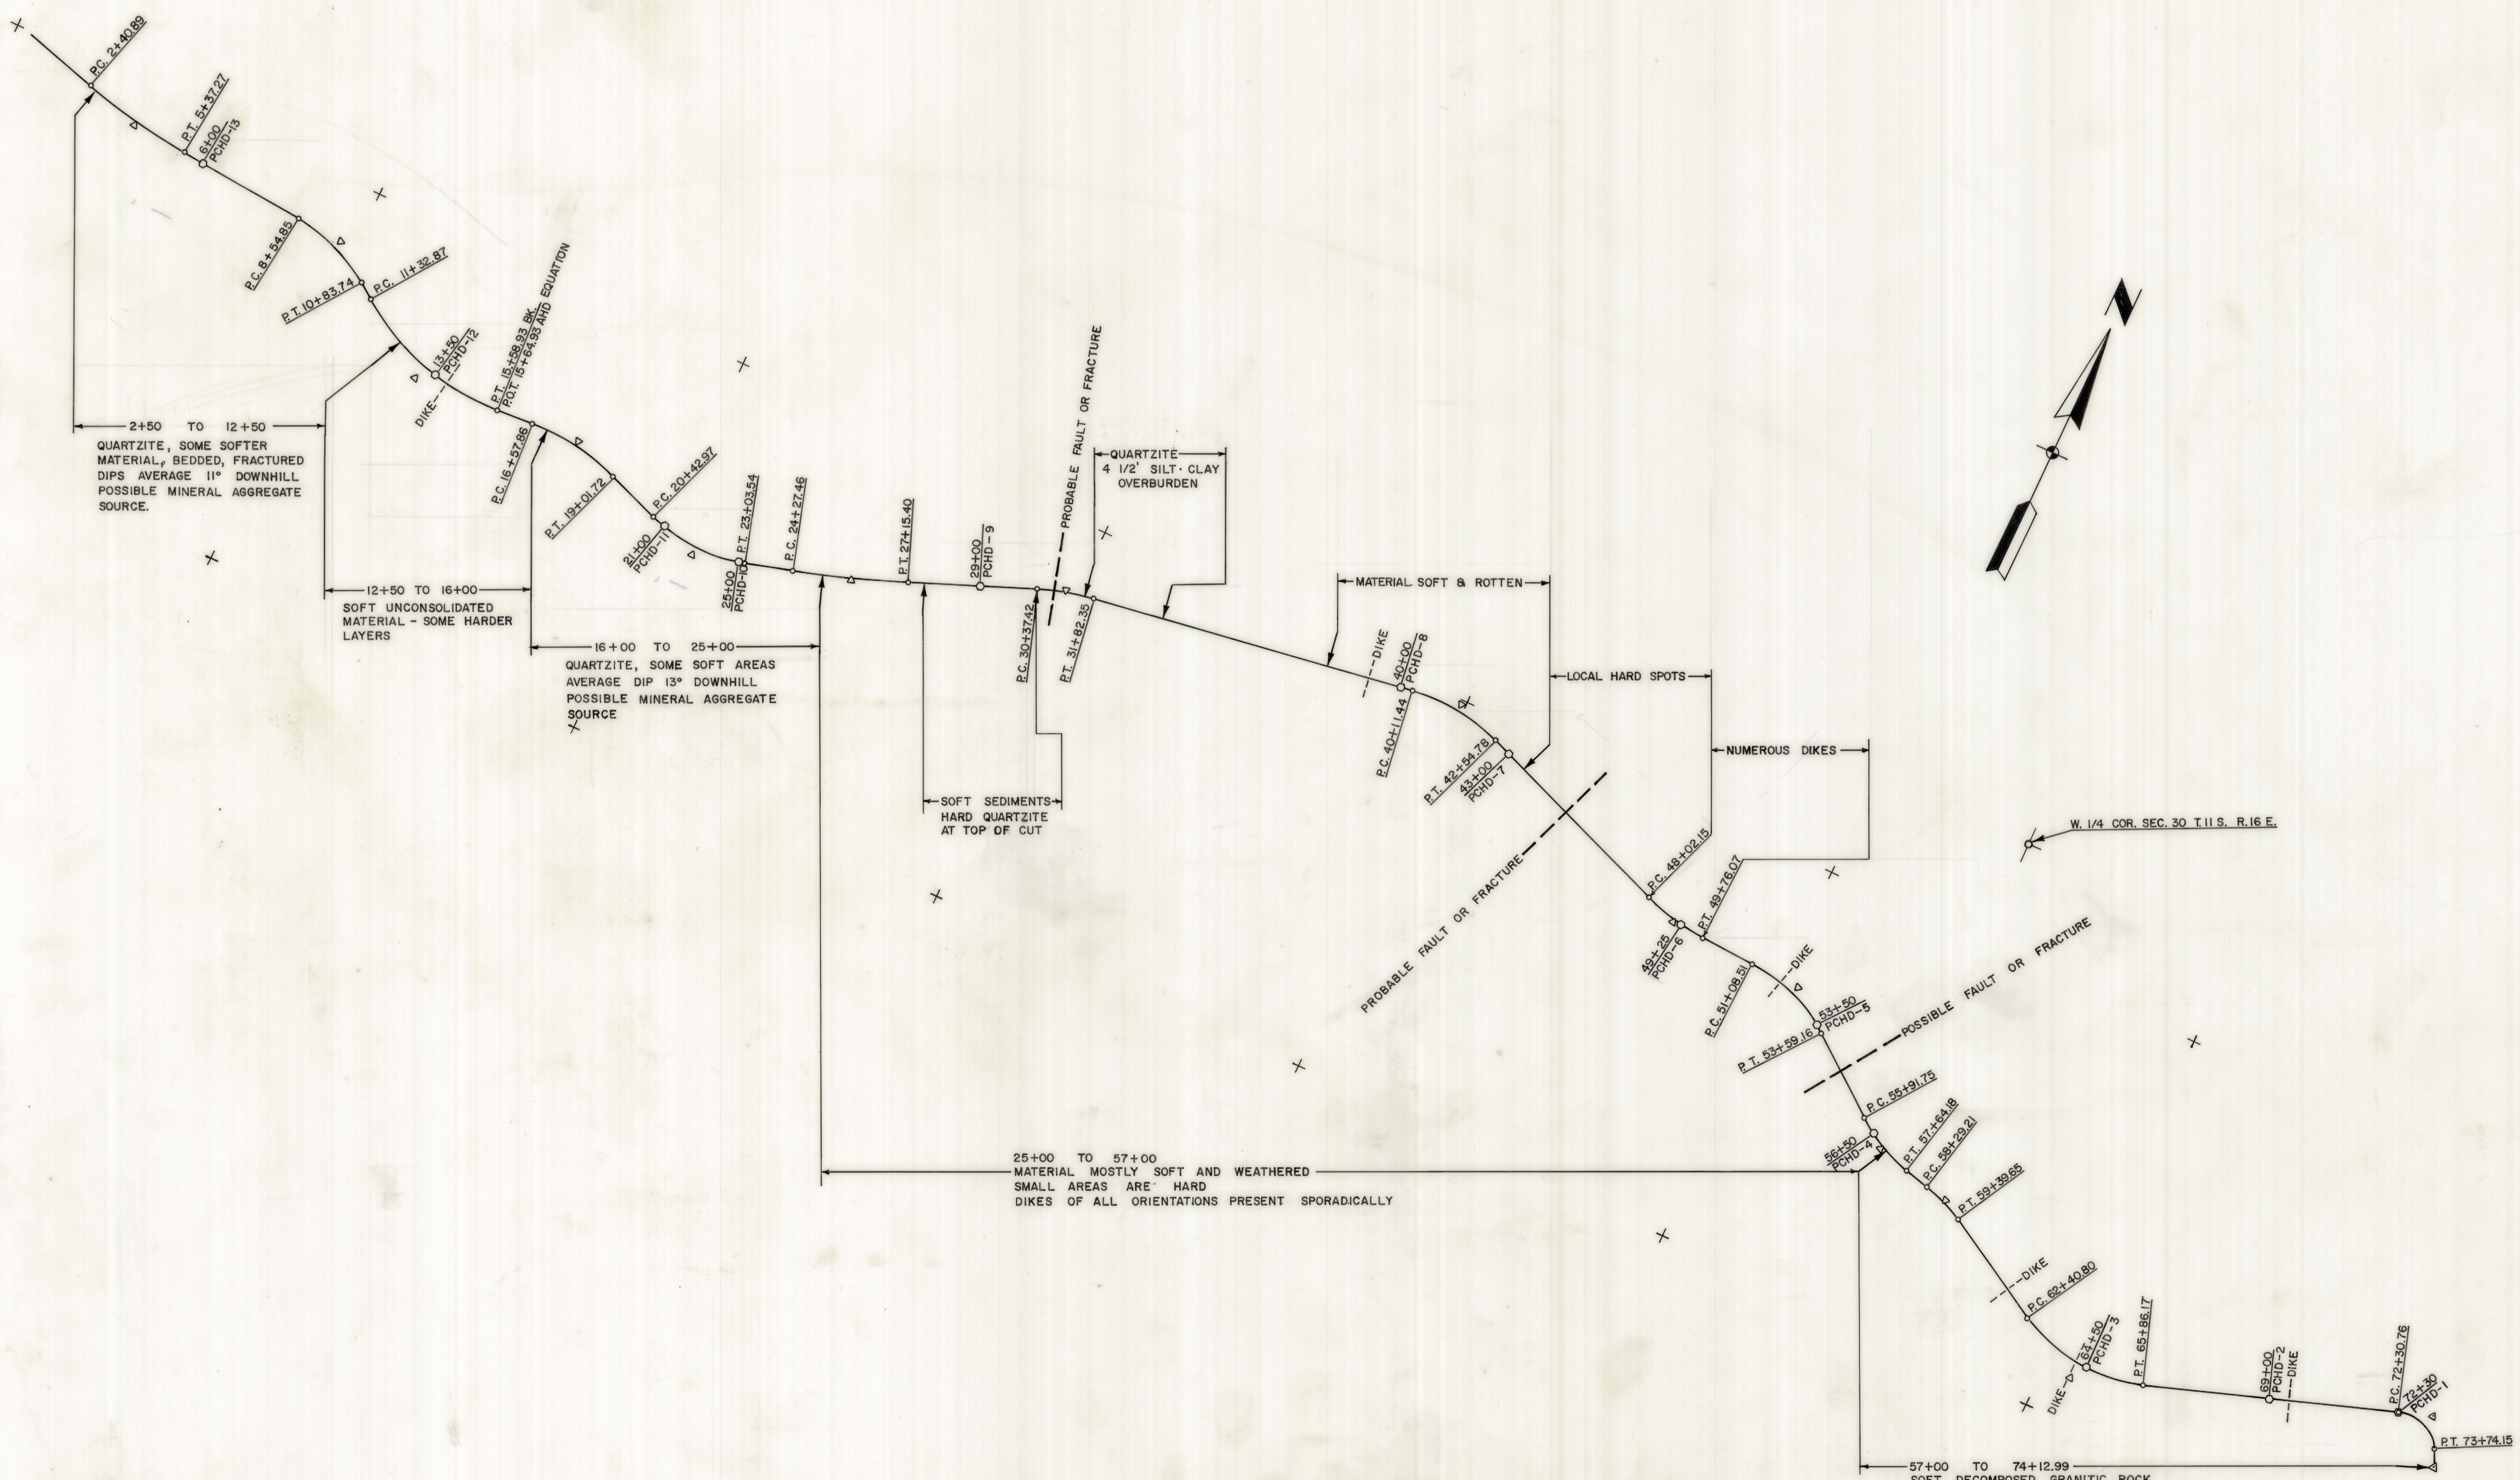
2+50 TO 12+50
 QUARTZITE, SOME SOFTER MATERIAL, BEDDED, FRACTURED DIPS AVERAGE 11° DOWNHILL. POSSIBLE MINERAL AGGREGATE SOURCE.

12+50 TO 16+00
 SOFT UNCONSOLIDATED MATERIAL - SOME HARDER LAYERS

16+00 TO 25+00
 QUARTZITE, SOME SOFT AREAS AVERAGE DIP 13° DOWNHILL. POSSIBLE MINERAL AGGREGATE SOURCE

SOFT SEDIMENTS - HARD QUARTZITE AT TOP OF CUT

25+00 TO 57+00
 MATERIAL MOSTLY SOFT AND WEATHERED. SMALL AREAS ARE HARD. DIKES OF ALL ORIENTATIONS PRESENT SPORADICALLY.

57+00 TO 74+12.99
 SOFT DECOMPOSED GRANITIC ROCK. PEGMATITE DIKES 1' TO 20' THICK

o 53+50 SAMPLE LOCATION
 PCHD-5
 OVERALL SHRINK ESTIMATED 10%
