PLATE 3
ORIZABA MINE
 MARICOPA COUNTY, ARIZONA
 GEOLOGIC AND GEOPHYSICAL DATA
 COMPILATION MAP

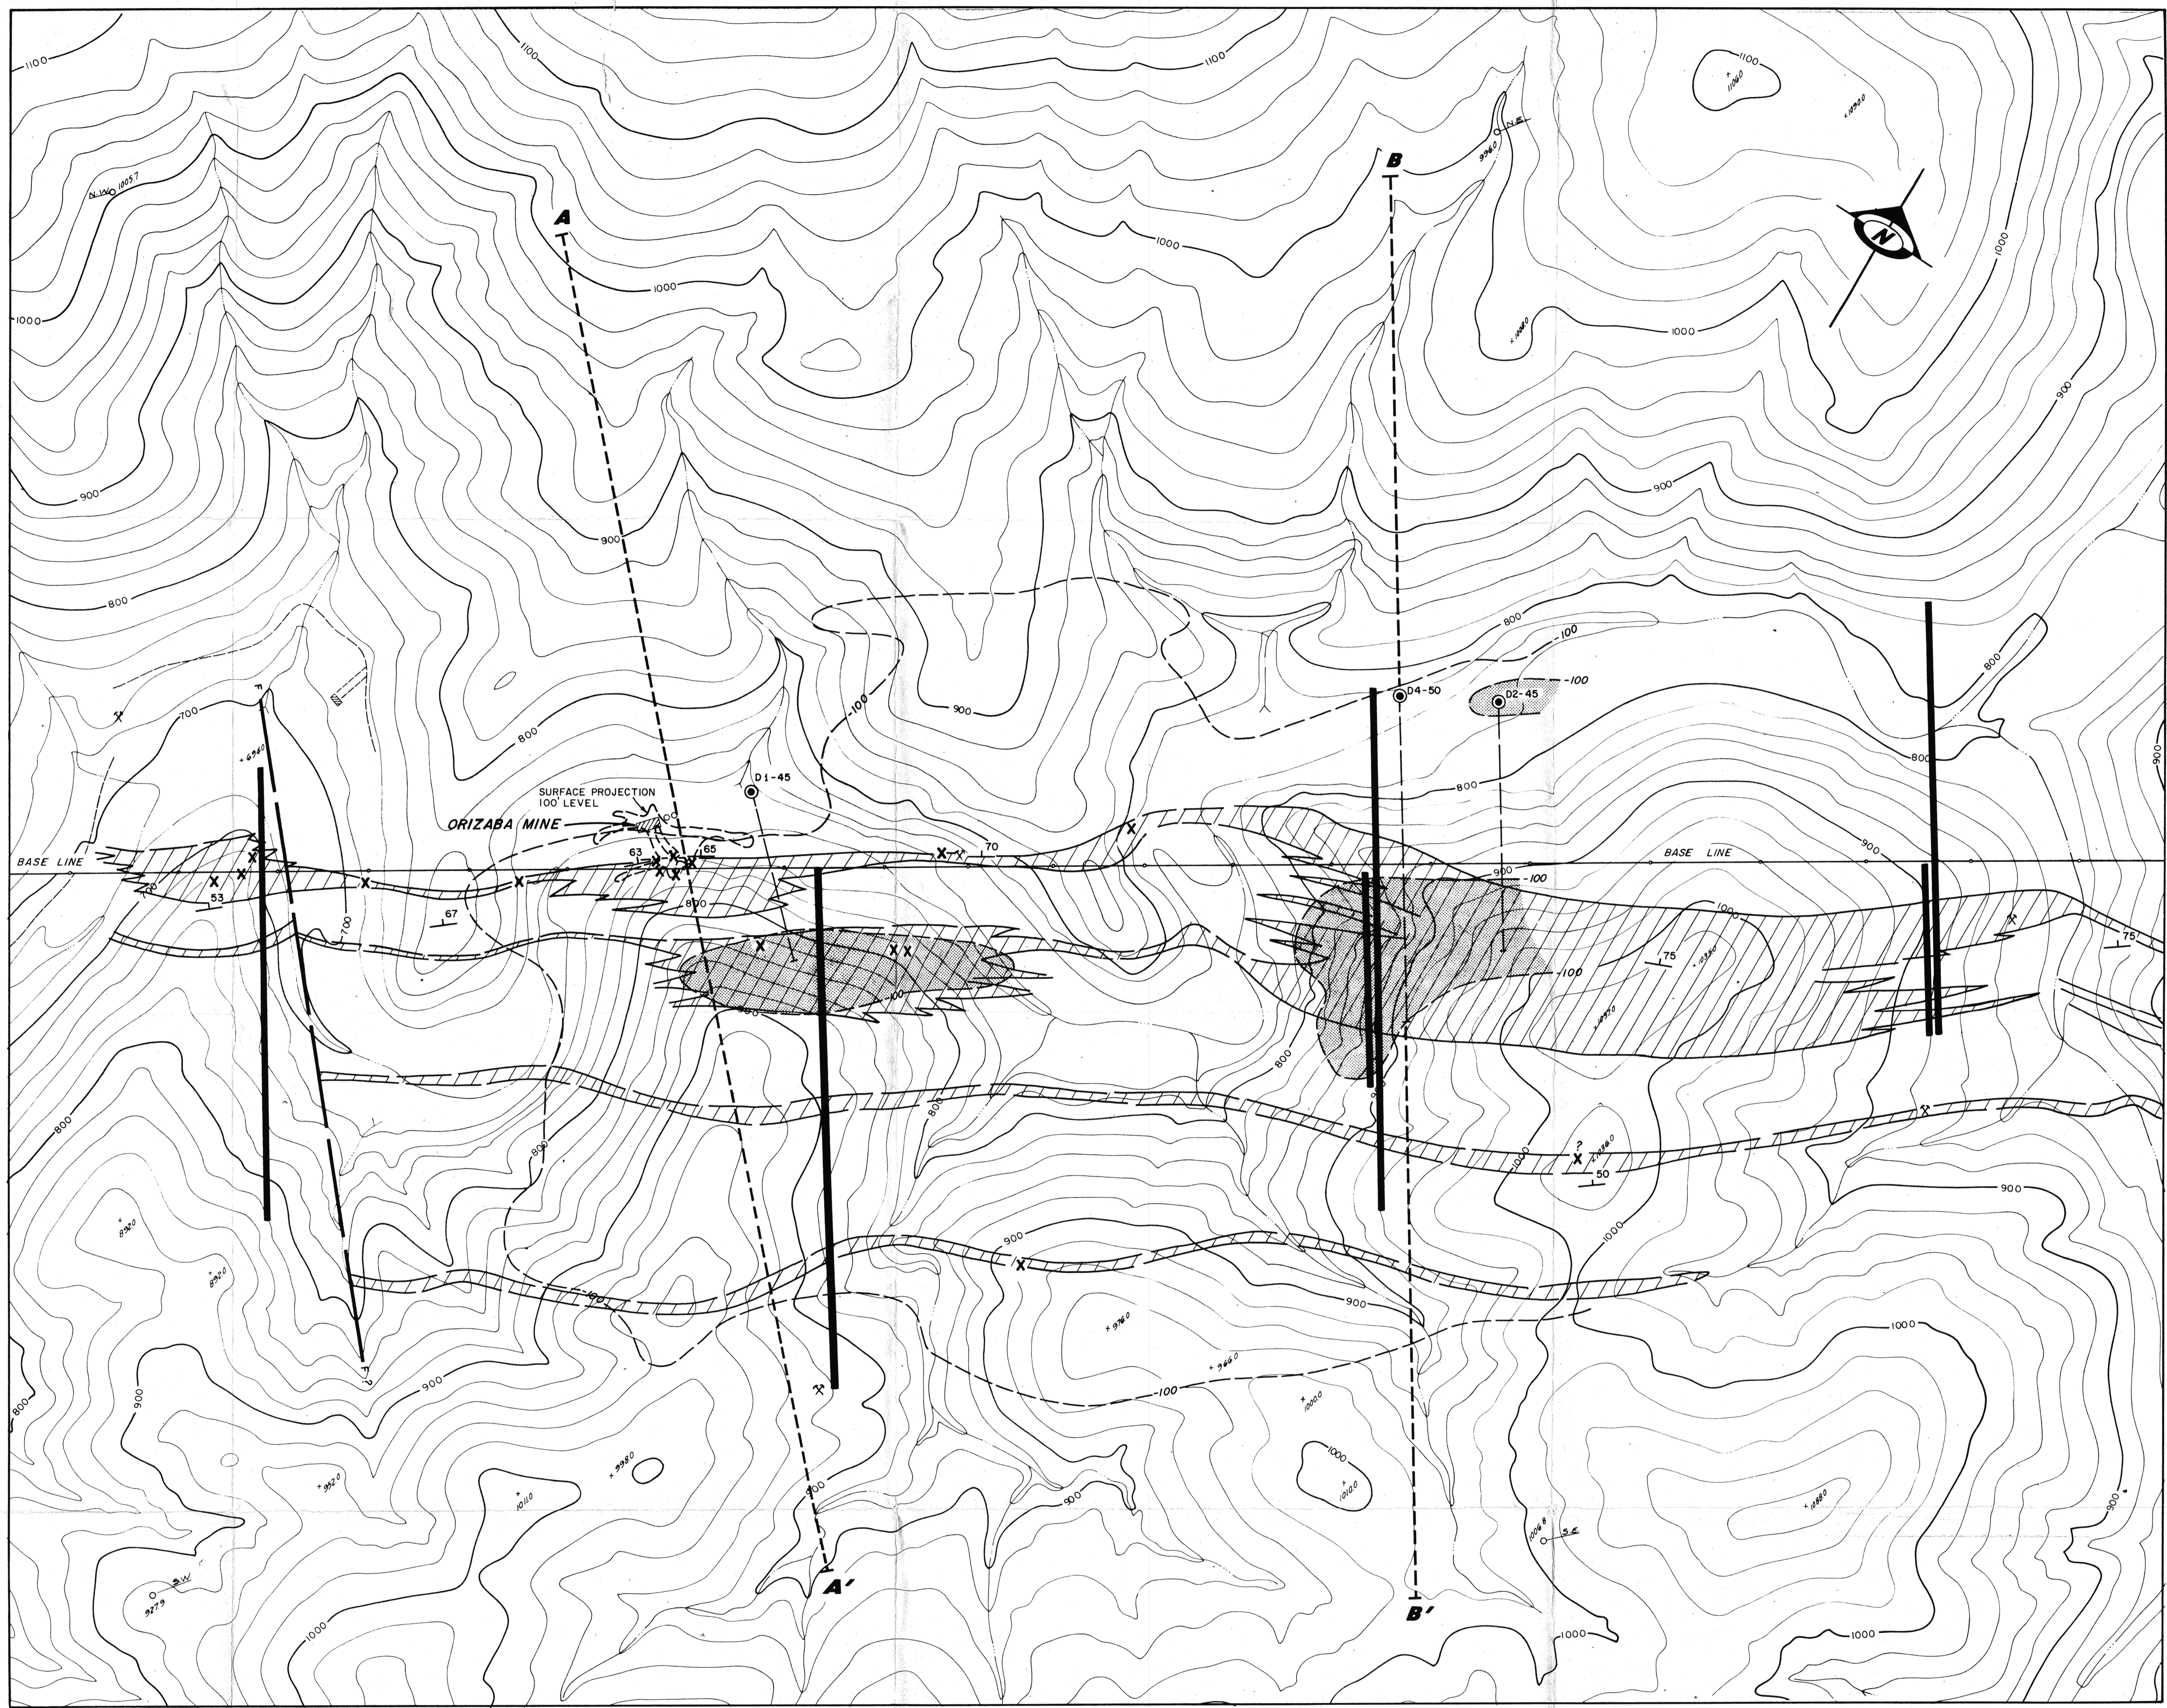
I.P. ANOMALY
-

S.P. ANOMALY
-

COPPER SHOWINGS (Malachite)
-

FAULT
-

UNDERGROUND WORKINGS
-

ZONES OF SURFACE IRON STAINING
