3rd Level  
L.P.?

ANWR  
B310-008

1" = 50 FT (?)  
Lucky Cuss Mine

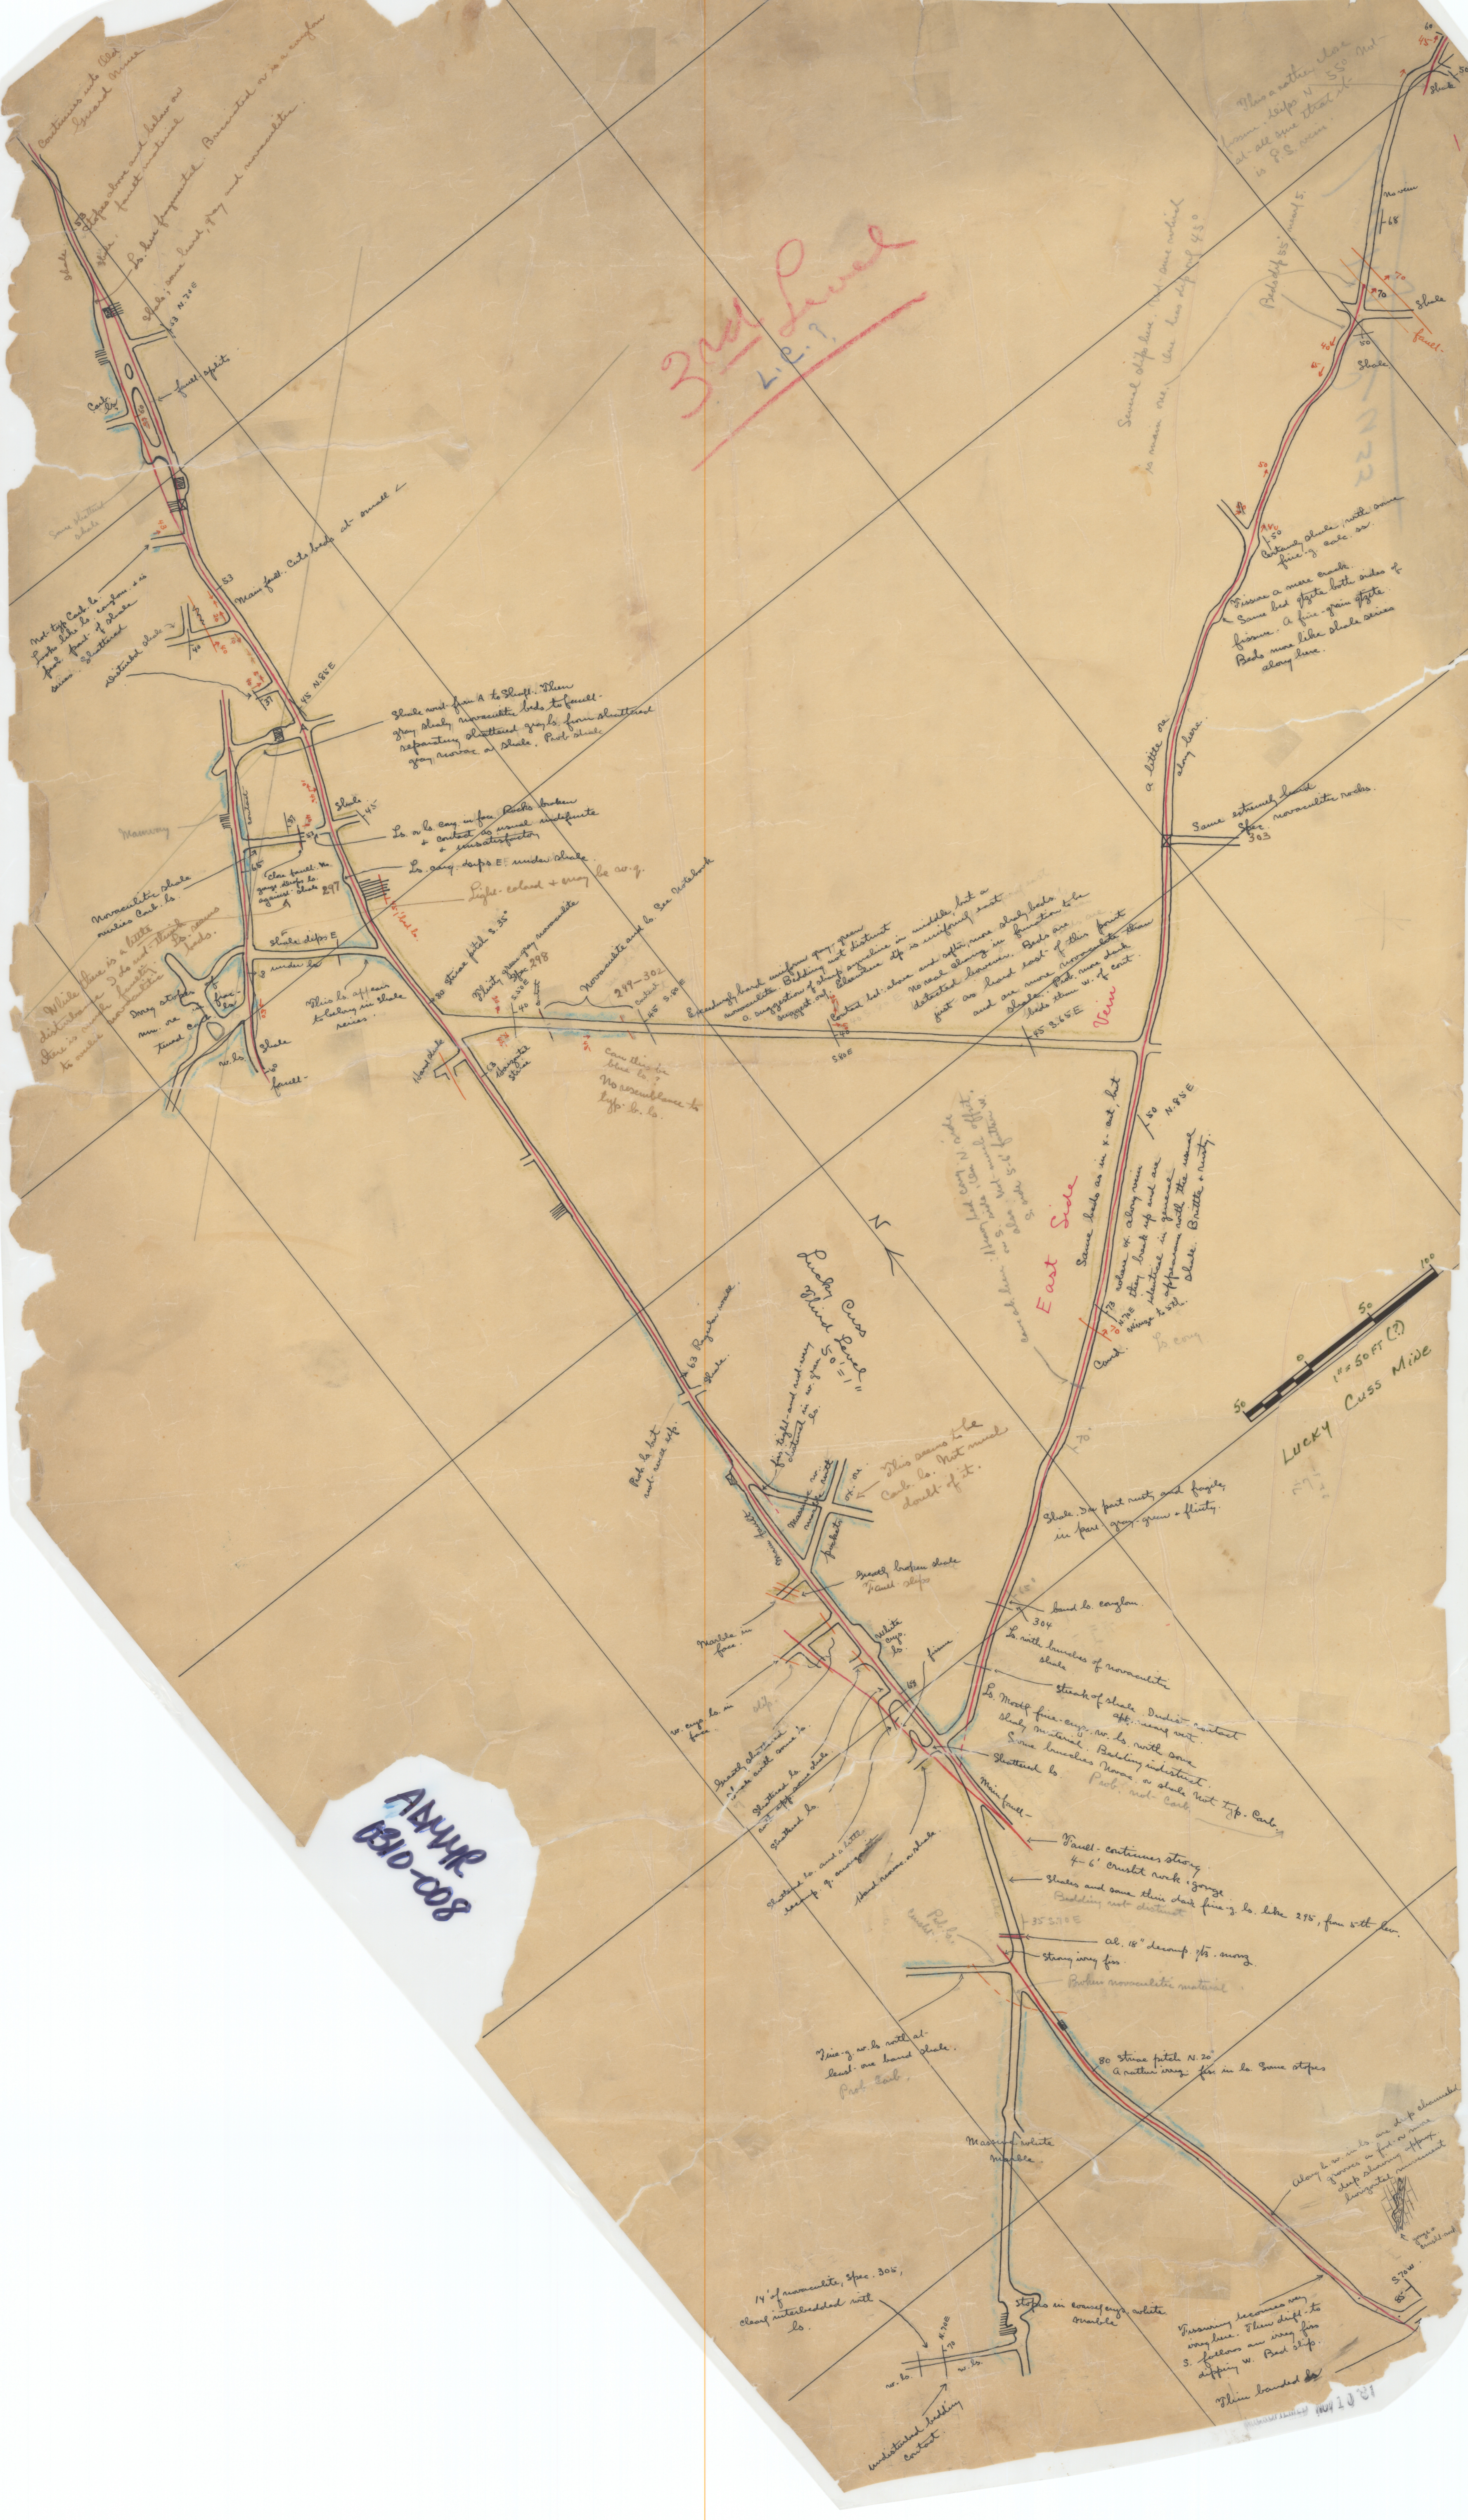
14' of marlstone, spec. 305,  
clear interbedded with  
ls.

Transition becomes very  
irregular. Thin drift to  
S. follows an irregular  
dipping w. road slip.  
Thin bedded ls.

Along ls. in hills are deep channels  
formed in fine ls. some  
deep showing of  
horizontal movement

Massive white  
marble

Thin ls. with at  
least one hard shale.  
Prob. ls.

80' fine pitch N. 20°  
Another irreg. fiss in ls. some steps

at 15" drop 7/8' irreg.  
strong irreg. fiss

Basal marlstone material

4-6' crustal rock + gouge  
shales and some thin chert fine-g. ls. like 295, from 5th lev.

shale. In part rusty and flinty  
in part gray-green + flinty.

band ls. conglon.  
304  
Ls. with laminae of marlstone  
shale

streak of shale. Dishes contact  
shaly material. Building indistinct  
Some laminae have a shale not typ. Carb.

shattered ls. Prob. not Carb.

shattered ls. and a little  
shaly of marlstone
