CHRISTMAS PROJECT 1419

Fig. 39. MUDD DIAMOND DRILL HOLE 57-A

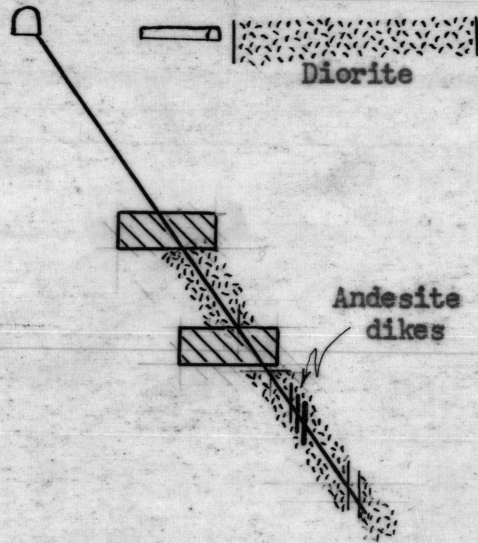
Footage	% Recovery		% Copper		
	Core	Sludge	Core	Sludge	Accepted
100 - 110	30			1.03	
110 - 117				3.13	3.13
117 - 124	3	178	3.30	1.91	1.93
124 - 125				2.95	2.95
125 - 126				4.52	3.23
126 - 129	100		0.90		2.22
129 - 129.3				2.94	2.51
129.3-132	63		1.00	2.95	2.51
132 - 133					
134 - 141	44		0.40		
184 - 189	0			2.52	2.52
189 - 194	3		0.10	1.85	1.83
194 - 199	30		5.30	2.15	2.49
199 - 204	10		2.90	2.27	2.29
204 - 209	13		1.00	2.78	2.70
227 - 235				0.41	
235 - 237				0.62	
237 - 242				0.20	
242 - 248				0.41	
284 - 288				1.44	
288 - 292				1.03	
292 - 293				0.71	
293 - 295				1.03	
295 - 299				0.92

Coordinates: 7207 north  
5973 east  
Elevation: 2313.0  
Bearing: South 45 east  
Dip: Minus 55  
Depth: 299  
Size hole: EX
