CHRISTMAS PROJECT 1419

Fig. 40 . MUDD DIAMOND DRILL HOLE 57-B

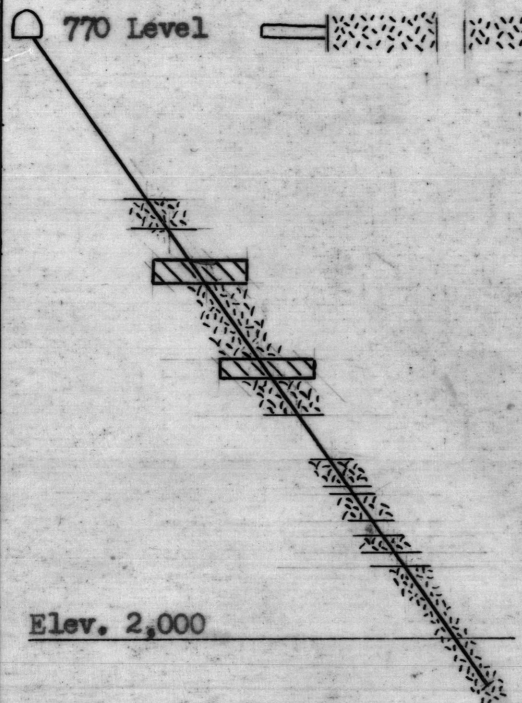
Coordinates: 7207 north
5964 east
Elevation: 2313.0
Bearing: South 36 west
Dip: Minus 55
Depth: 411
Size hole: EX

Ore blocks

Footage	% Recovery		% Copper		
	Core	Sludge	Core	Sludge	Accepted
25 - 29	83			1.50	
92 - 95	36		0.10		
95 - 98				1.03	
98 - 100	33		0.20	2.95	
104 - 105					
105 - 107	67		0.56	1.65	
114 - 115	33			0.60	
122 - 124	100				
124 - 127	22		1.70	1.04	1.70
127 - 128	83	106	2.36	0.93	1.35
131 - 132	50			1.65	
132 - 133				0.72	
141 - 147	15	102	1.18	2.00	1.96
147 - 148	42			2.88	2.88
148 - 150	33		3.34		2.93
150 - 151	25		2.07		5.10
151 - 153		143		5.40	5.53
153 - 157	33		6.48	5.77	5.85
171 - 172½	50		9.25		
172½ - 174	92			0.85	
206 - 207	50				
207 - 208				1.75	1.75
208 - 211	13		2.07	2.15	2.15
211 - 215				1.55	1.57
215 - 216	58				2.36
216 - 217			1.23	2.44	2.19
217 - 218	58			1.75	1.64
218 - 220	63		3.29		2.09
244 - 247	17	73	2.21	4.22	4.10
247 - 248	33			2.20	
267 - 269				2.16	
269 - 270	67	127	0.56	1.85	
286 - 287	72				
287 - 289				0.72	
289 - 292	53		0.62	0.95	
292 - 293					
293 - 293½					
293½ - 294			0.10	1.13	
294 - 295	38

295 - 299	25			1.10	
299 - 303	63	94	0.30	1.96	1.59
303 - 304				0.82	1.10
304 - 305	61	122	2.10	4.33	3.85
305 - 306				1.10	1.32
306 - 310	90	75	1.50	1.08	1.21
310 - 313	67	83	3.00	2.15	2.35
313 - 316	33	79	2.20	3.04	2.94
316 - 318	25	98	1.80	2.25	2.21
318 - 321	89	119	1.60	2.27	2.06
321 - 323	38		0.40		
336½ - 337	100		3.40
