Moonlight Mine T22S R10E Sec 27 Santa Cruz Co AZ
Owned by Glynis Burkhardt - Tucson
Narrow NW structure w/ 6"-1' gtz in.
No alteration of wall Rx
No mineralization in wall Rx Qtz Diorite
No interest.

PRIMARY NAME: MOONLIGHT MINE

DEPARTMENT OF MINERAL RESOURCES
STATE OF ARIZONA
OWNERS MINE REPORT

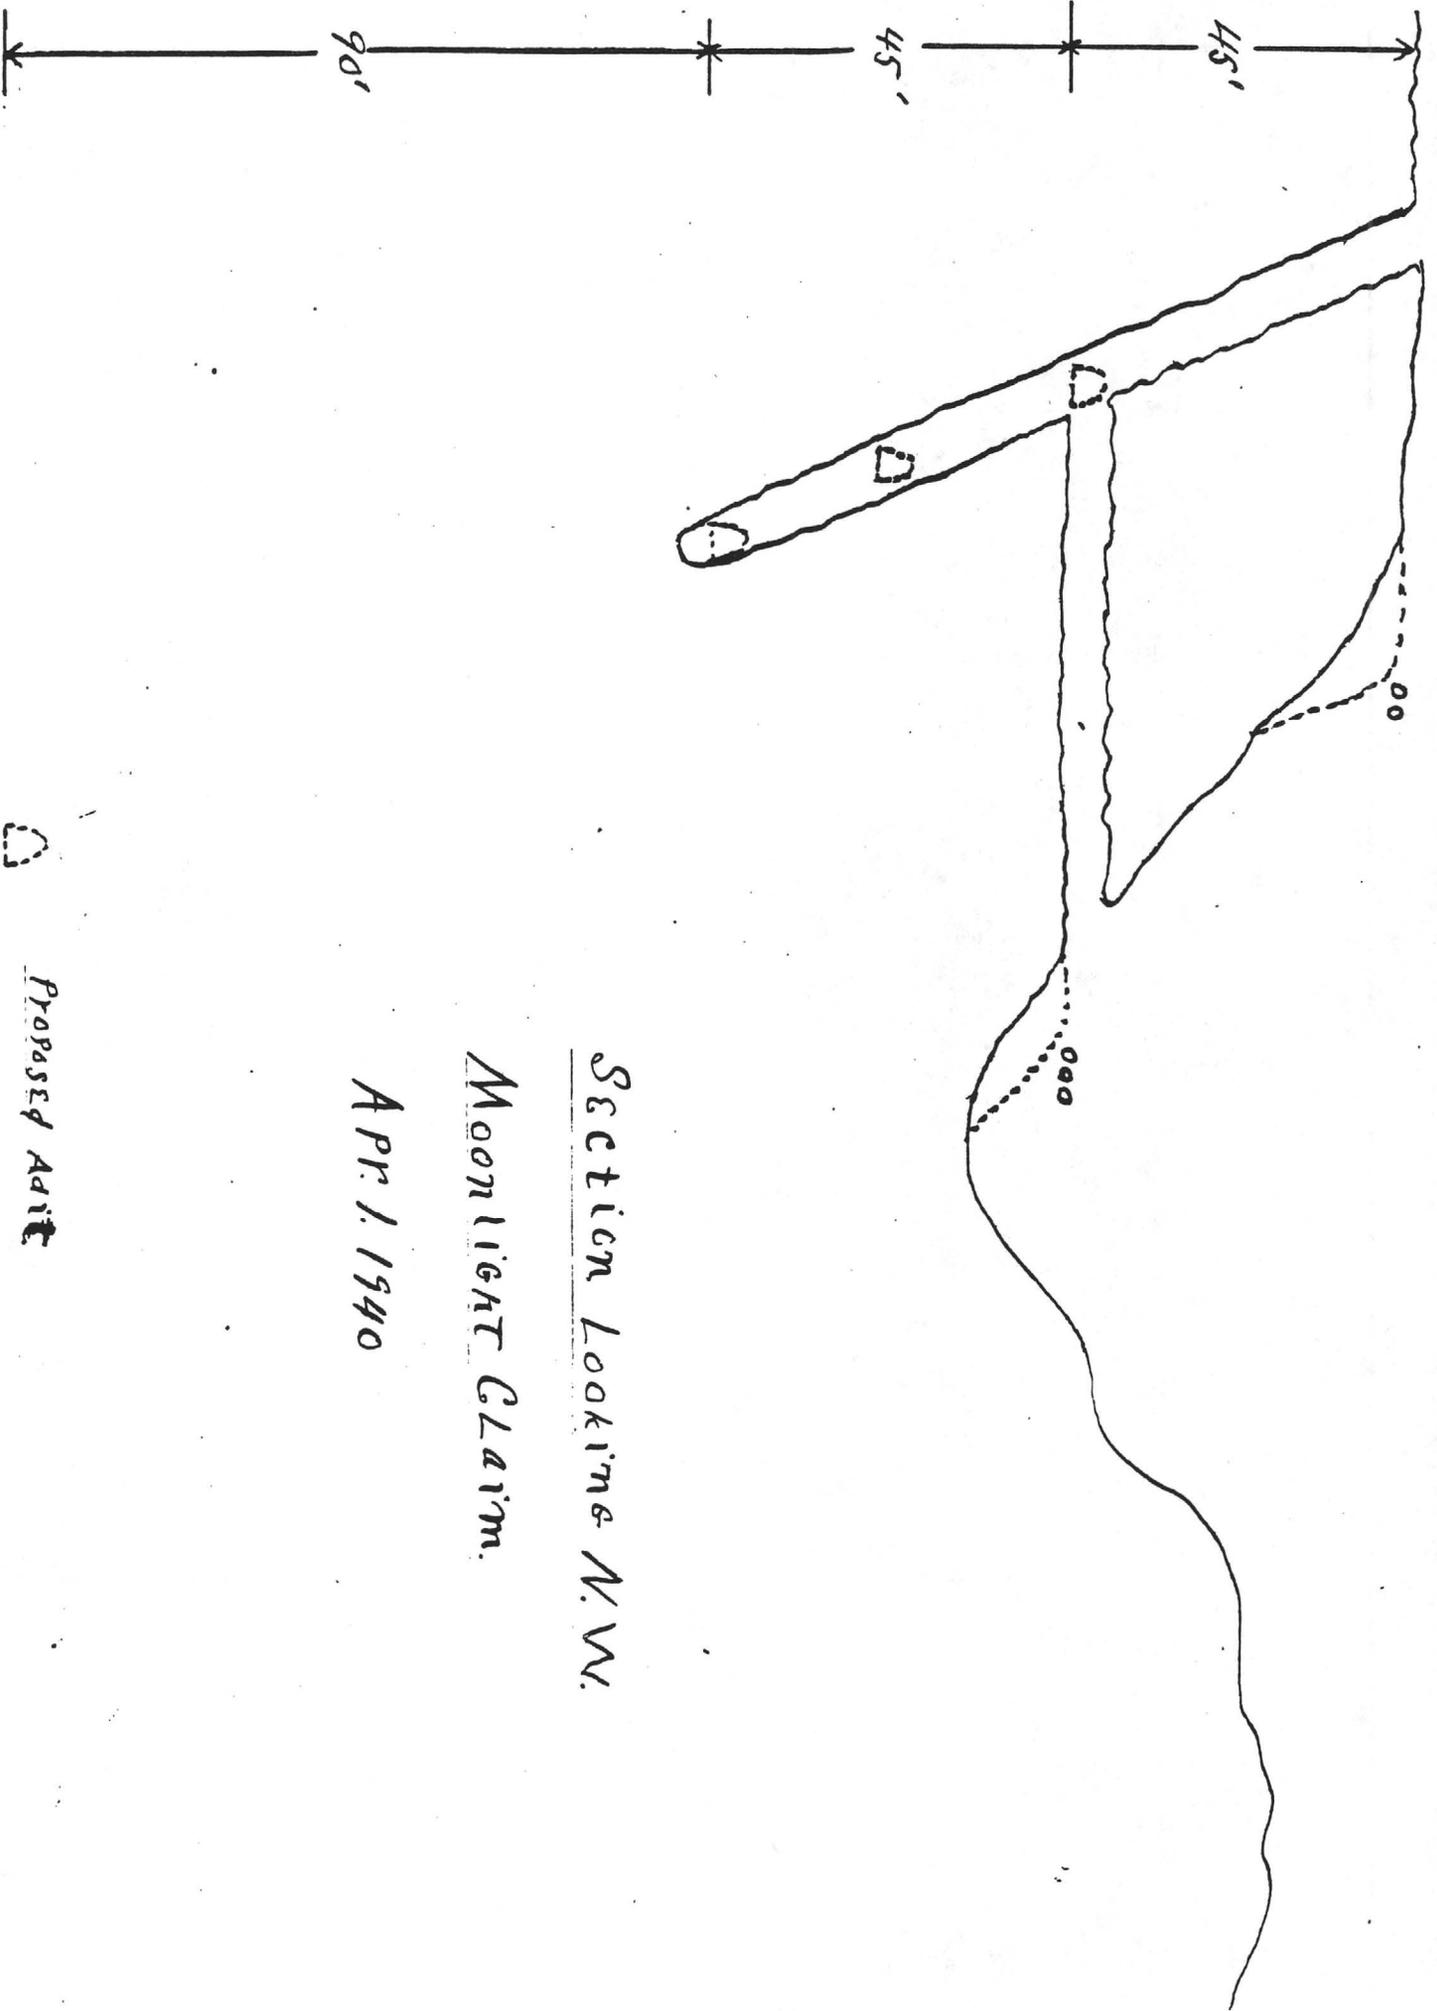
Moonlight Claim.

22. Approximately 200 ft. of development work has been done, nearly all on the lode. Attached sketches show the distribution of this work and the location of proposed further development. All workings are open for inspection and sampling.

Section Looking N.W.

Proposed Adit

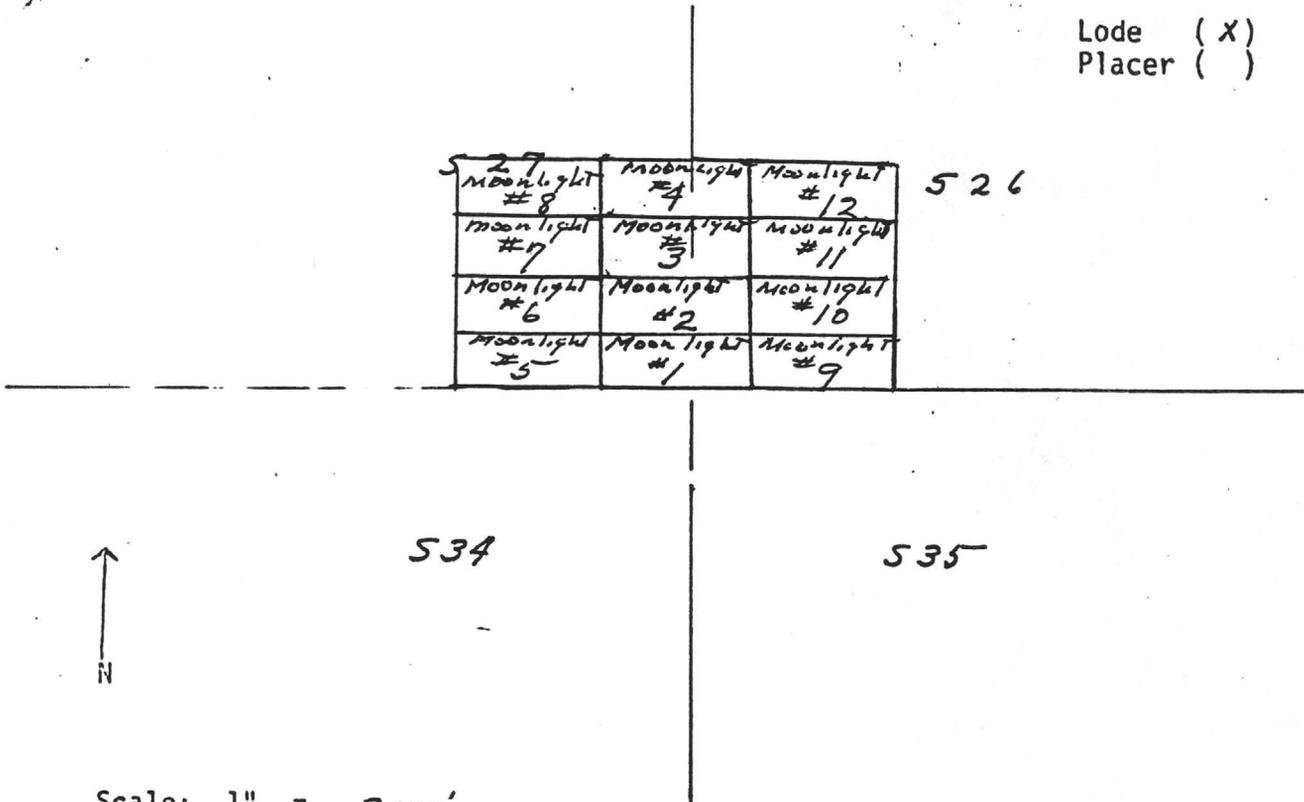
CLAIM MAP

1. The above map depicts the Moonlight mining claims which is located in Section(s) 26/27, Township(s) 22S, Range(s) 10E, G&SR#1, Santa Cruz County, Arizona.
2. Type of corner and location monuments used are as follows: _____
2'x2' x 4 1/2' & 4'x4' x 4 1/2'
3. The bearings and distances between claim corners are as depicted on the above map.
